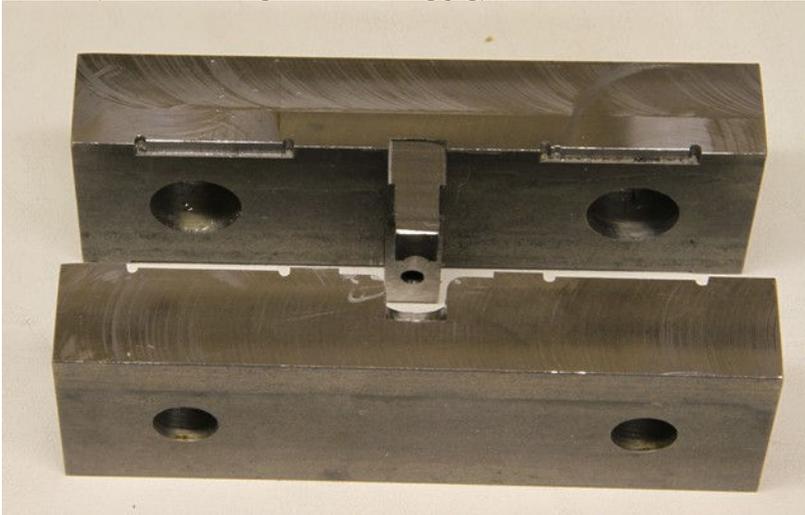
Pic #1 (Rocker arm guide forming jig)

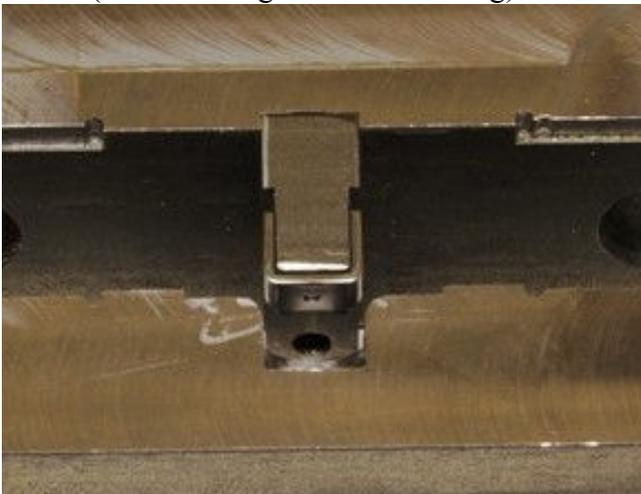
Pic #2 (Rocker arm guide after forming)

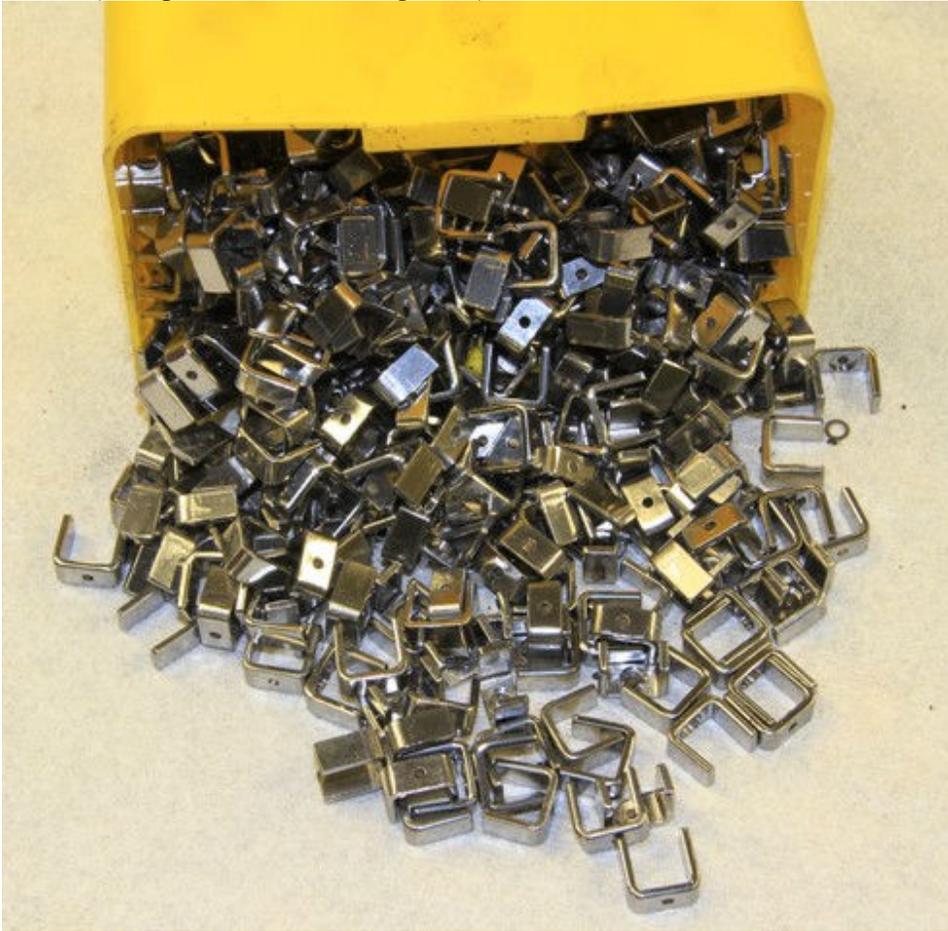
Pic #3 (Completed rocker arm guides)

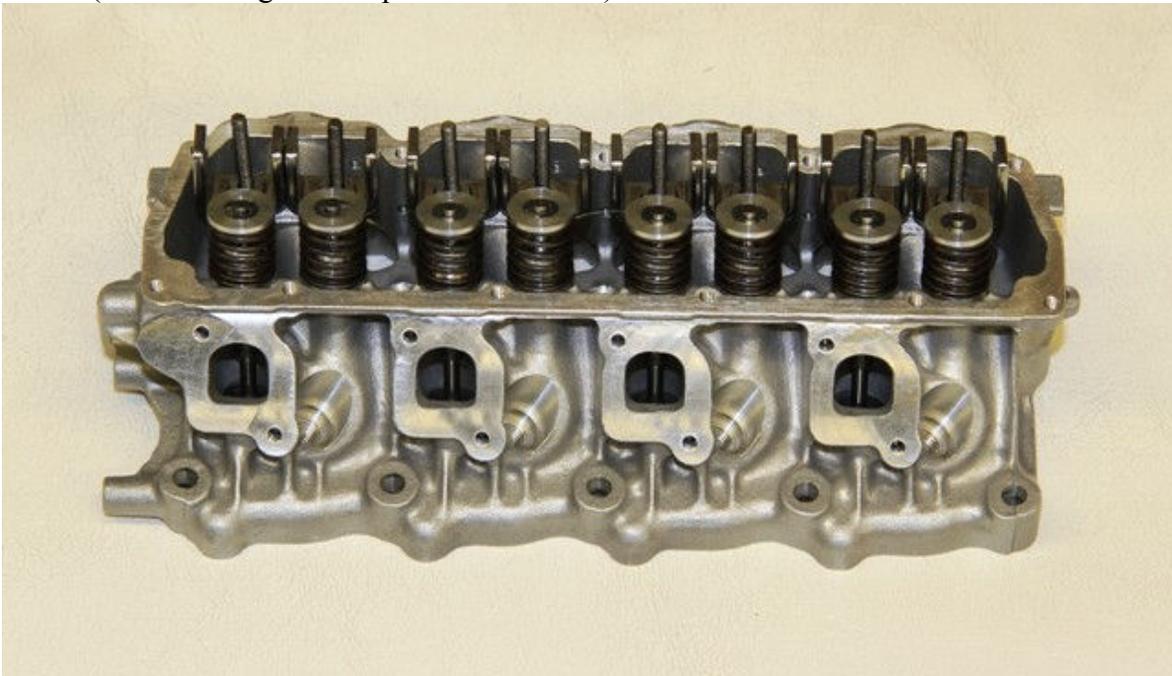
Pic #4 (Rocker arm guides in place on the head)

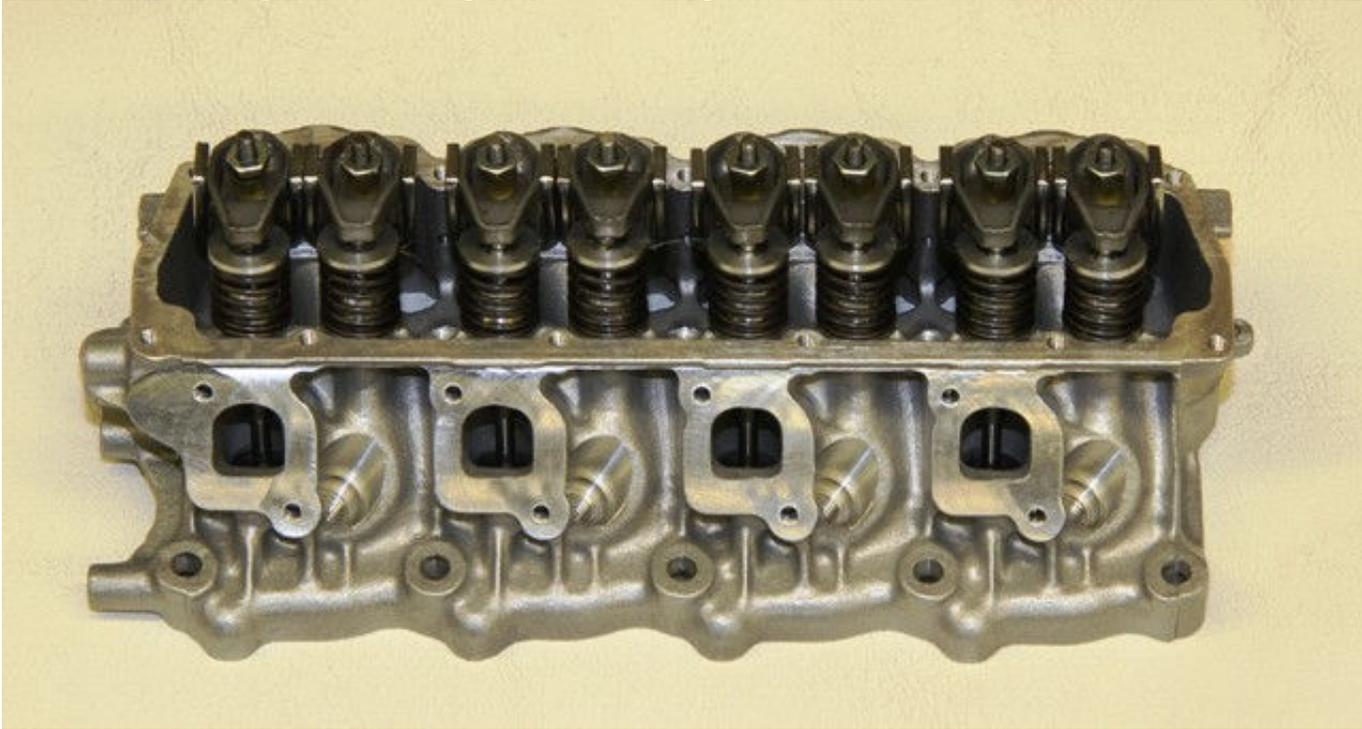
Pic #5 (Rocker arm guides with sample rocker arms in place)

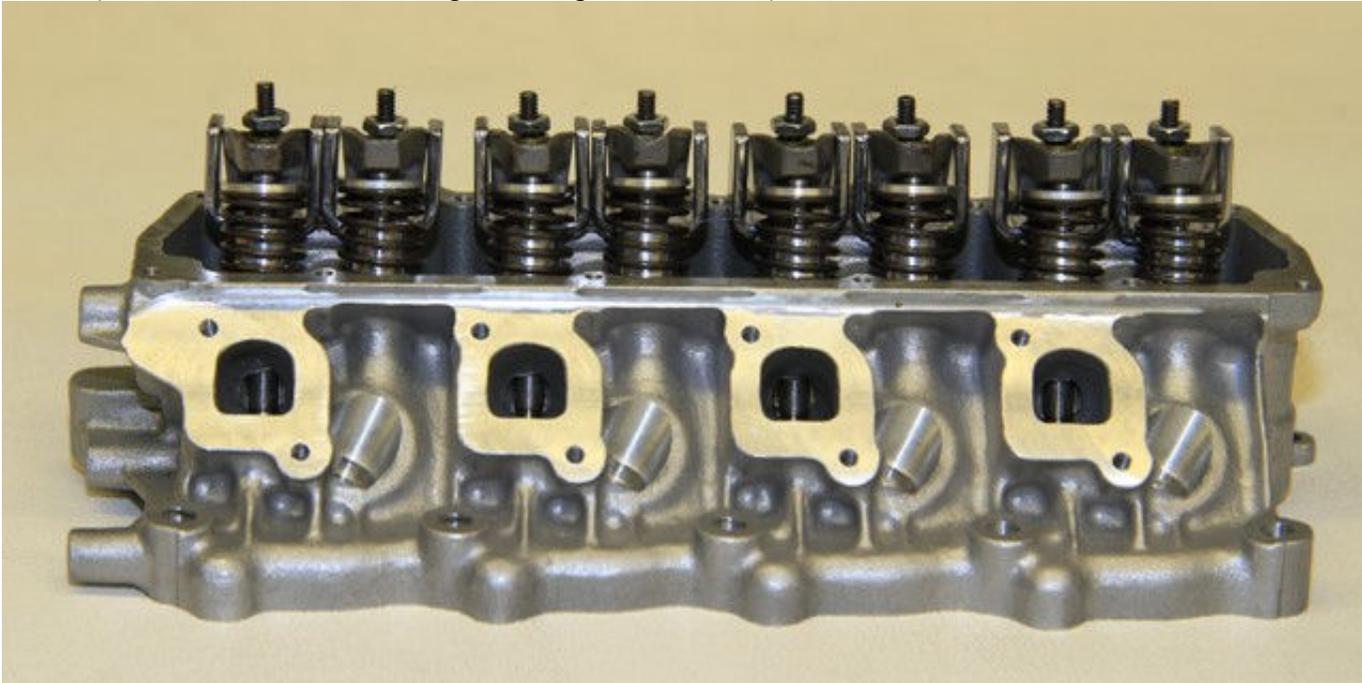
Sorry for the delay everyone, but I have just completed two weeks of “hell”. It all started with the new pushrod guides. After installing the heads on several engines, I noticed that there seemed to be too much side play at the contact point where the rocker arm touches the top of the valve. If you remember, I was very careful to make the pushrod guide plate with very close tolerances. The thickness of the material was also increased to help eliminate movement. Obviously there needs to be some clearance not only for hole in the pivot but also where the pivot contacts the inside of the rocker arm. Furthermore there is a mechanical advantage which allows for the tip of the rocker arm to move further than the heel. Is everyone still with me? Unfortunately this mechanical movement also allows for an exaggerated lateral movement of the tip. After some serious time and several sleepless nights, I went back to the prototype design and improved on it. I needed to make a forming jig which would insure every new bracket was identical. As you can see from the pictures the new rocker arm alignment bracket does not allow any lateral motion! In other words, there is no way the tip of the rocker arm can pivot from side to side. So, all the pushrod guide plates were removed and the new alignment brackets installed. The old pushrod guide plate was an improvement when I put it in - and an even bigger improvement when I took it out.

Pic #6 (Notice how rocker arms align with top of each valve)

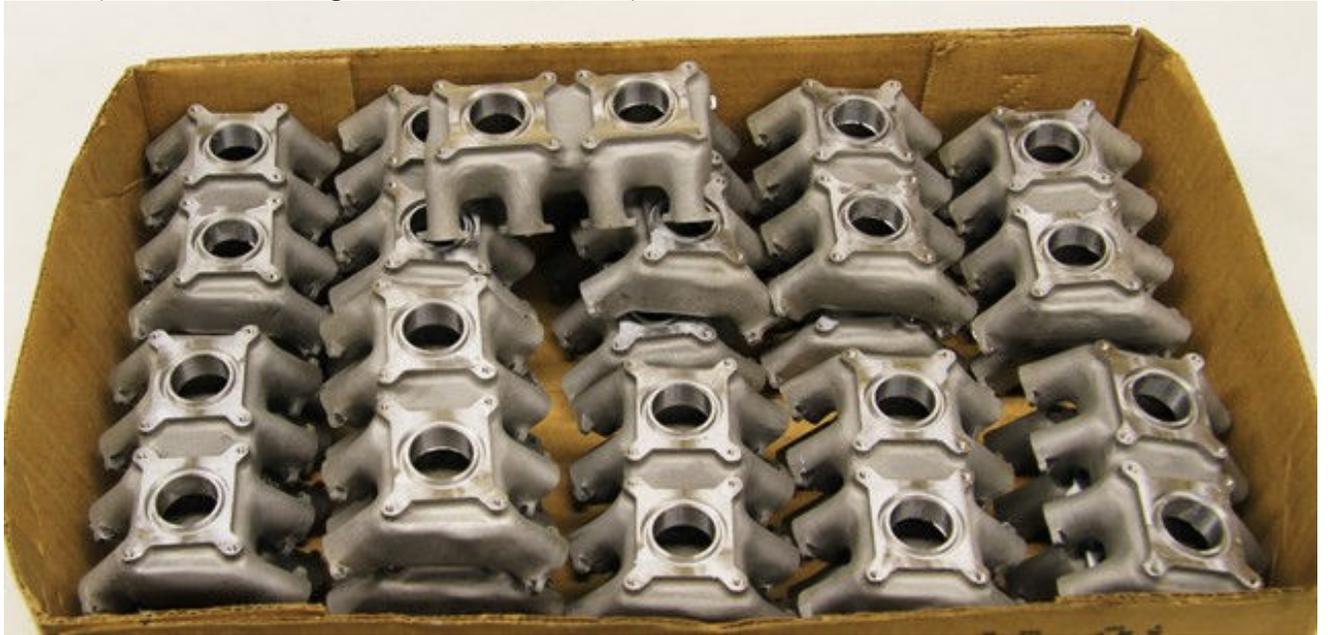
Pic #7 (22 additional completed intake manifolds)
