(29 April 2008)

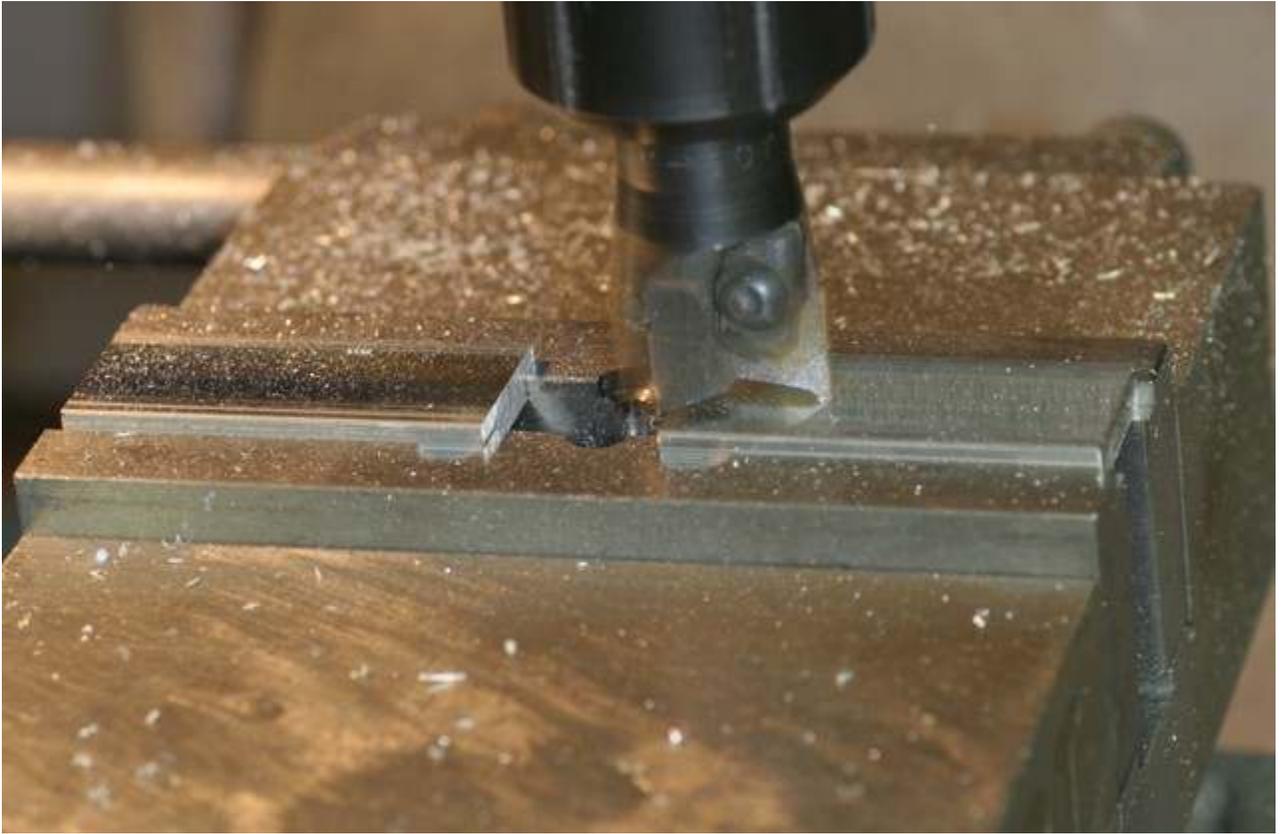
Pic #1

Picture #1 shows the initial set-up. Firstly, the side of each connecting rod is machined to the proper thickness. The holes are then drilled for the wrist pin and pilot hole for the rod journal (picture #2).

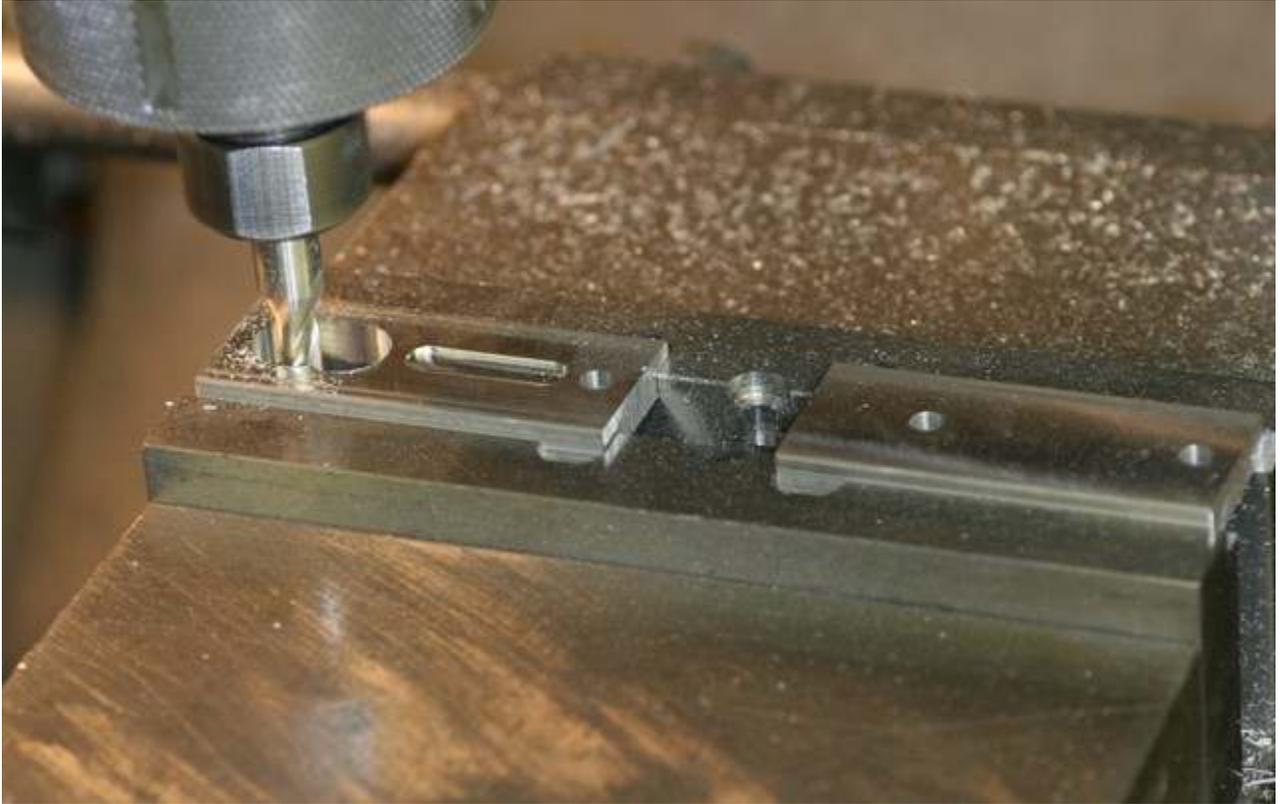
Pic #3

The initial internal shape is machined (picture #3). The outside contours are then machined (picture #4). The three items in picture #5 shows the initial bar stock (left) and finished profile (right). The holes are drilled for the rod bolts and then each rod is put into another jig where a milling cutter separates the upper part of the rod from the rod cap. This makes for a perfect match. The rod body is then tapped, the caps replaced and then each rod is honed to the exact dimension. Picture #6 shows the complete set of 8 rods.
