A lot of things are happening now that the first run of engines is getting closer to completion. The pans castings are totally finished and can be seen in pictures below. They are self explanatory but if you look you will see there are a lot of pan screw holes - 27 to be exact. The pan could probably be held in place using just 4 screws, but by using 27, the pan is now a "structural member" of the engine. This adds a tremendous amount of rigidity and strength. Is it necessary, maybe not, but I am trying very hard to make the best engine available and if this lessens the possibility of problems later, then it was worth the extra effort. One more thing, if you look closely at the inside of the pan you will notice a channel machined into the bottom of each chamber. This is not just a groove but is actually a descending angle which directs the used oil to the two holes that are drill and tapped into the side of the pan. There is a fitting placed into each hole, then oil lines are installed which go the oil pump, which returns the oil back to the holding tank. This was not mandatory but any little thing like this helps to make it a better engine. If you remember in my past emails, I sai

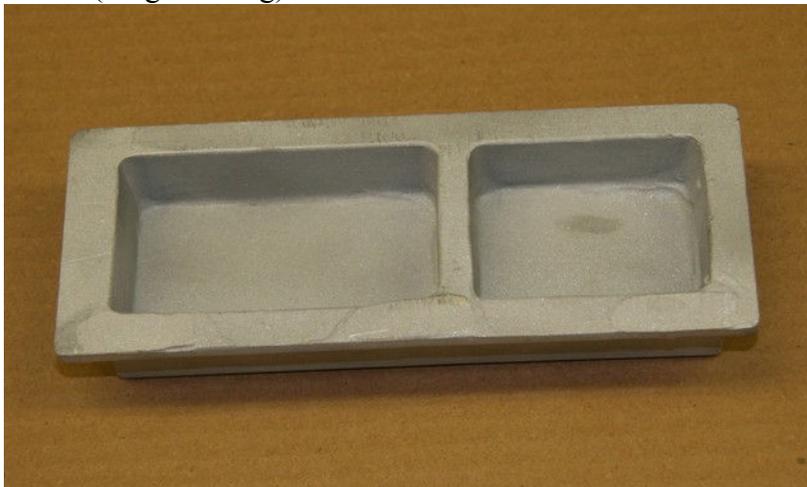
Pic #1 (rough casting)

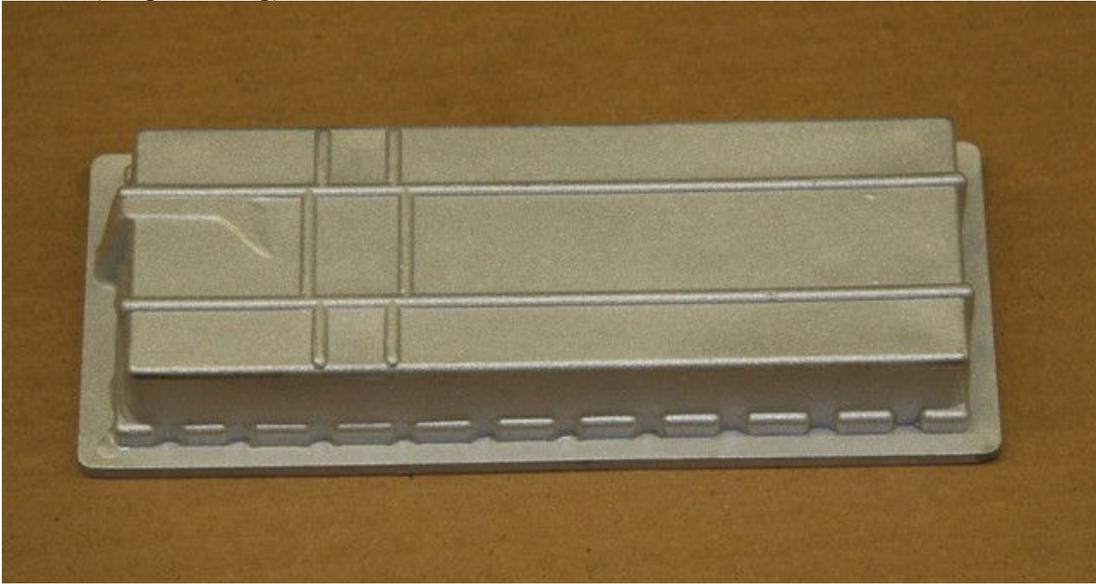
Pic #2 (rough casting)

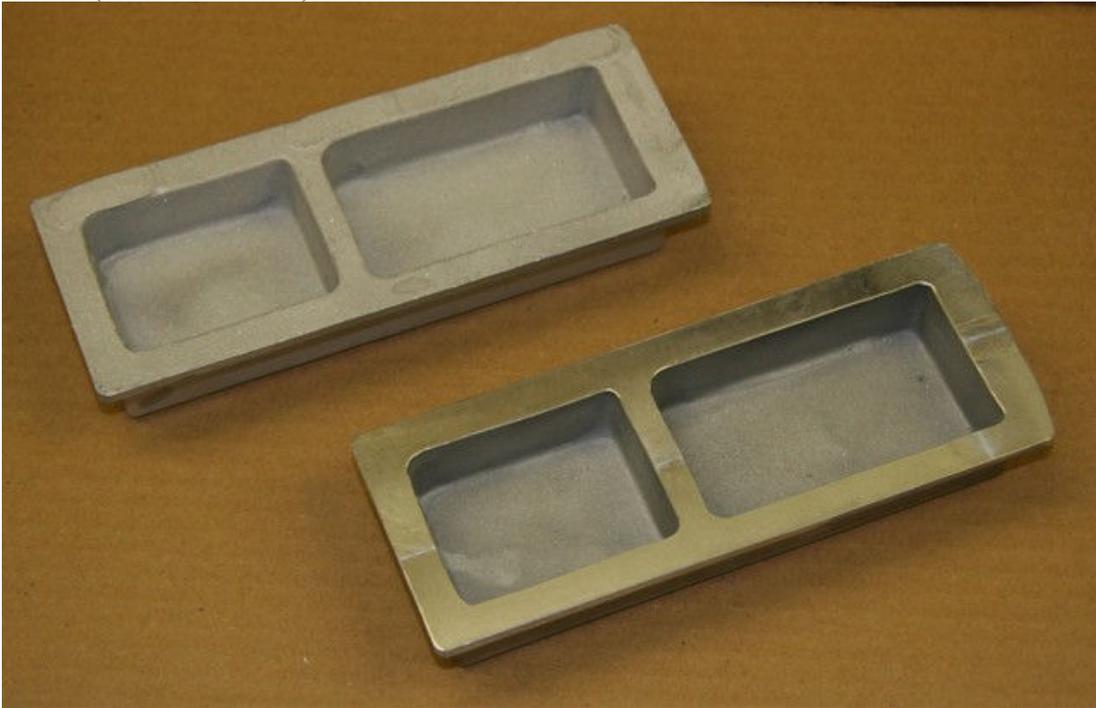
Pic #3 (before and after)

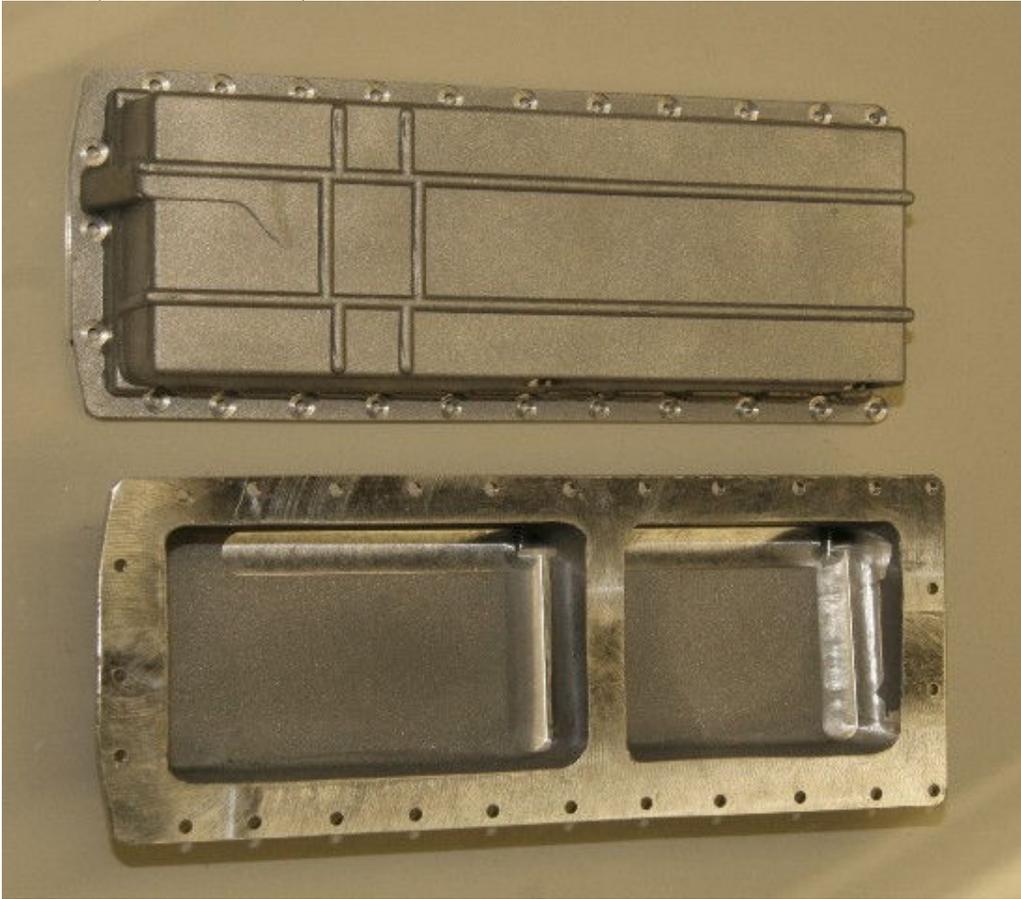
Pic #4 (before and after)

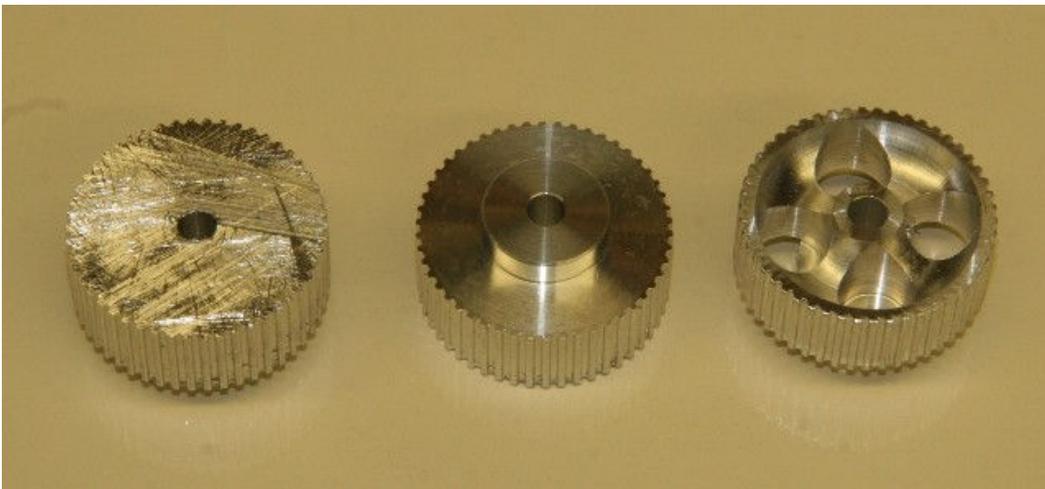
Pic # 5 (alternator pulley progression)

The toothed pulleys for the alternator start out just as the crankshaft drive pulley in my previous update. This is a good example of spending the extra time to make the engine more esthetically pleasing. Like one of my customers said "if it takes a couple of extra months to finish the engines - who cares". I could have very well have left the pulley as it was, but I think the change is worth the extra effort. Once again, the pictures are self explanatory. You be the judge!

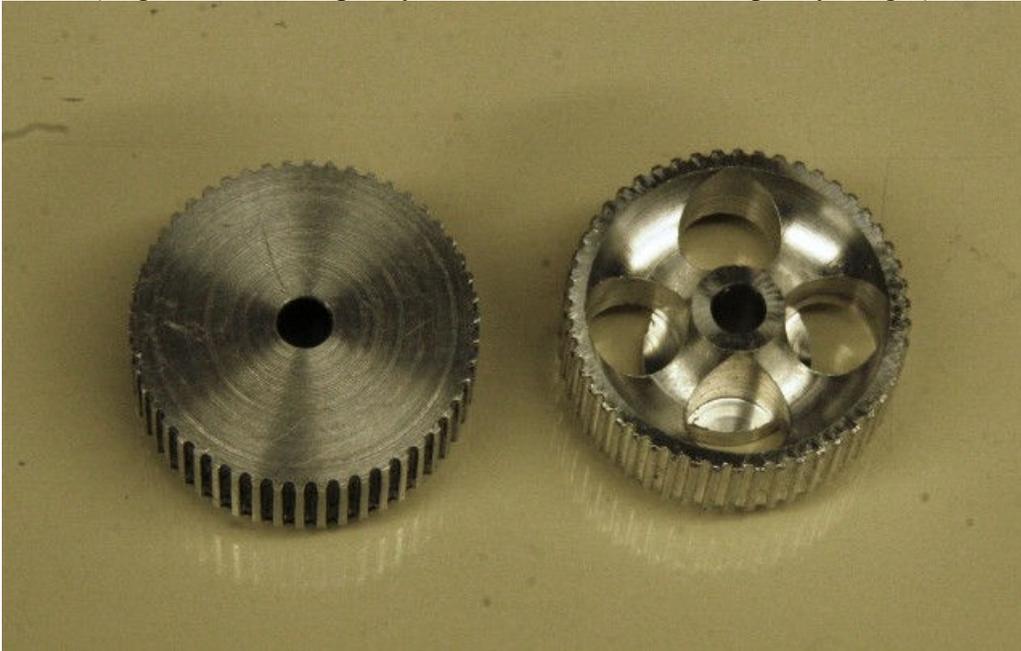
Pic #6 (original alternator pulley – left, and new alternator pulley – right)

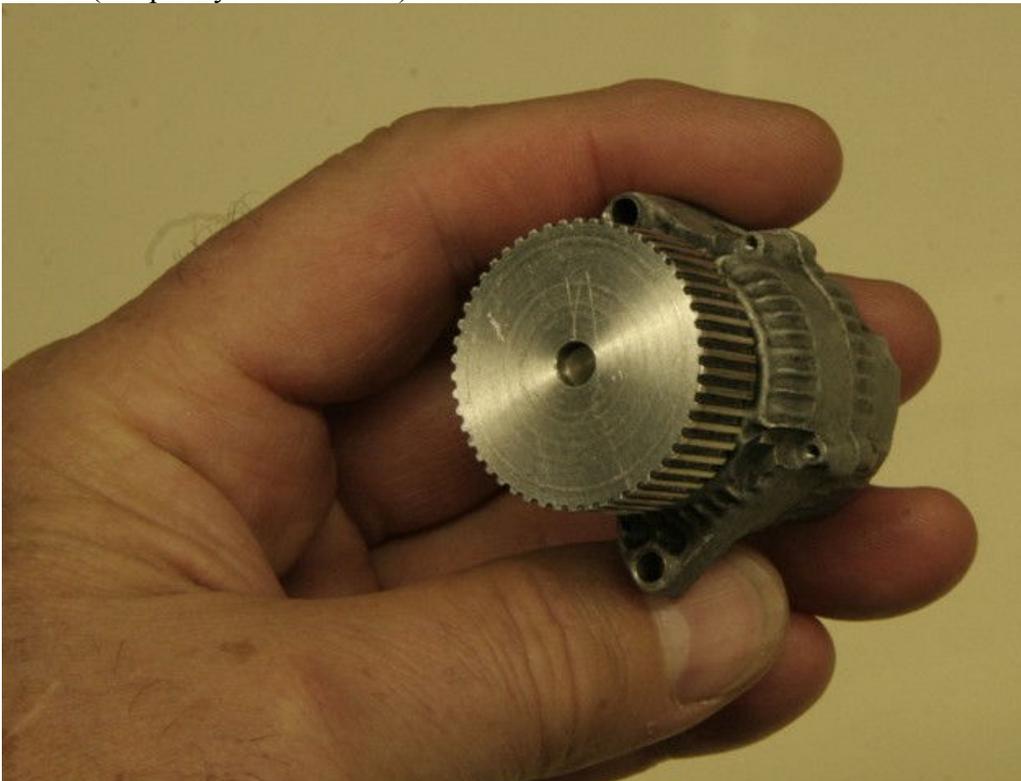
Pic #7 (old pulley on alternator)

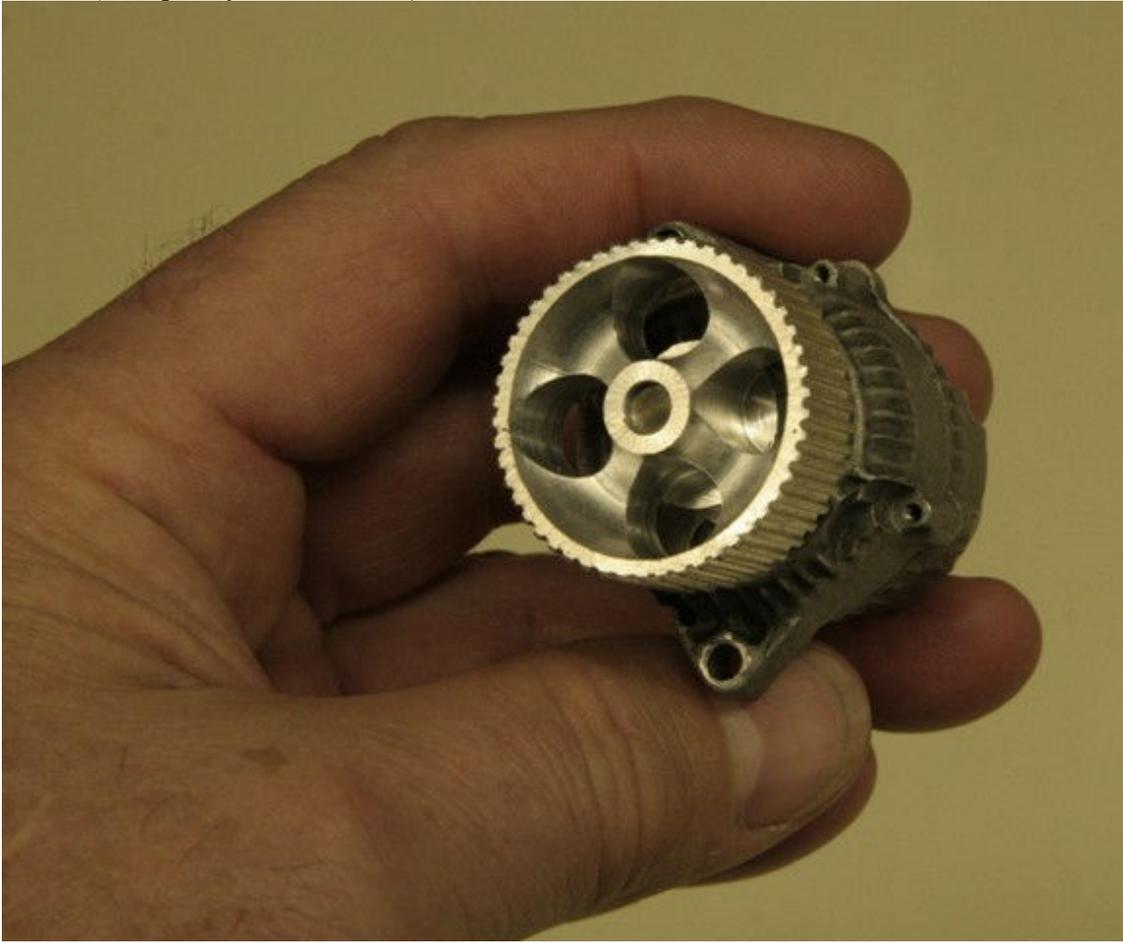
Pic #8 (new pulley on alternator)
