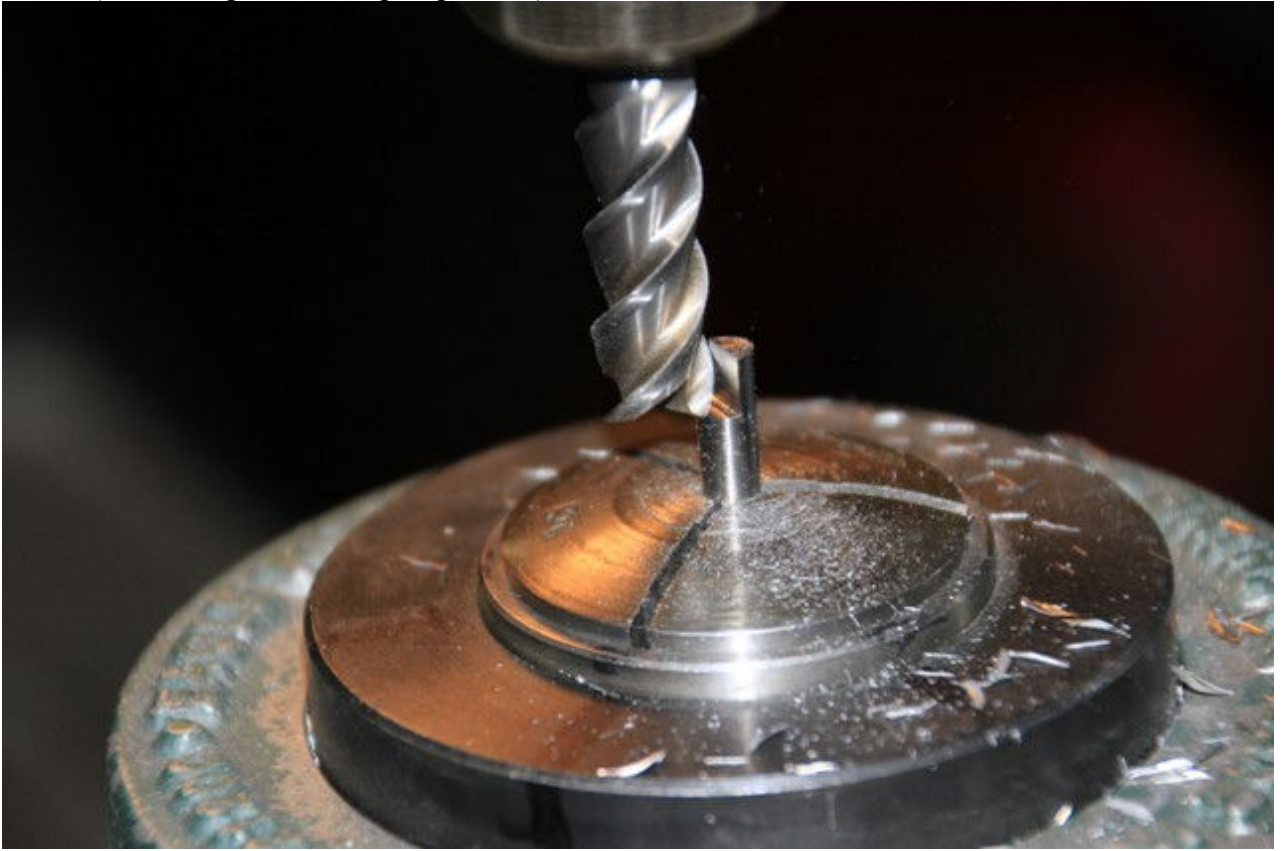
Pic #1 (Machining flat on oil pump shafts)

Once the shafts for the oil pump, water pump, distributor, and supercharger impellers have been cut to the exact length, they must then have a variety of different flats and areas machined. Keep in mind, in each oil pump there are three separate shafts, each with a different configuration. When you multiply this by 80 oil pumps, it is easy to understand just how demanding some of these parts and components are! Add to this equation, 5 ball bearings, two seals, 8 bolts, 6 gears (3 of which must be soldered to the machined shafts) one center section with check valve, and one toothed pulley. I am tired just thinking about it. Ha. Ha. Each pump must be carefully assembled which nothing left to chance!!! Picture #8 shows a partially run of completed oil pumps .After assembly, each pump will be thoroughly tested for pressure and flow.

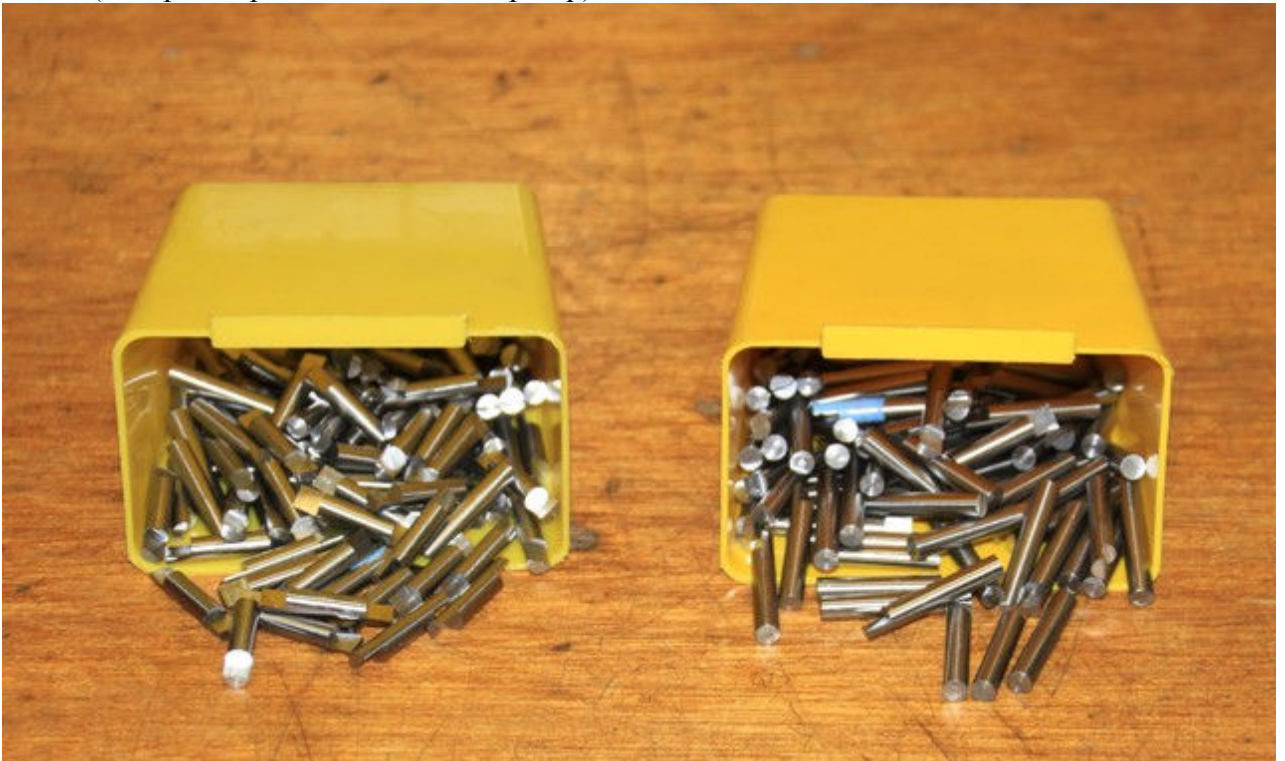
Pic #2 (Completed partial shafts for oil pump)

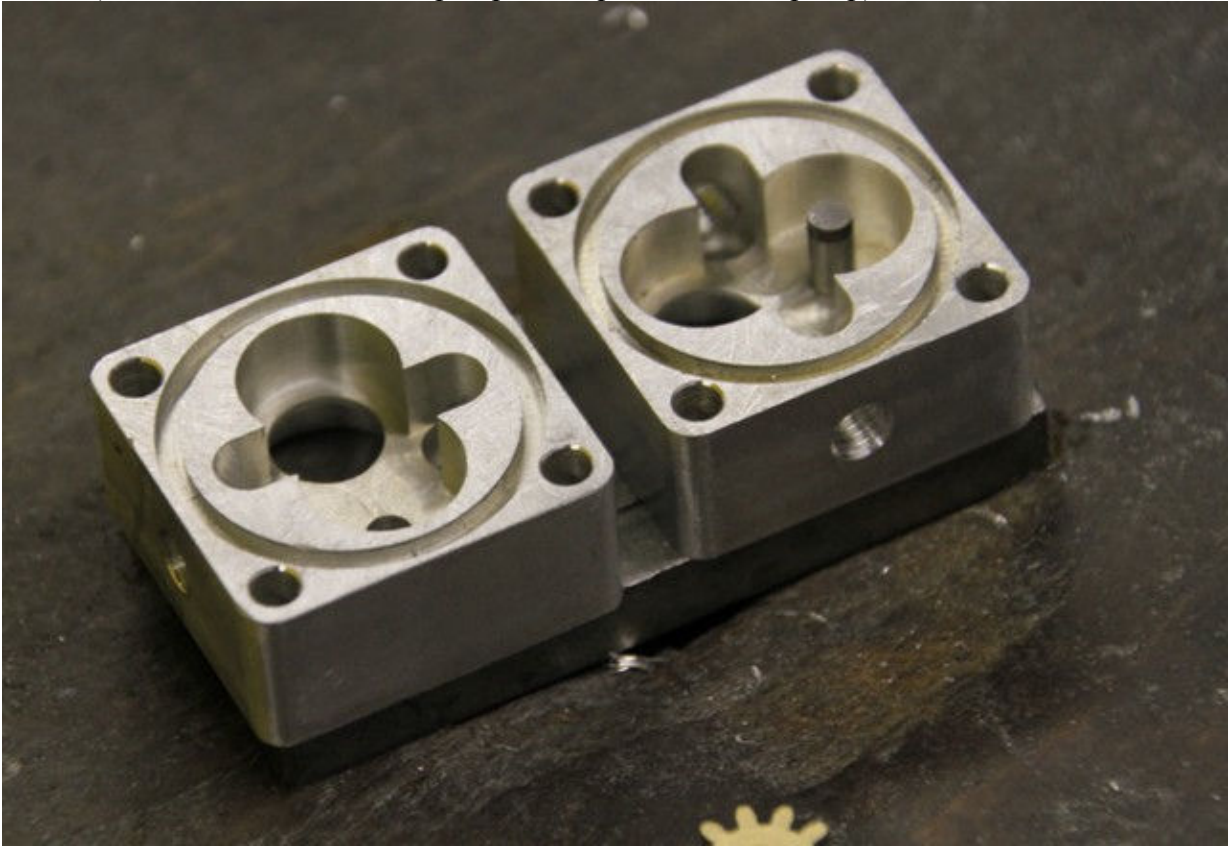
Pic #3 (Machined sections for oil pump – 3 required for each pump)

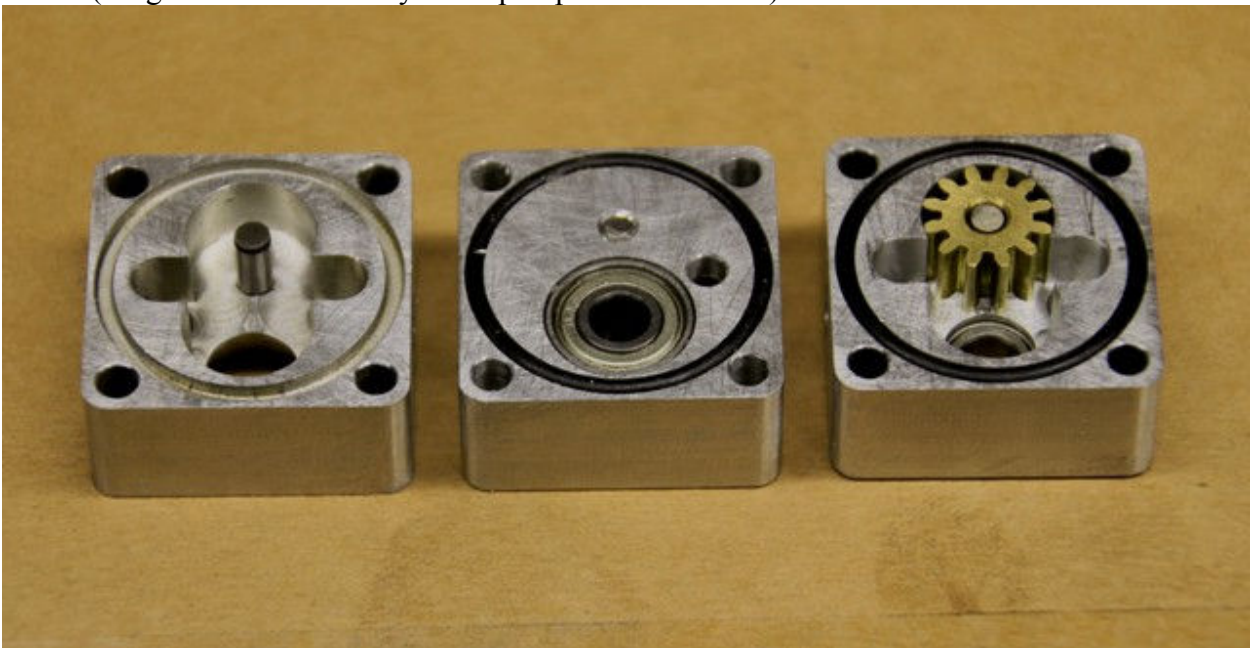
Pic #4 (Progression of assembly of oil pump center sections)

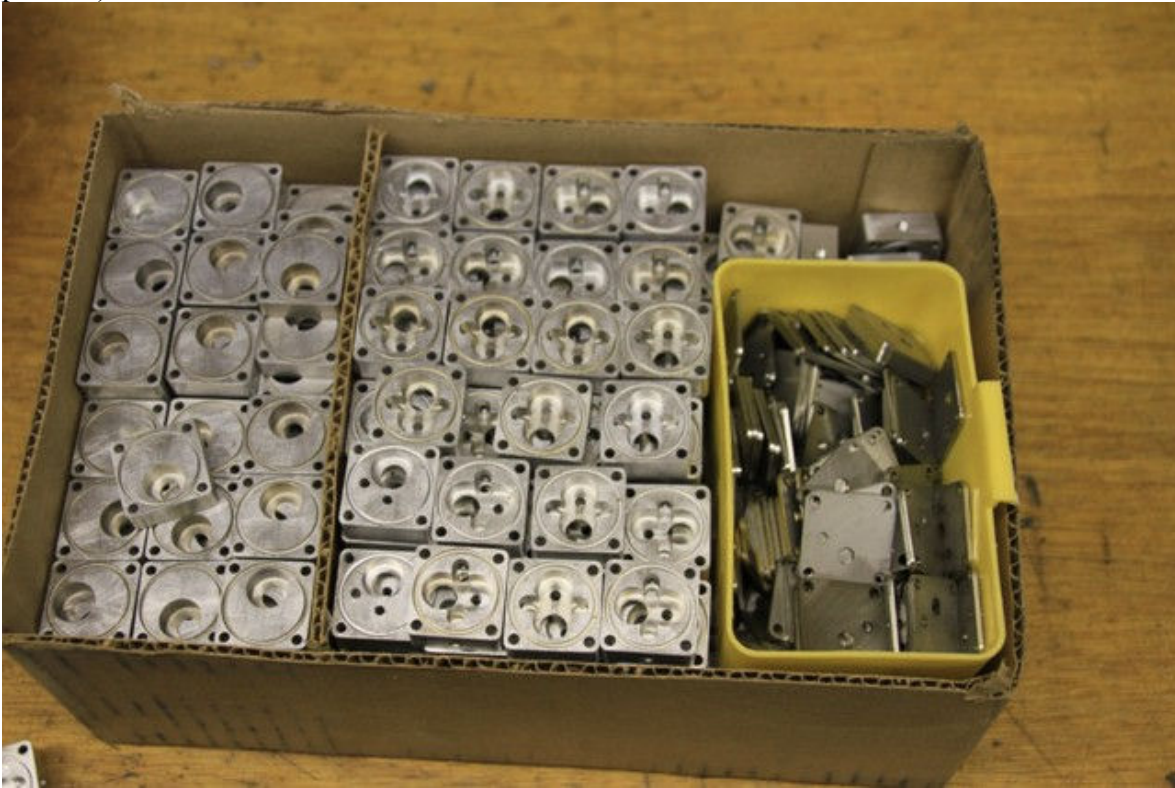
Pic #5 (Lot of front, center gear sections, and thrust plates ready to start the assembly process)

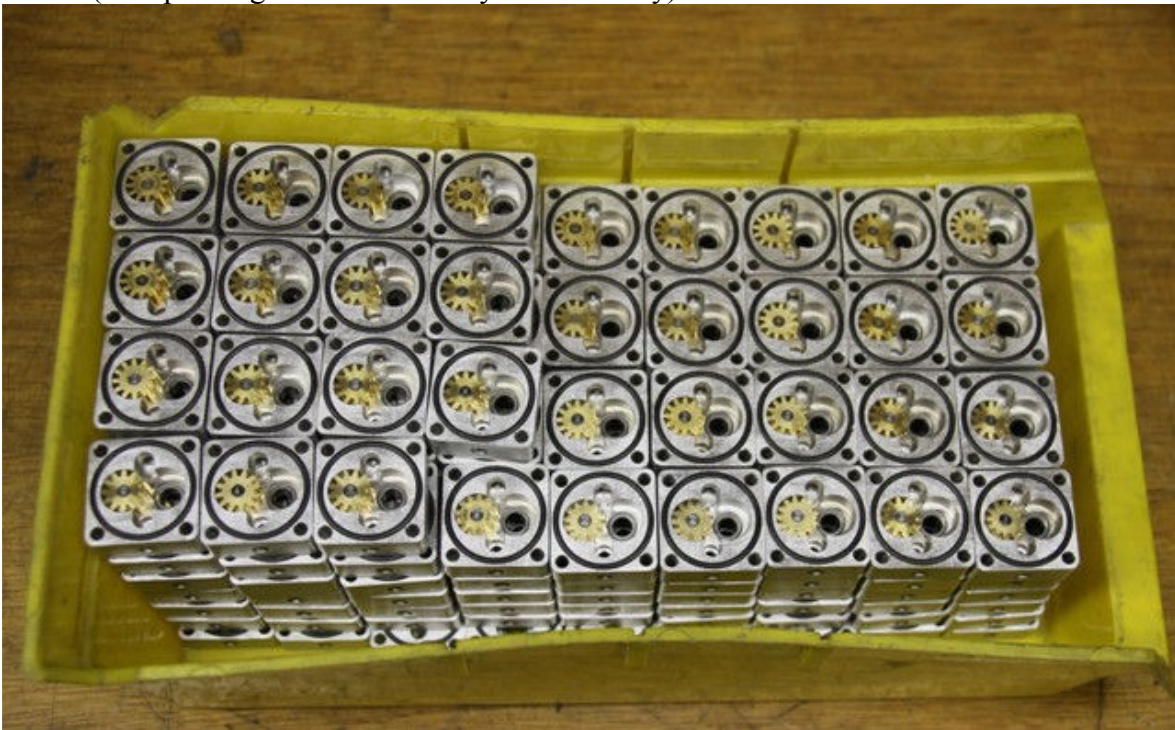
Pic #6 (Completed gear sections ready for assembly)

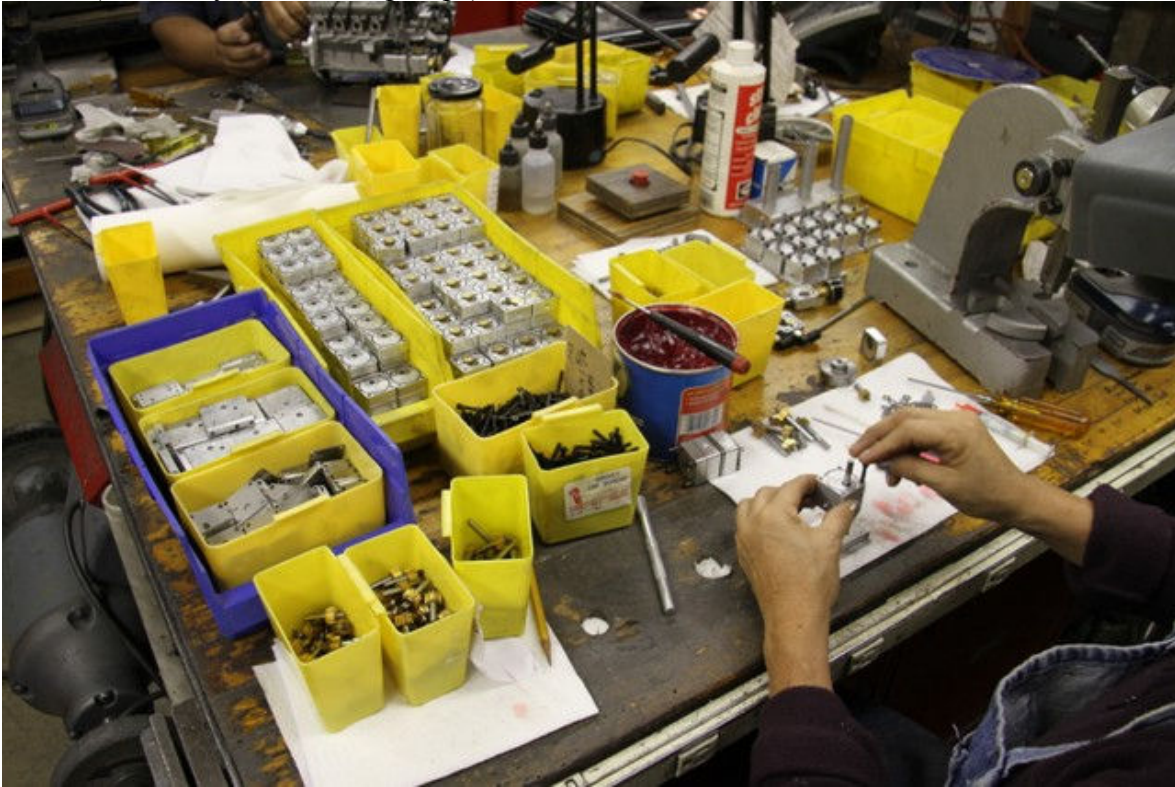
Pic #7 (Assembly area for oil pumps)

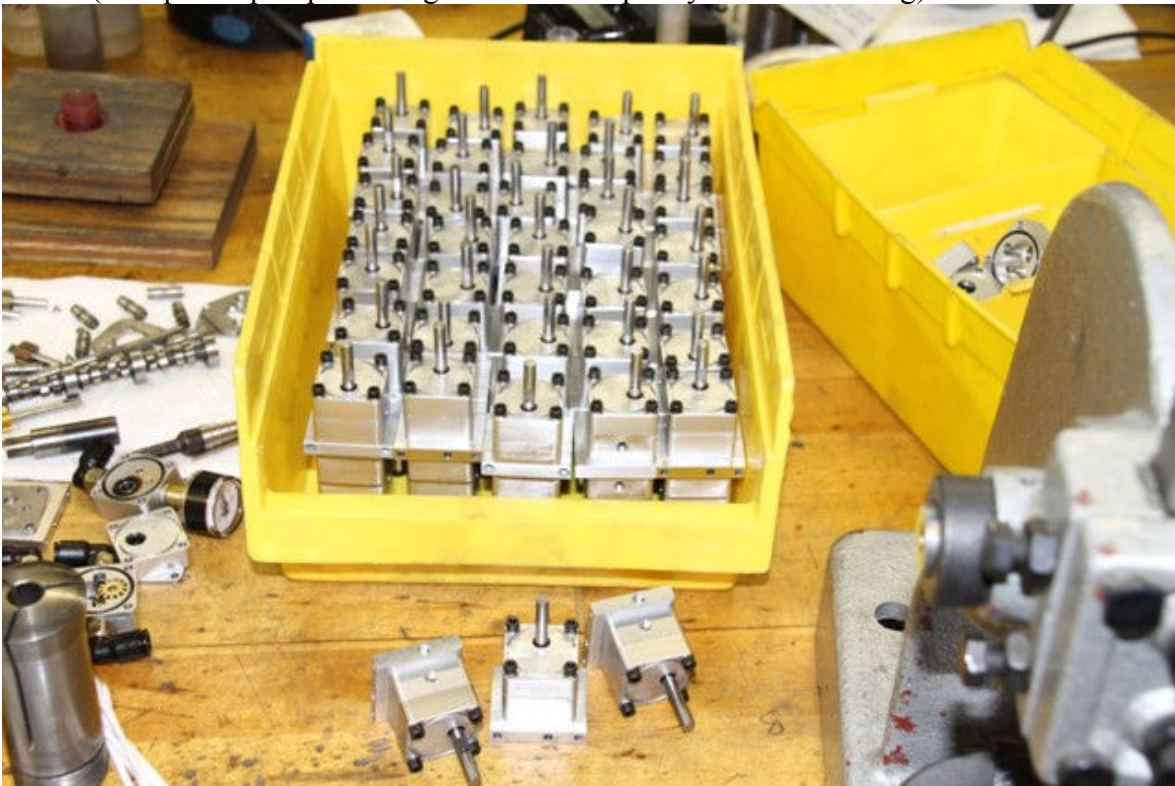
Pic #8 (Completed pumps waiting for tooth belt pulley and final testing)

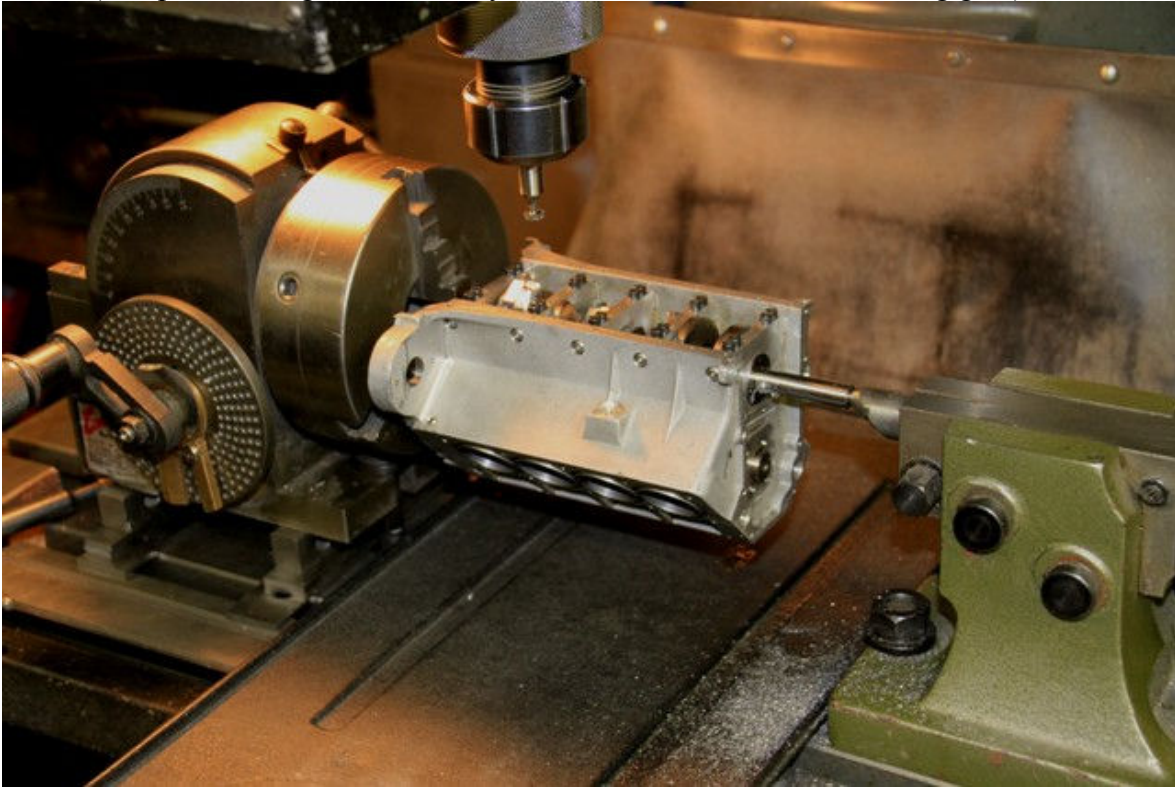
Pic #9 (Setup for cutting Woodruff key slot in crankshaft for lower timing gear)

While the pumps are being assembled, a lot of other things are happening at the same time. The keyway slot for the lower timing gear is machined into crankshaft. Like most items on this engine, this is an important operation which is very evident when I set the camshaft timing.

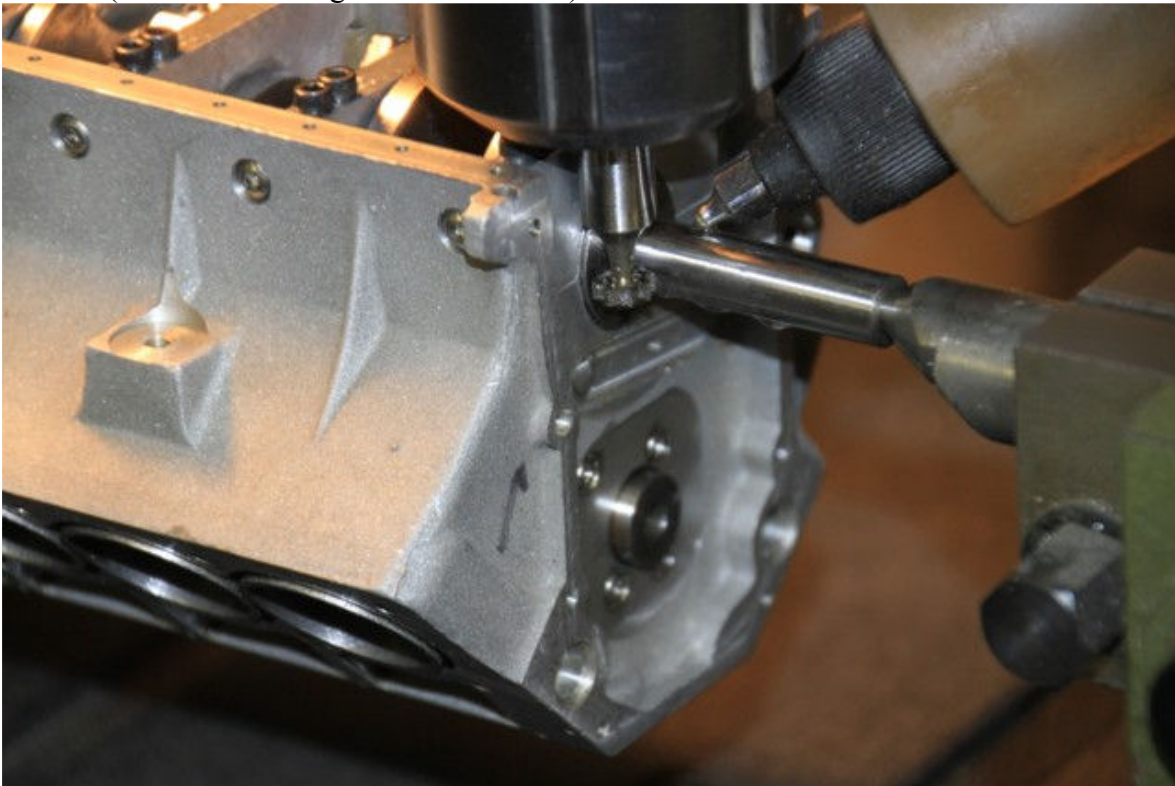
Pic #10 (Actual machining of Woodruff slot)

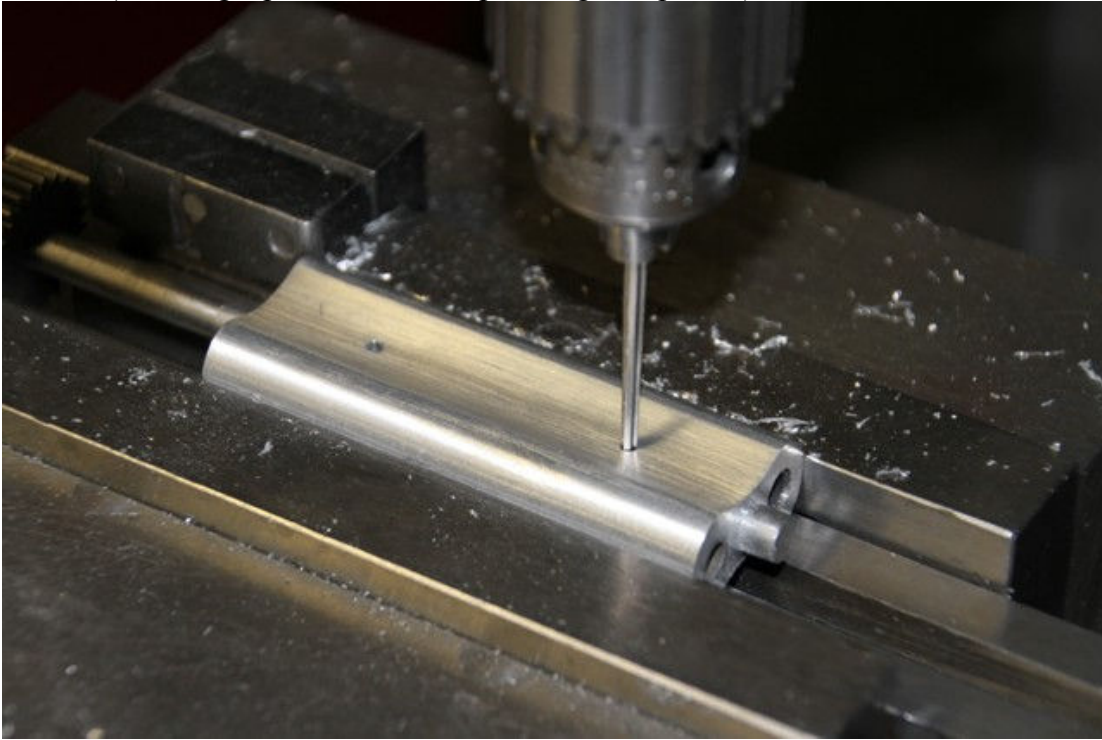
Pic #11 (Reaming tapered hole for supercharger impellers)

The initial machining operations have been started on the supercharger impellers. What you are seeing in the next to the last picture is the tapered reaming operation. When finished a tapered pin is hammered into place, using a flat end punch. The excess pin material is removed and then each side is spot faced. Just think about this, there are two impellers per supercharger, four holes which must be drilled – four holes to ream – four tapered pins installed – excess material removed from each tapered pin – 8 spot faced surfaces. I have not even started to describe what must be done to the housing and end plates. More about this on a later update! The last picture shows ten sets of matched impellers. The gears must be matched perfectly and these two impellers must always remain together. There is no chance for error. If I am only off by 1 degree, then the impellers could touch and because of the high rpm of the engine, any abnormality would be noticed instantly. I actually had one customer who ran his engine without the air cleaner and someway a piece of paper was ingested into one of the carburetors and totally destroyed the supercharger. Luckily none of the internal engine components were damaged. It did, however cost him over \$1,800.00 for me to fix the engine. Just something to think about!

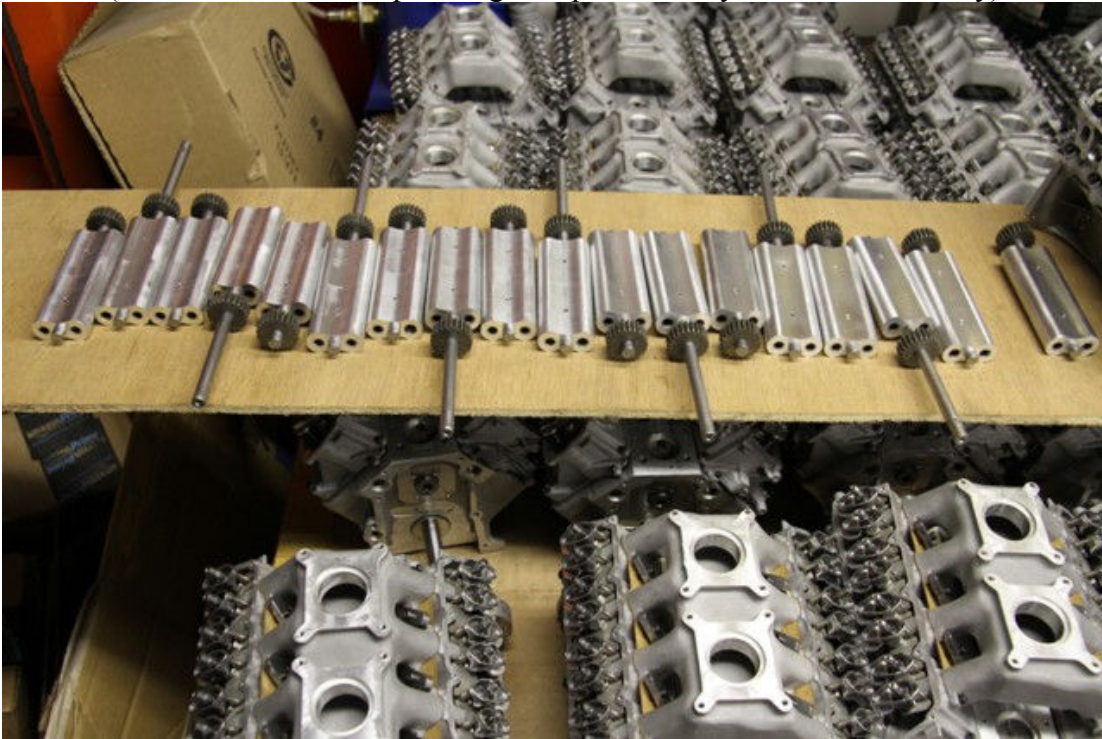
Pic #12 (10 sets of matched supercharger impellers ready for initial assembly)
