Well, I can only say, the holiday season was very demanding and it started the day before Thanksgiving. Without dwelling too much on the past, I am happy to report, “things” are back to normal. Engines are slowly being shipped out. If you ordered an engine with a car or test stand, it will take a little longer, but at least the end is in sight.

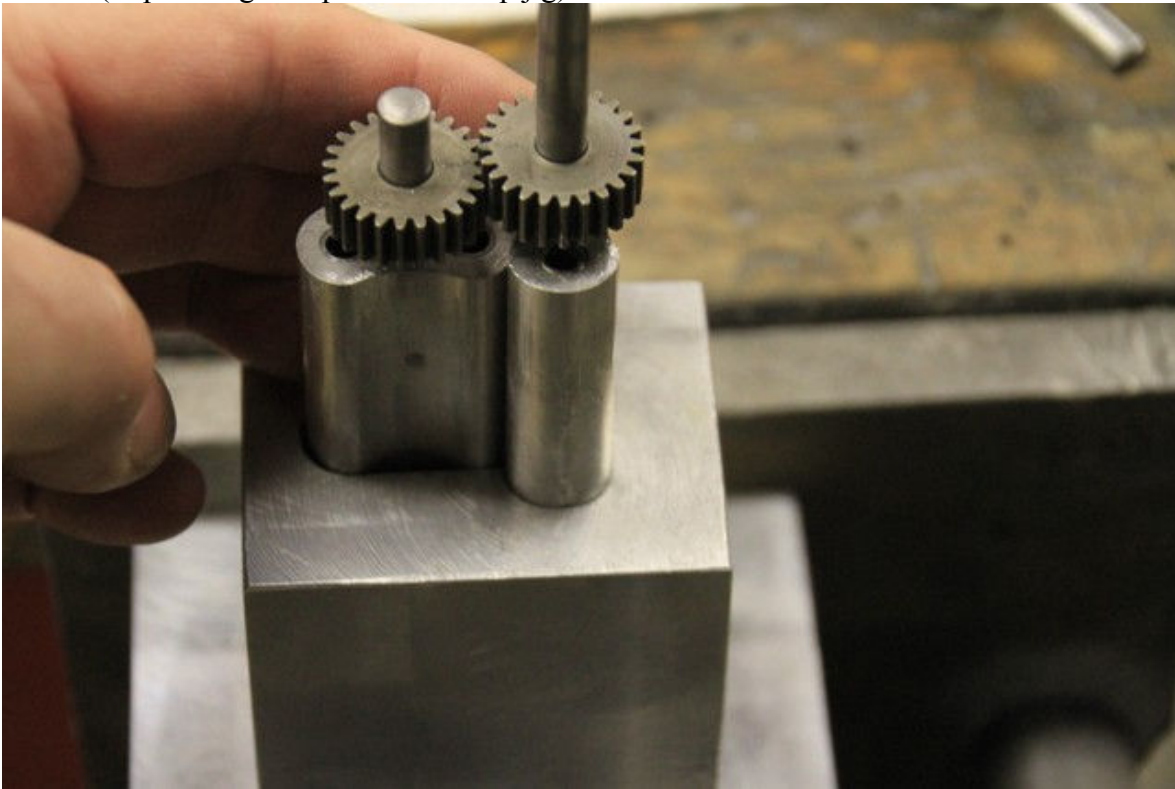
Pic # 1 (Supercharger impellers in setup jig)

A lot of time has been devoted to completing the superchargers. Remember, about 95 of the engines being shipped were supercharged. At first glance my supercharger looks like a relatively simple item. The trouble begins when the rotors are assembled and need to be “timed”. Because the tolerances are so close, the timing must be exact. I mean exact! The distance between each rotor is about .004, which is just about the thickness of a human hair. The first rotor (driven) has the center shaft install and pinned. Then the gear is put in place, which is keyed. Next, the drive rotor has a gear installed but the center shaft is not pinned yet. Using a special jig, as can be seen in the pictures, the gear mesh is set as close as possible. Once this is done then the two rotors are installed in a test front housing, and rear housing. By rotating with my hand, I can see and feel if there are any interference problems. For what it is worth, they never fit exactly, the first time. Depending where the rotors touch, they are marked then the entire rotor assembly is removed and placed back in the setup block. I can then rotate the drive gear an extremely small amount. Once again, the rotor assembly is reinstalled in the front and rear cover. I then test by hand again. This process may need to be repeated several times until the rotation is smooth and there is no binding. I then place a sheet of .003 thick paper between the rotor and rotate by hand to make absolutely sure everything rotates smoothly. After this, the entire assembly is placed on a motor driven base, which gives me a definitive answer as to the smoothness. I then electronically etch each gear as to position and correct side. As you can see this takes a lot of time and a lot of work. Next the entire assembly is removed, then the drive impeller must be drilled, taper reamed, taper pinned, and spot faced. These matched set of rotors will stay together, until they are installed in a supercharger housing. The end result is nothing less perfection. Like my motto says “At Conley Precision, Perfection is almost good enough”!

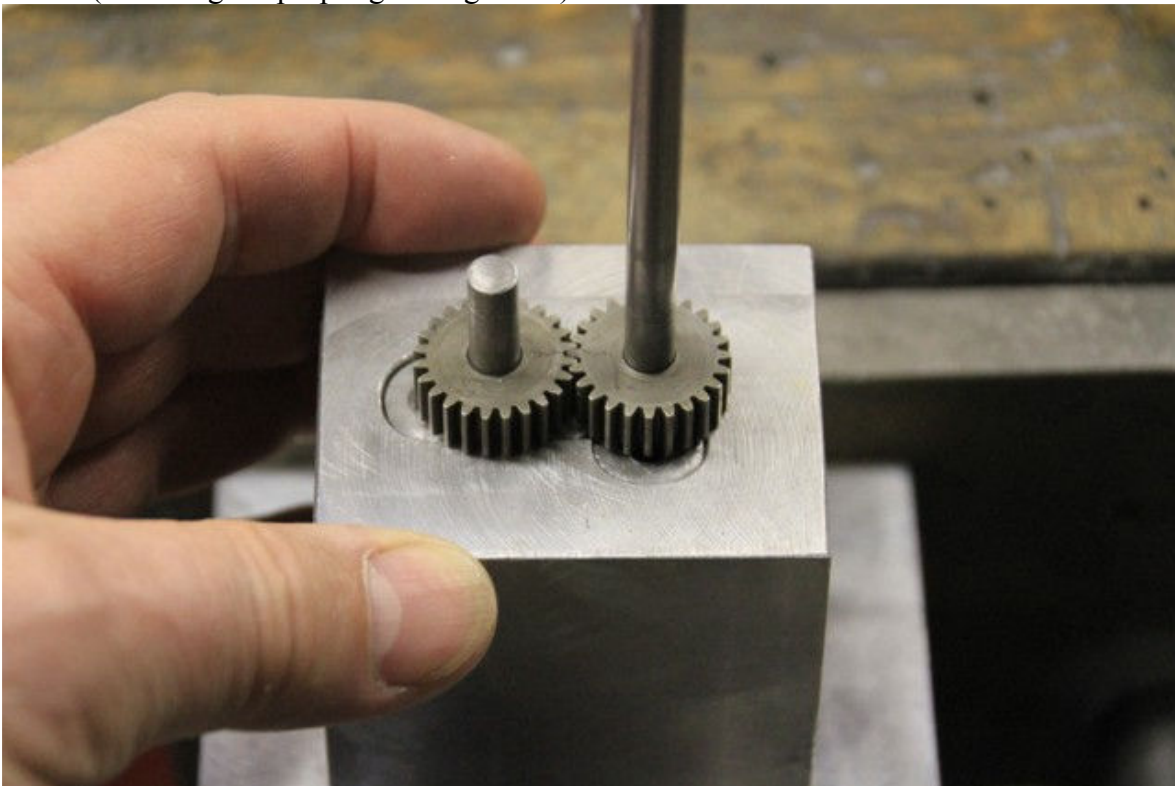
Pic #2 (Checking for proper gear alignment)

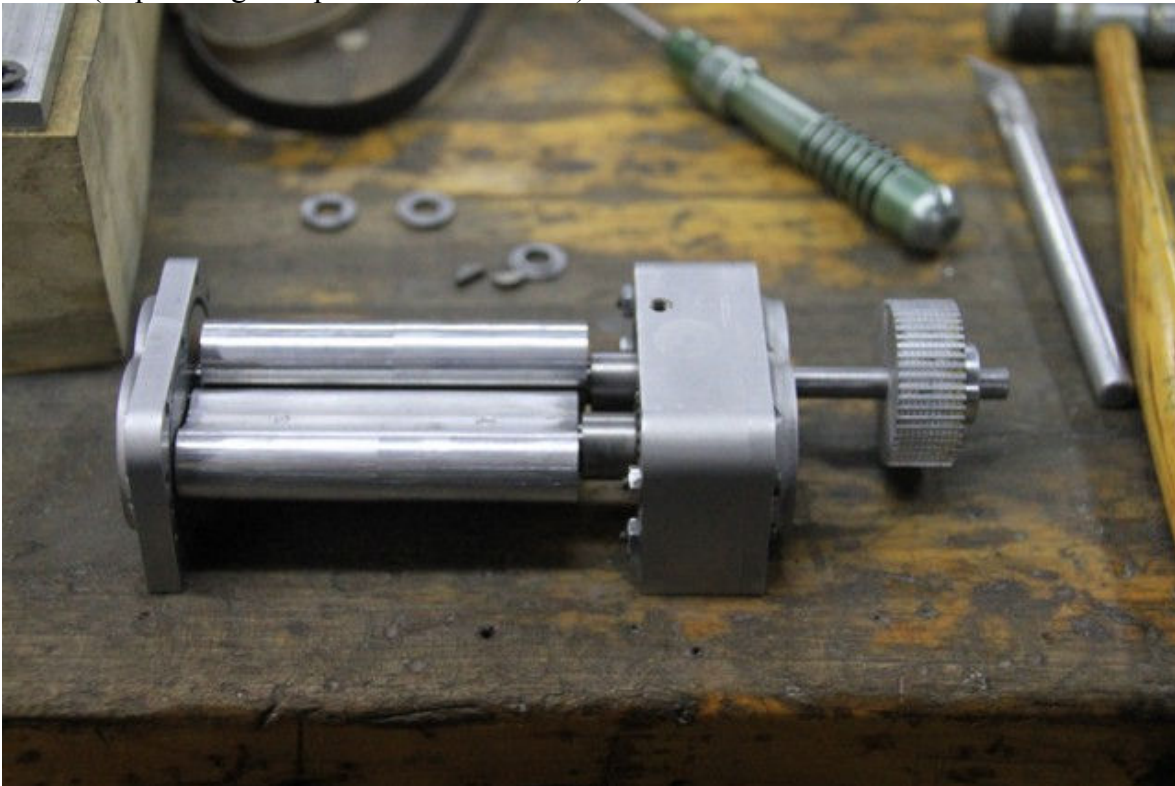
Pic #3 (Supercharger impellers in test covers)

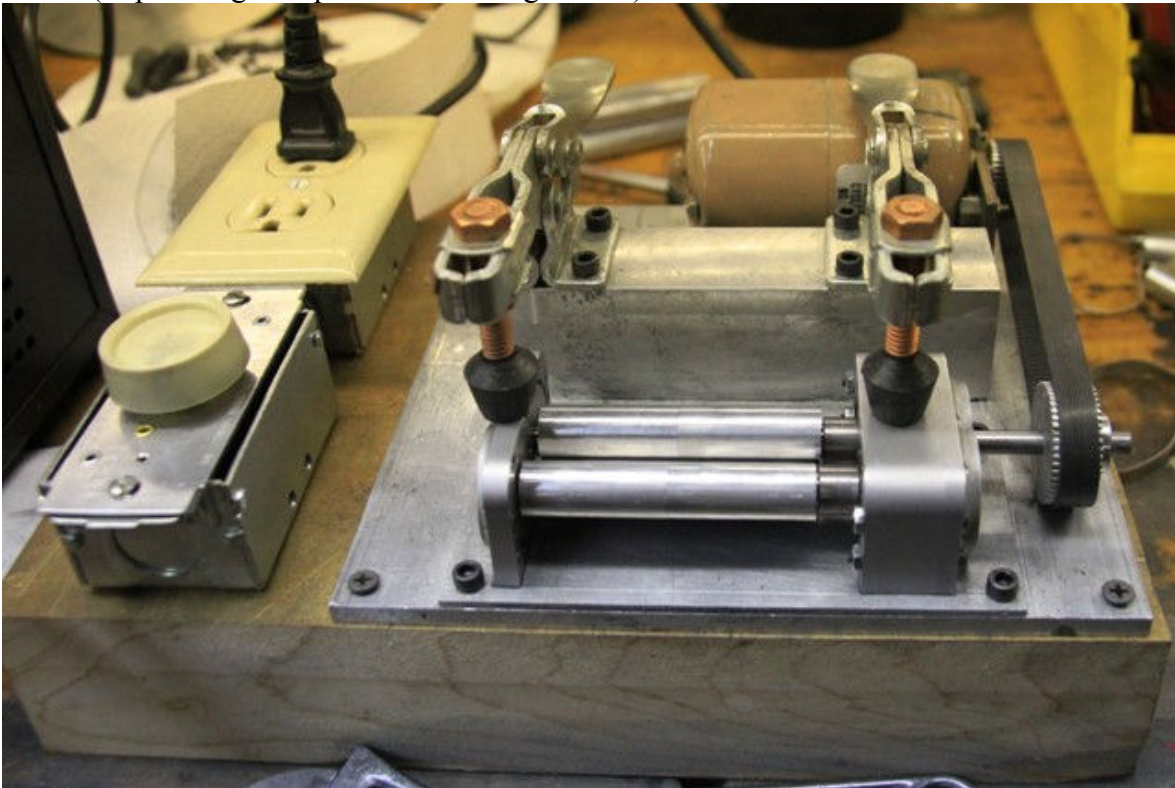
Pic #4 (Supercharger impellers in rotating fixture)

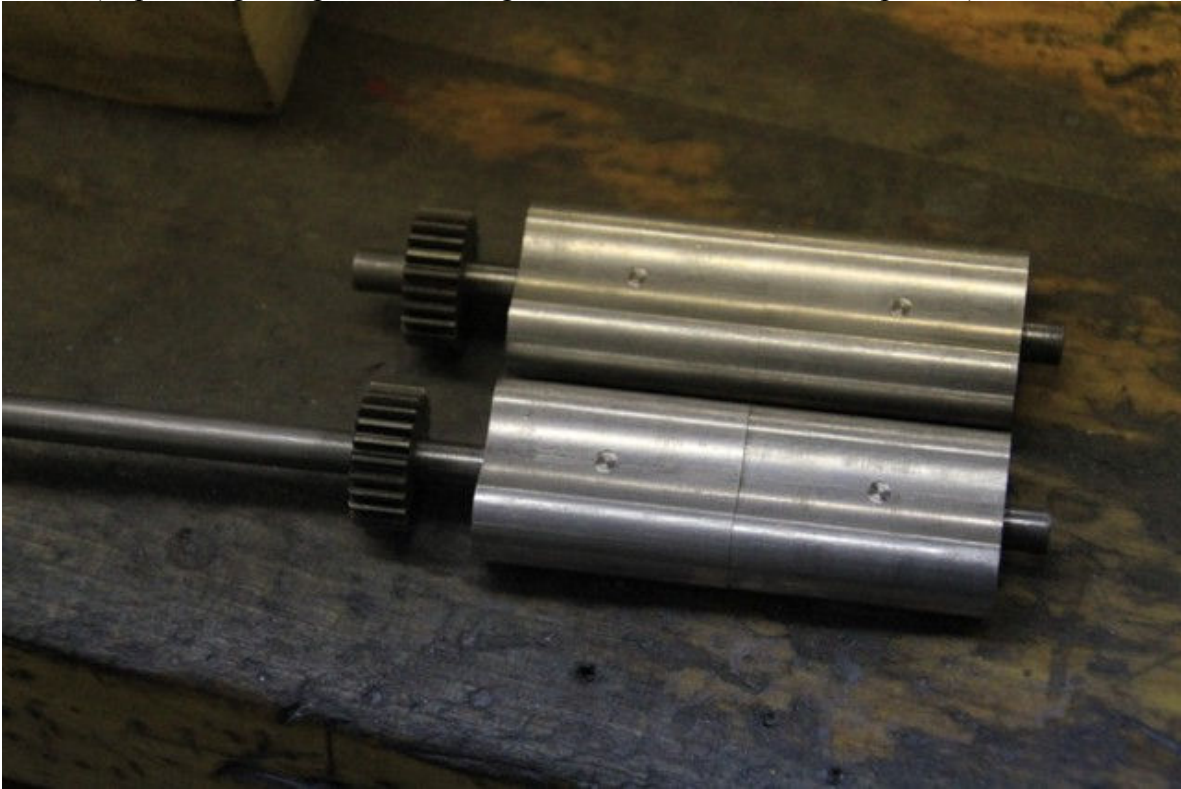
Pic #5 (Supercharger impellers showing that each shaft is timed and pinned)

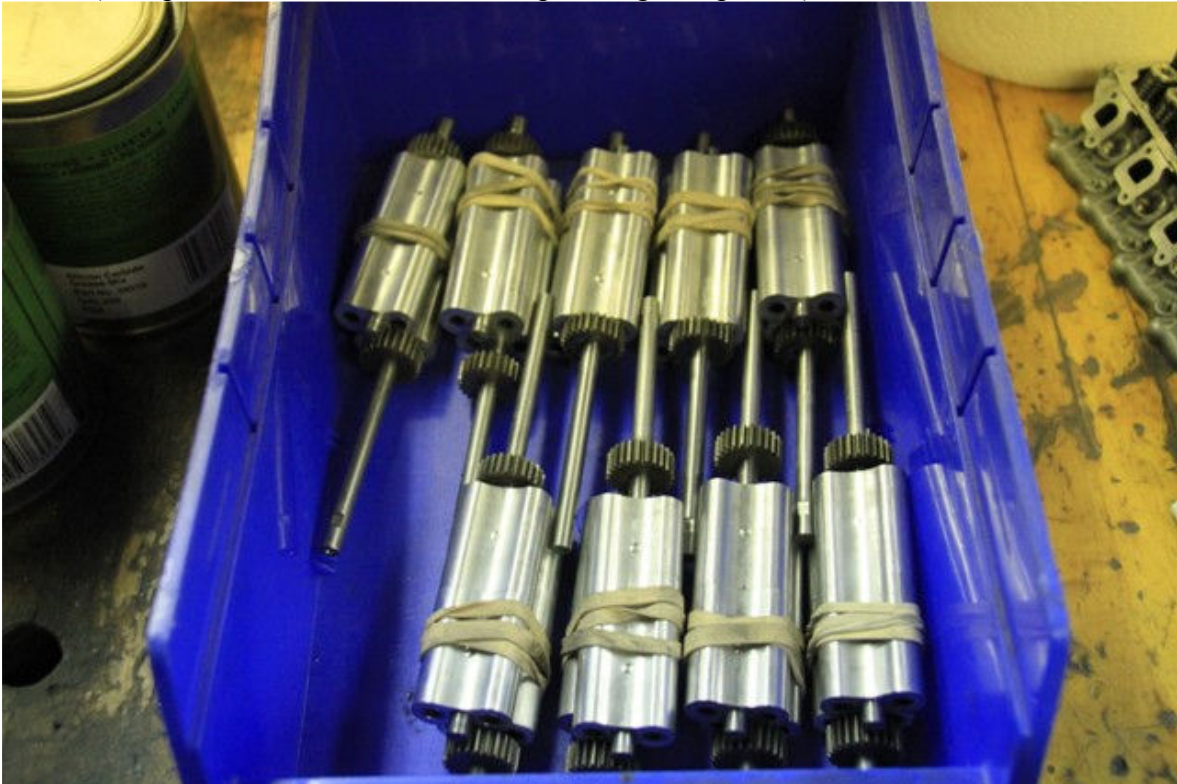
Pic #6 (Completed and matched sets of supercharger impellers)

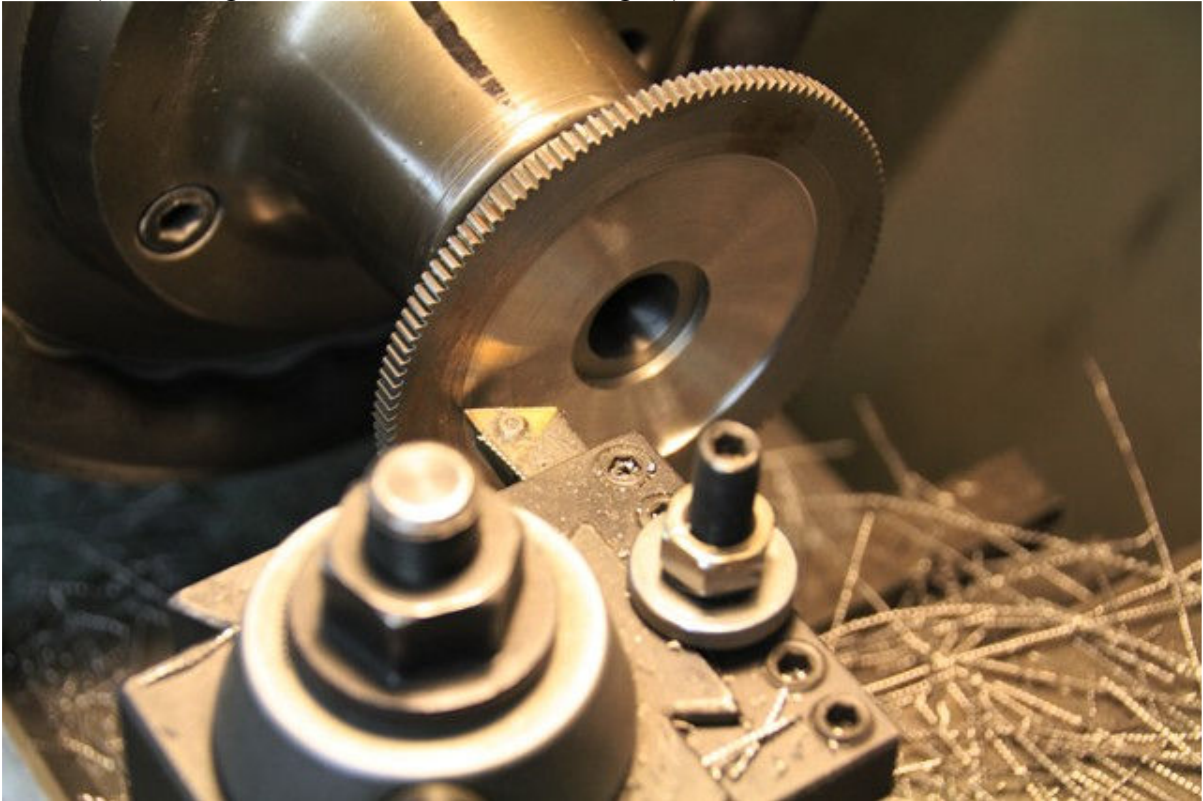
Pic #7 (Machining recess in back side of starter gear)

The ring gears must recessed on the back side for clearance of the socket head cap screws. They will then have the one-way clutch bearing pressed into place.

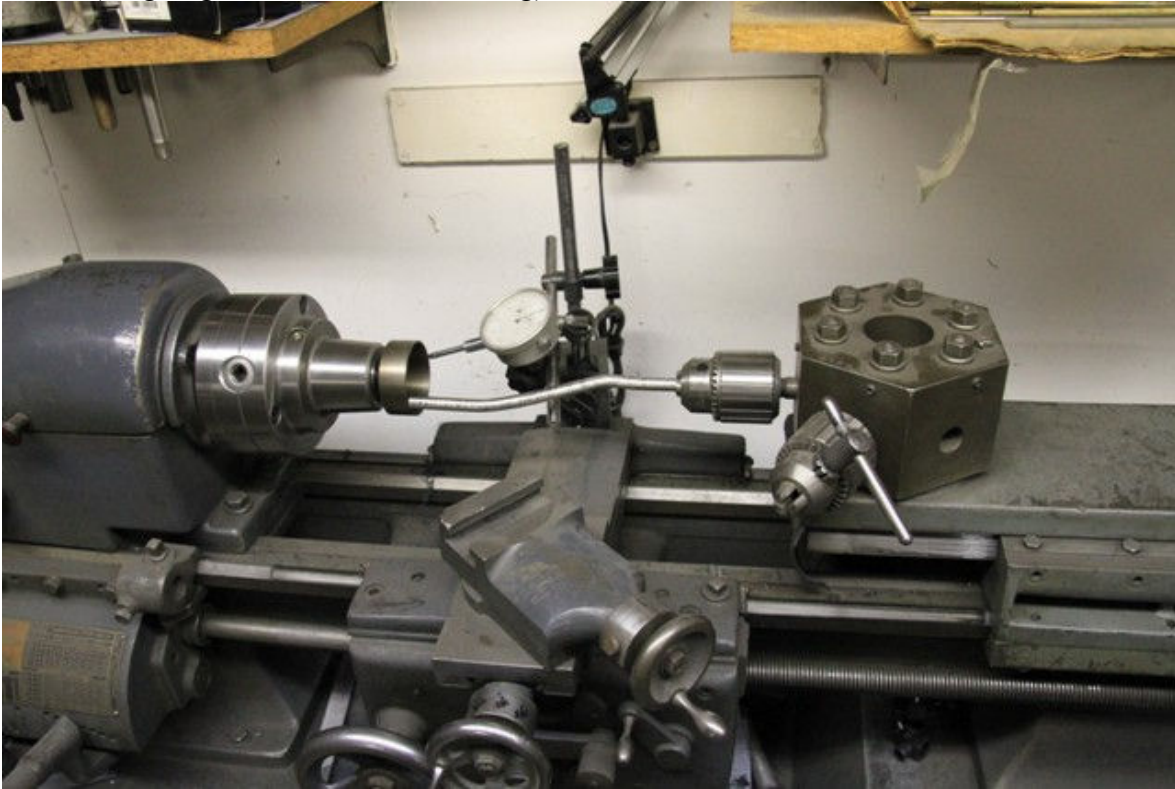
Pic #9 (Aligning clutch bell after welding)

The clutch bells are assembled and welded. Each must then be adjusted to make sure they run true, because there is a certain amount of distortion when welding. The makeshift setup on the small lathe does a great job of this procedure.

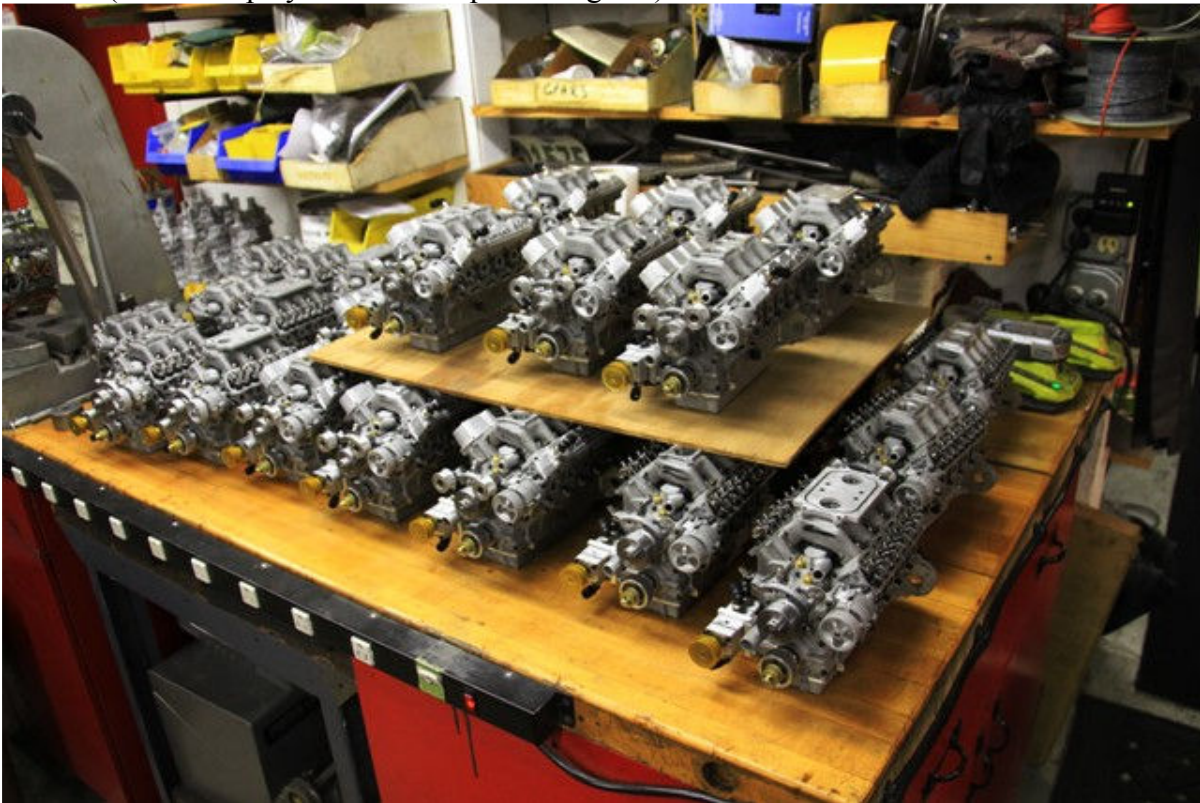
Pic #10 (Partial display of semi-completed engines)

As this run of engines near completion, I literally have engines everywhere. Each engine is now about 90 % complete. The only items that need to be added are the starter motors, carburetion, superchargers - if needed, and distributors. The only one of these components that is not ready to install are the superchargers, but with any luck by the next update, these will be completed. Hang in there everyone, I am on the final stretch.
