It is now about 7:00am on Sunday morning and although I have a full day of work ahead of me, I thought that it may be the only time that there was a break, long enough to get a weekly update finished. Since I started on the second run of engines, there just is not enough time to devote and do justice to an update. That being said, the blocks are in full production. As you can see from the pictures, the bottom of each block is the first operation which must be done. The reason is, all other dimensions are taken from this machined surface – so it is critical that everything be done perfectly. There are also four “locator” holes which are placed at each corner of the bottom surface and once again are used for alignment during the consecutive machining operations. If a mistake is made here, then it is like a snow ball rolling down hill – everything progressively gets worse, until the block is no longer salvageable and must be discarded. Keep in mind a lot of time, work, and money has gone into each block, so when one is destroyed, it is very costly.

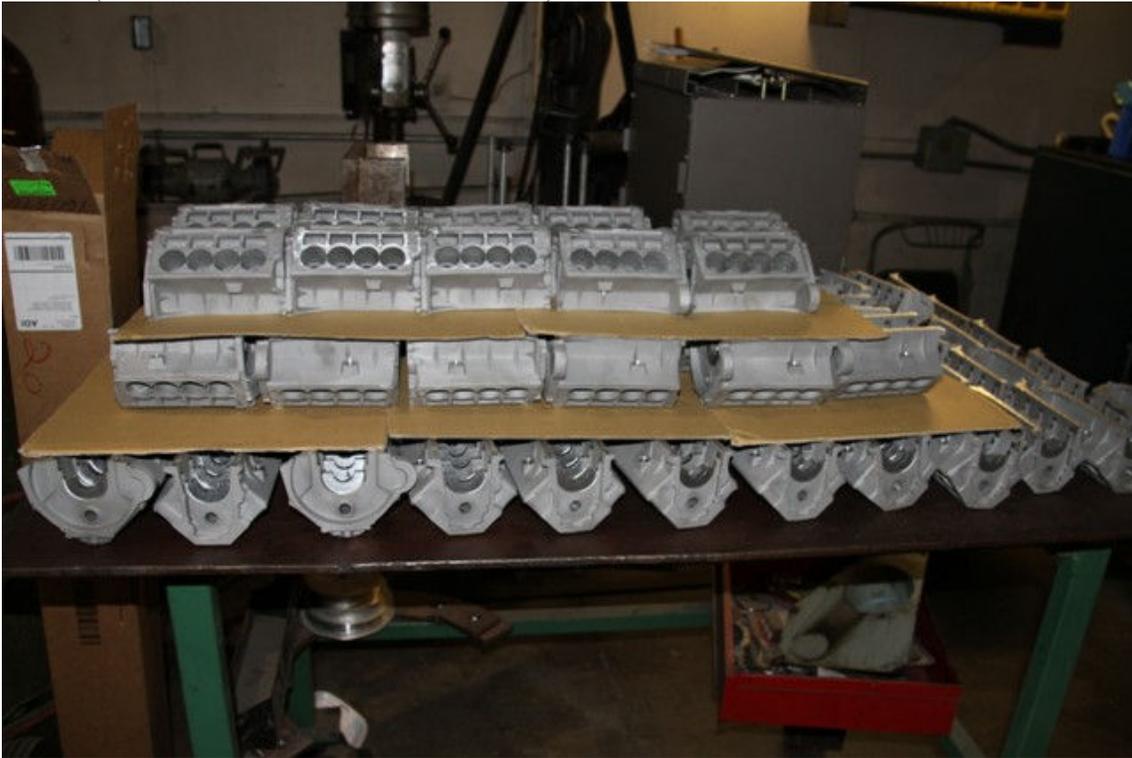
Pic #1 (New blocks with bottom machined)

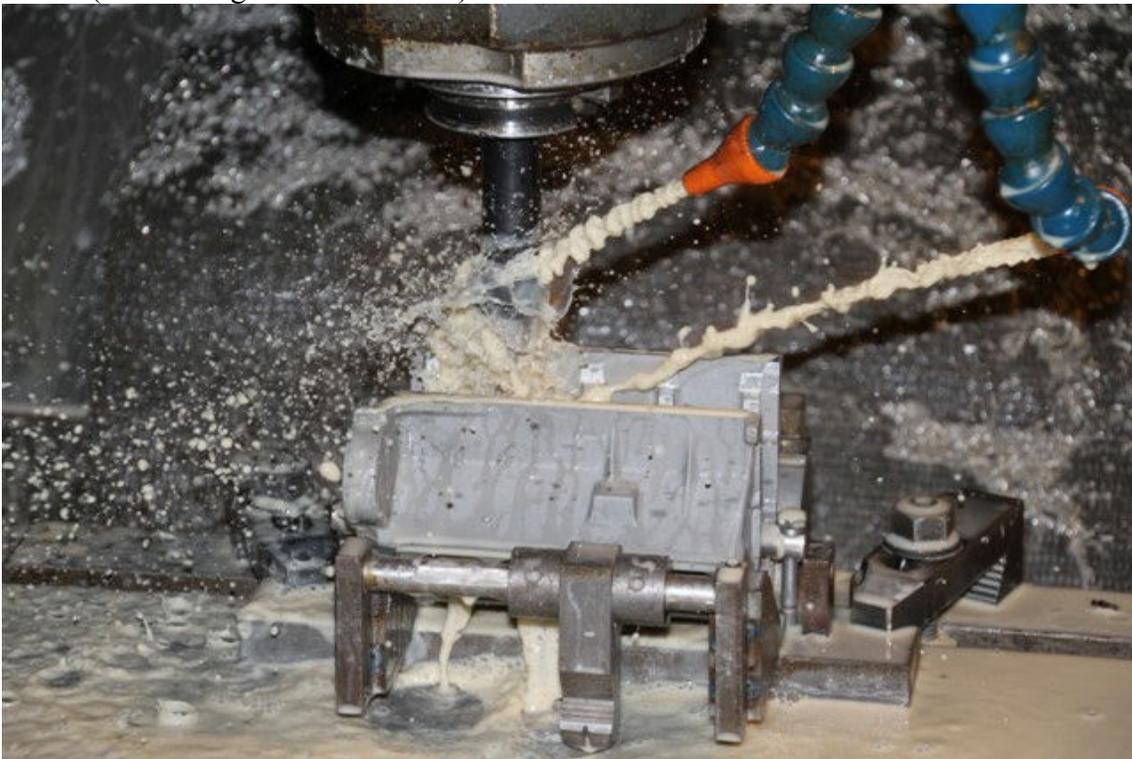
Pic #2 (Machining bottom of block)

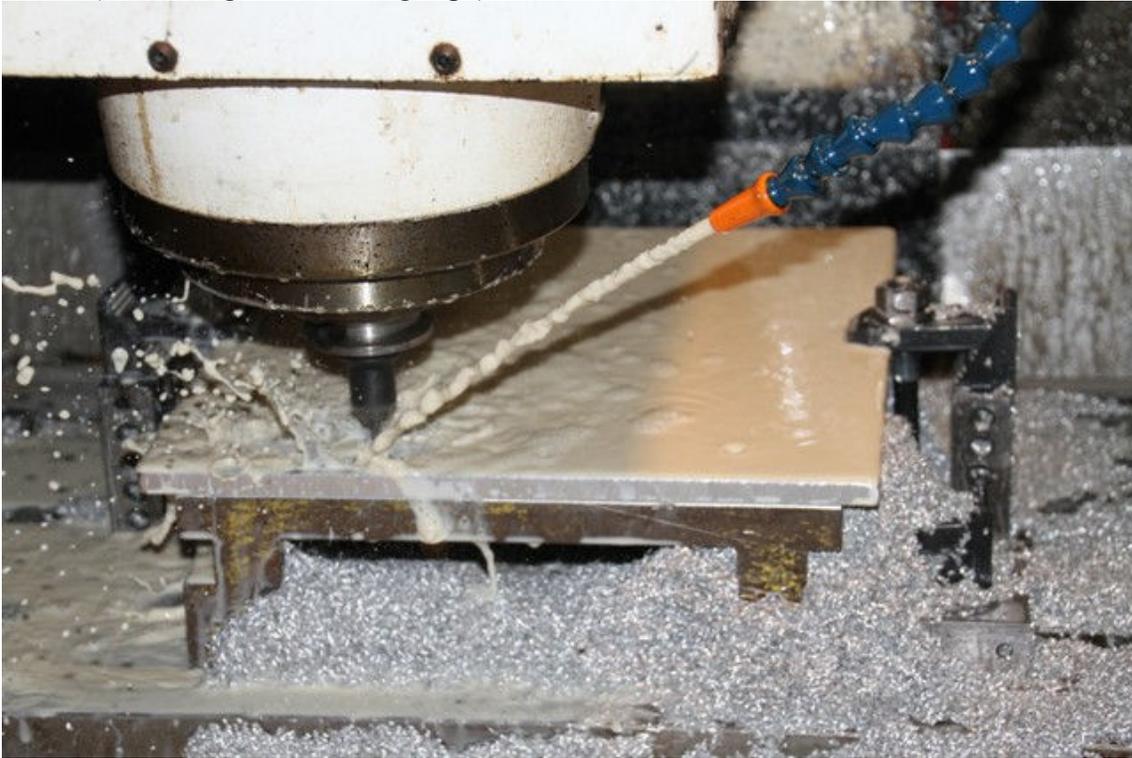
Pic #3 (Machining main bearing caps)

After the bottom of each block is finished, then the main bearing caps must be machined and installed, before the crankshaft (main bearing) hole can be bored. Once again, this is a critical operation. If the bore is in the wrong place, then the center distance from the camshaft hole is off. This results in a miss-alignment of the timing gears. Also the deck height is compromised. When the pistons are at top dead center, the deck height must be the same for each side. If this is not correct, then the intake manifold does not fit. It should be evident by now, why every dimension is checked and triple checked, before the machining process begins. Once metal is removed, it is very difficult or in most cases, impossible to be re-added. If a measurement is off and there are 75 plus blocks being machined, it is easy to understand the potential loss.

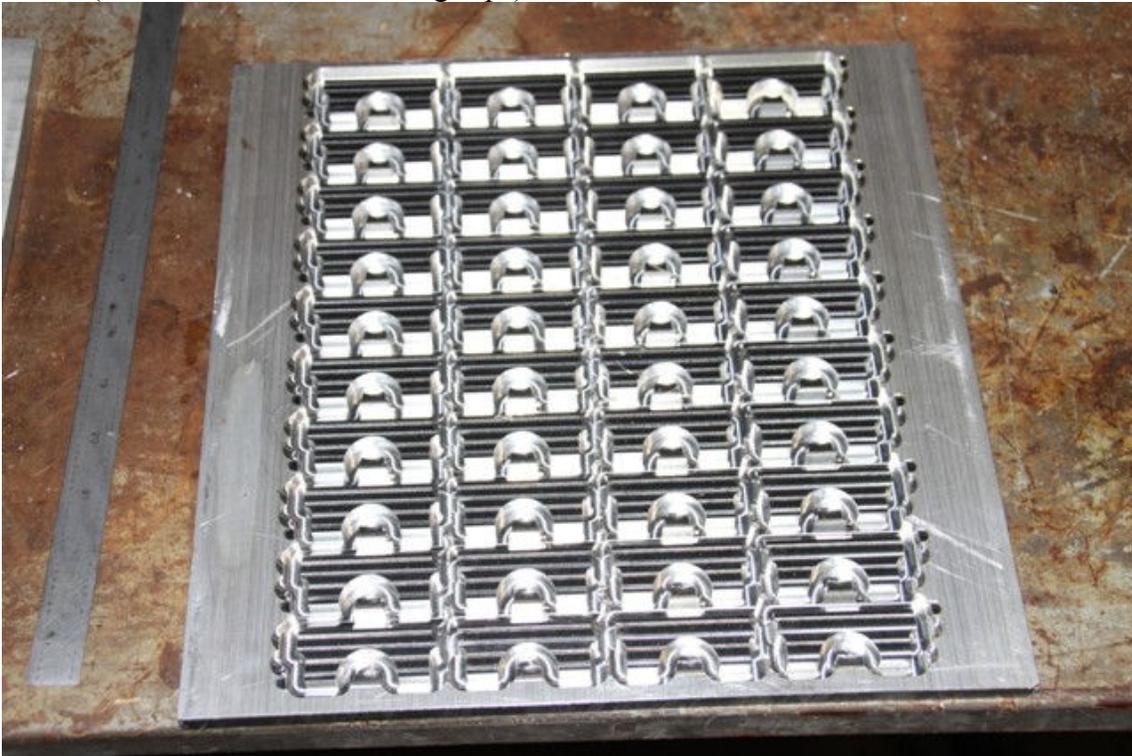
Pic #4 (semi-finished main bearing caps)

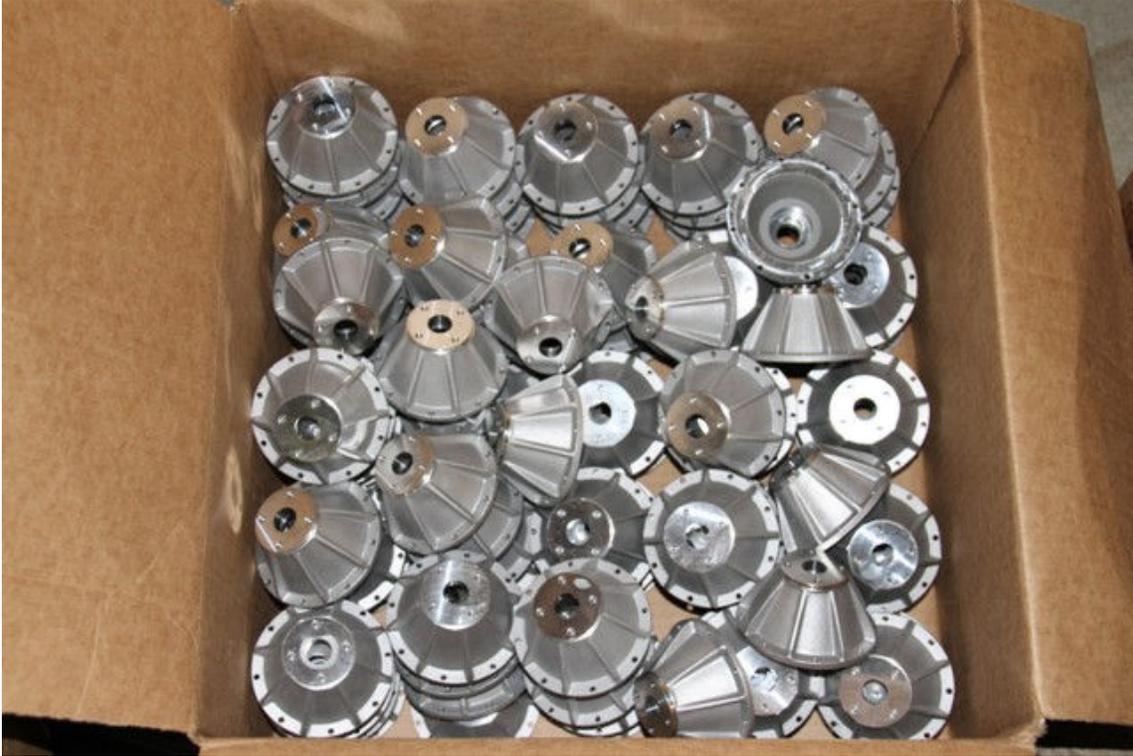
Pic #5 (Finished side covers for quick-change rearends)

Not only are the blocks being machined but work continues on the quick-change rearends. As you can see from the photos, the side covers are finished and the center sections are next to be machined.

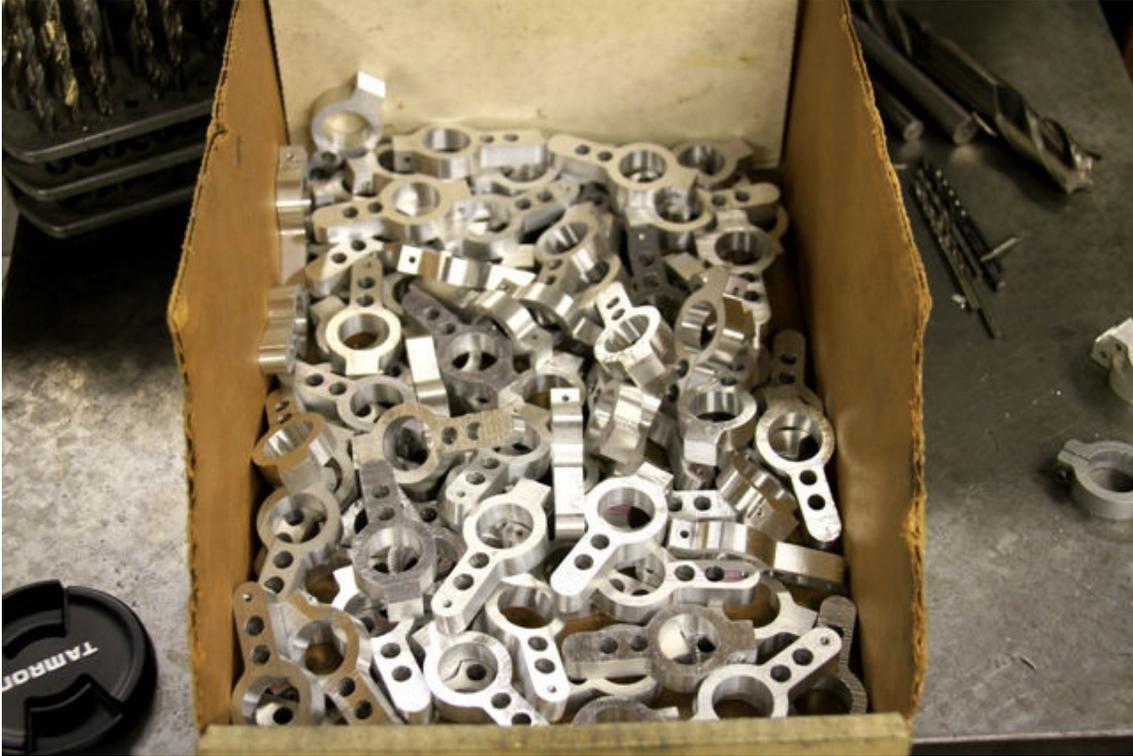
Pic #6 (Banjos for superchargers)

From now on, all weekly updates will be devoted to the next run of engines. The final picture is of the nearly completed “banjos” for the next run of supercharged engines. Although they will not be needed for quite a while, I needed to make a couple for the current run of engines and thought it would be easier just to finish all of them for the next run of engines.
