● 05 February 2009

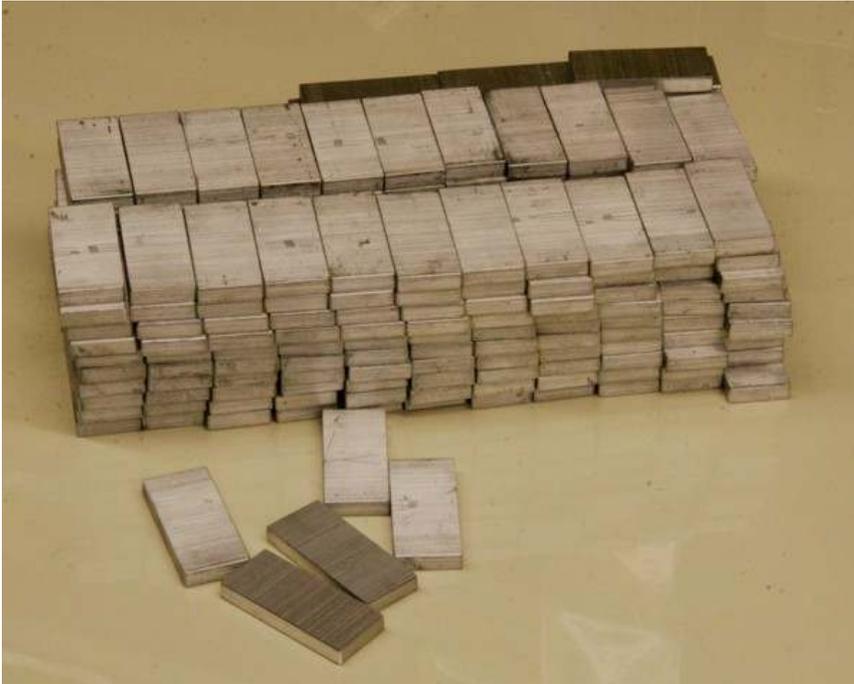
Pic #1

Once again another month has gone by. I have set down to do an update no less than 6 times and something always happens that takes me away from completing my task. As the last count I have no less than 19 different machining operations on just the blocks and they are still not completely finished. The main bearing caps proved to be far more demanding than originally thought. Picture #1 shows the stack of main bearing blanks after being cut to the proper length. Picture #2 shows a before and after shot. After machining the basic shape and drilling the initial bolt holes, they must then be fitted to each individual block. Once installed, each block must be placed at 90 degrees for drilling and tapping the cross bolt holes. Whereas this may sound easy, remember there are 5 holes per side. If you multiply this by 40 plus blocks it is easy to see how much time is involved. After this operation is finished then socket head cap screws are screwed into each main cap. The blocks must then be positioned so that each cap can be side milled to the exact thickness. Because of the close tolerance that this engine demands it would be virtually impossible to make them the exact thickness and then install them into the blocks. When I say close I mean that the center orientation of the mains must be no larger than .006. This is just about the thickness of 2 human hairs. As of this update all the blocks have the mains installed and I am now in the process of drilling the initial oil inlet passage. These may sound easy, but each block must be positioned at 59.6 degrees. Not 60, not 59 but 59.6 degrees.
