(06 Jan 2008)

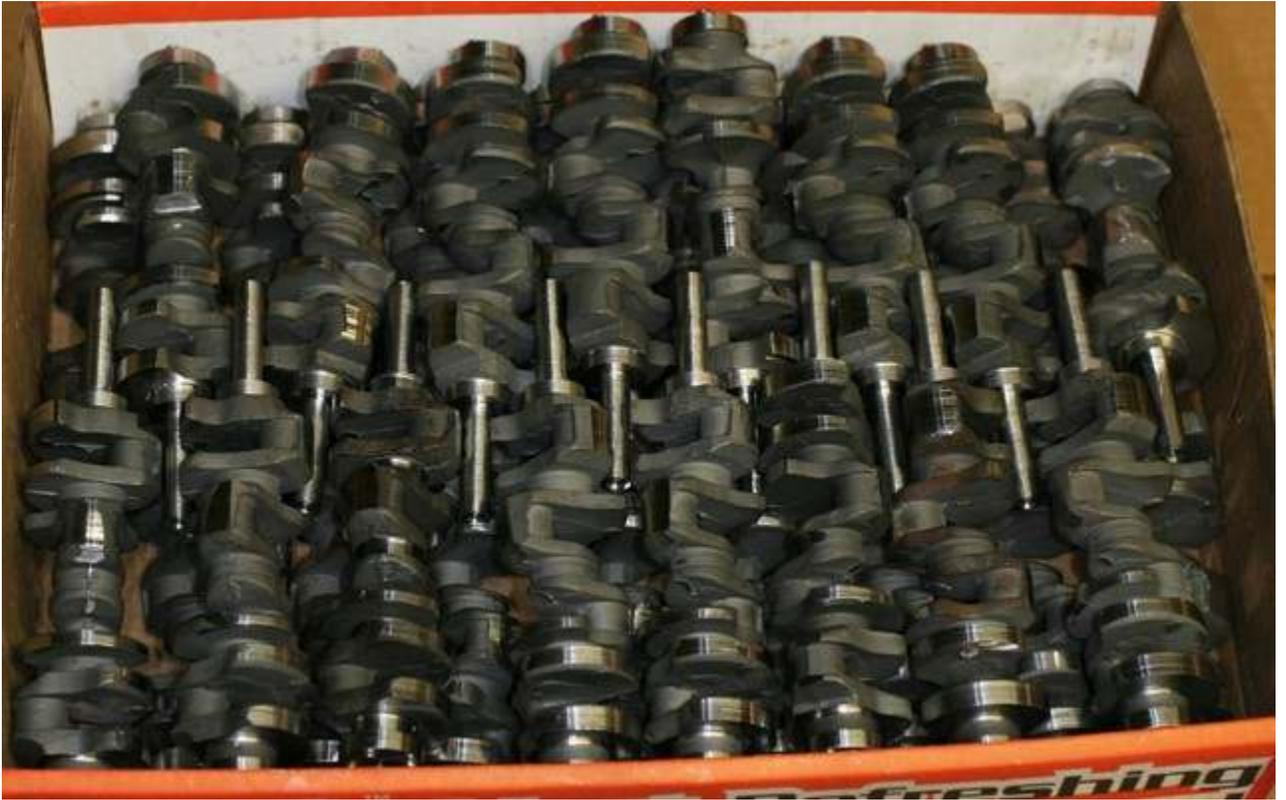
It is now Sunday evening about 8:32 and what Pic #1 shows is the culmination of a full weeks worth of work. Although at first glance it may not look like anything significant was accomplished, I can assure you that you would be very mistaken. **Finally** all of the critical dimensions on the length were finished. Like I said before, nothing can proceed until these operations have been successfully completed. So far only 3 crankshafts have been rejected.

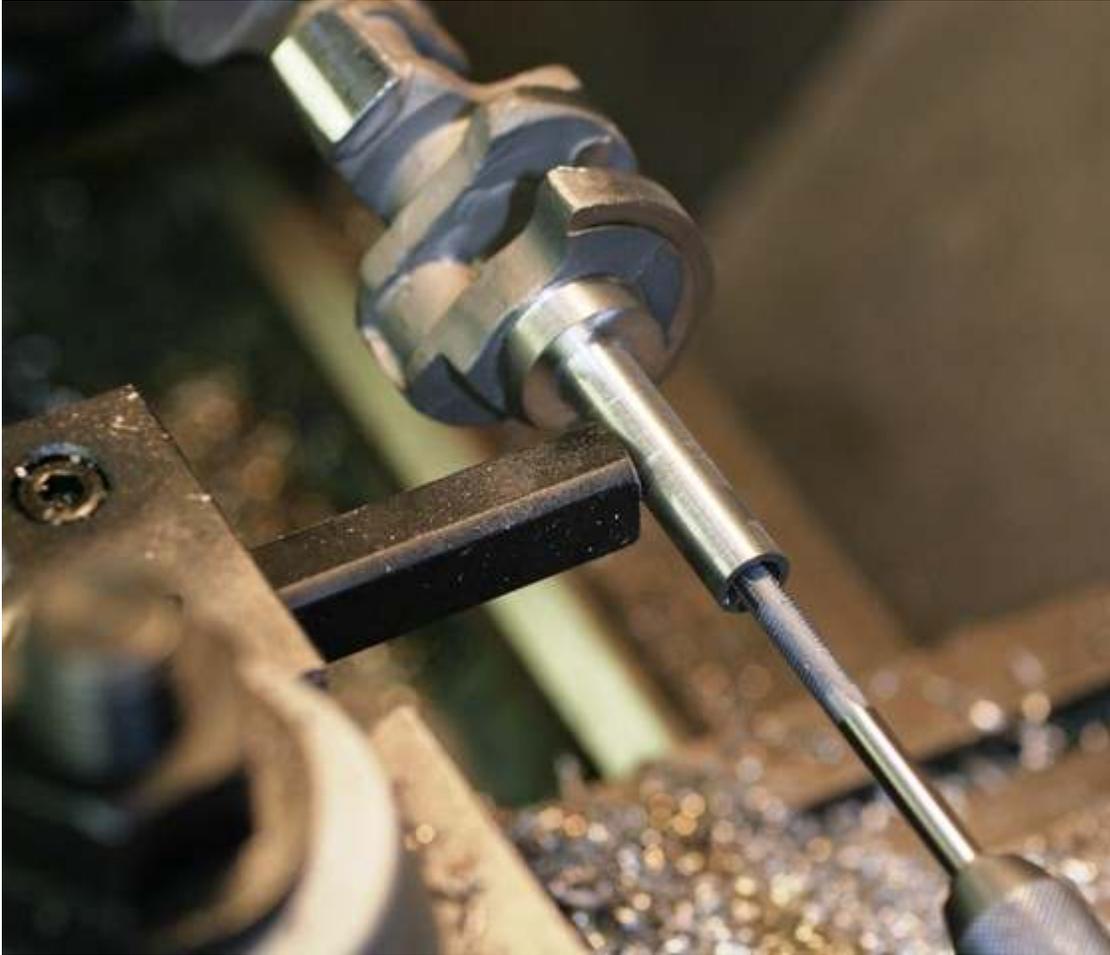
Once the exact length was known, then the two holes in either end were threaded. Pic #2 Remember, 4130 (high strength) steel was used for casting. As a result normal taps get dull very fast, so I had to resort to using a TIN coated M42 Cobalt tap. Luckily no breaks.

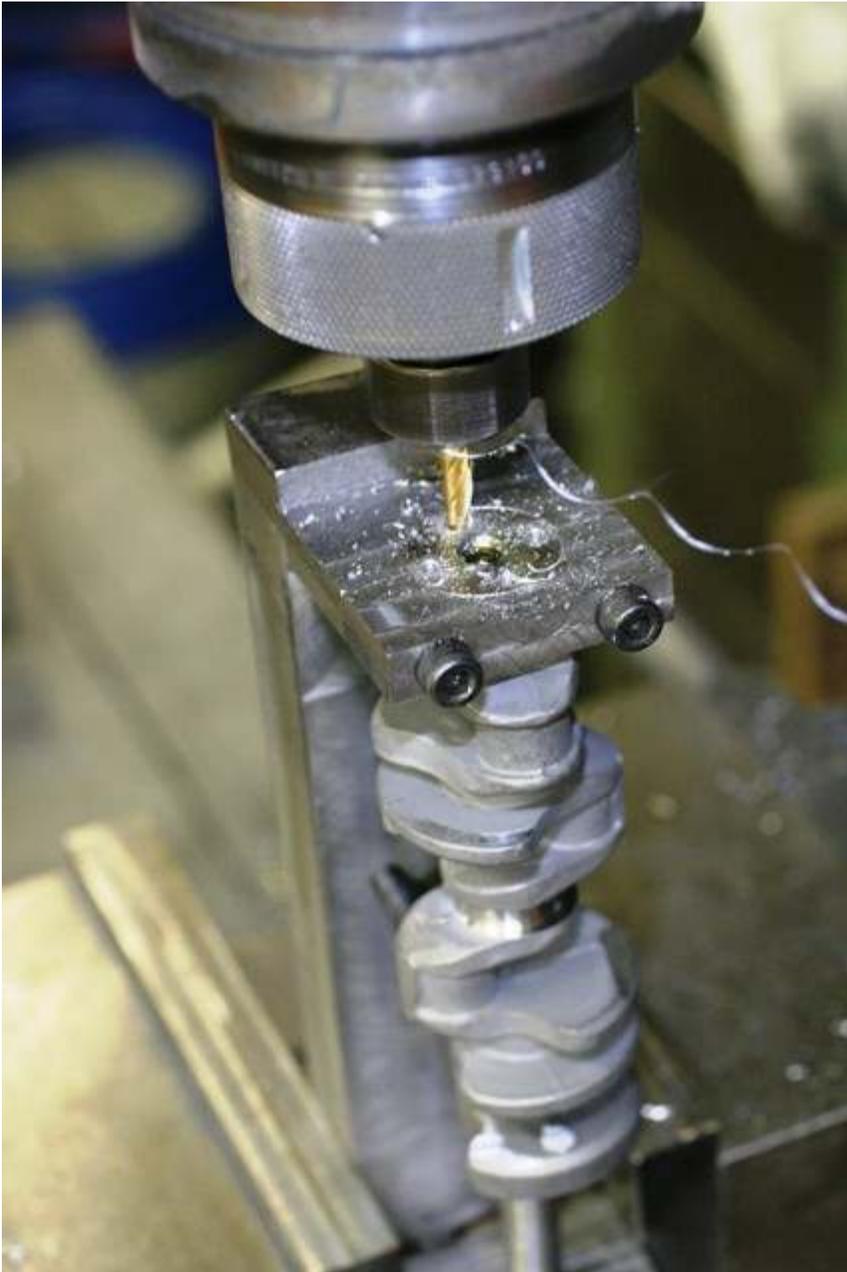
Pic #3 shows the flywheel end being drilled for the four dowel pins that will be used to center the clutch drive system. This was also a

significant design change from the original which used 8, 6-32 taped holes. The net result is higher accuracy, stronger, and easier assemble.

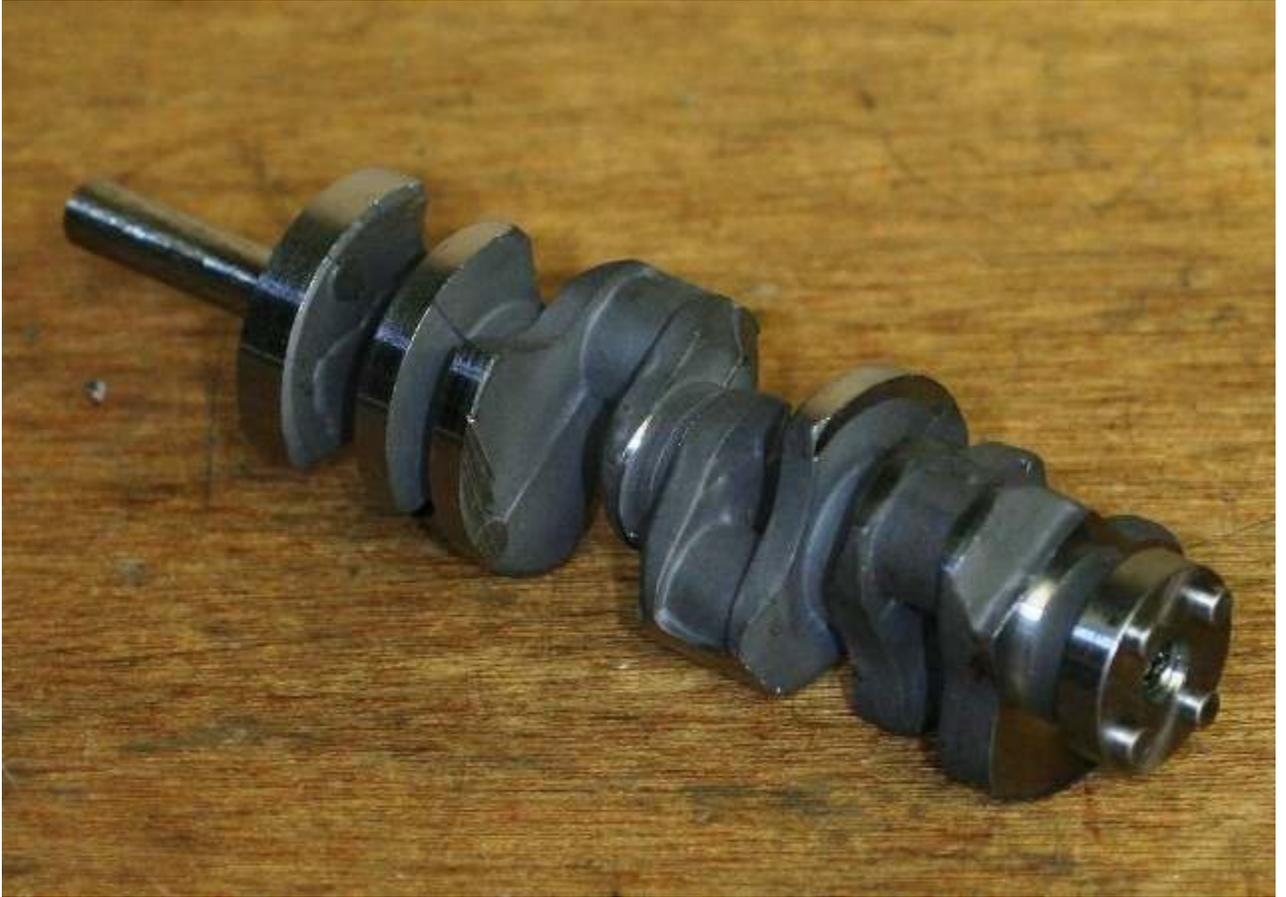
Pic #4 shows the crankshaft with the dowel pins installed, the OD of the flywheel end finish ground, the major OD finished turned, and the smaller OD on the front finished and cut to length. One crankshaft is difficult, but 50+ is insanity. Keep in mind that there has been 9 operations so far. This results is that over 450 times the crankshafts have been picked up, placed in jigs, and machined. Very, very, time consuming. Unfortunately, there is no easy way or short cut that can be taken. The next operations will include: machining away the majority of the excess metal for the main and rod bearings, rough grinding all diameters, finish grinding all diameters, drilling oil passages (not looking forward to this operation), milling keyway for timing gear, and cleanup any flashing or burrs.
