For what it is worth, I started this update the day after Christmas. It is now January the 7th. As the first run on engines nears completion, the stack of finished parts gets higher each day. Testing is continuing on some of the finished engines and although there were a couple areas which needed some changes or modifications, the net result is that the engines are running GREAT! The new air cleaner halves can be seen in picture #1&2. Notice the machined groove which allows for the filter element to be held in place. Each piece is then media blasted to make that great satin finish. Speaking of filter elements, I have done extensive sampling and testing to get the perfect material. It must have very little air restriction but still allow for microscopic particles filtration. Not only is it a great product but allows for the element to be cleaned with a little cool soapy water.

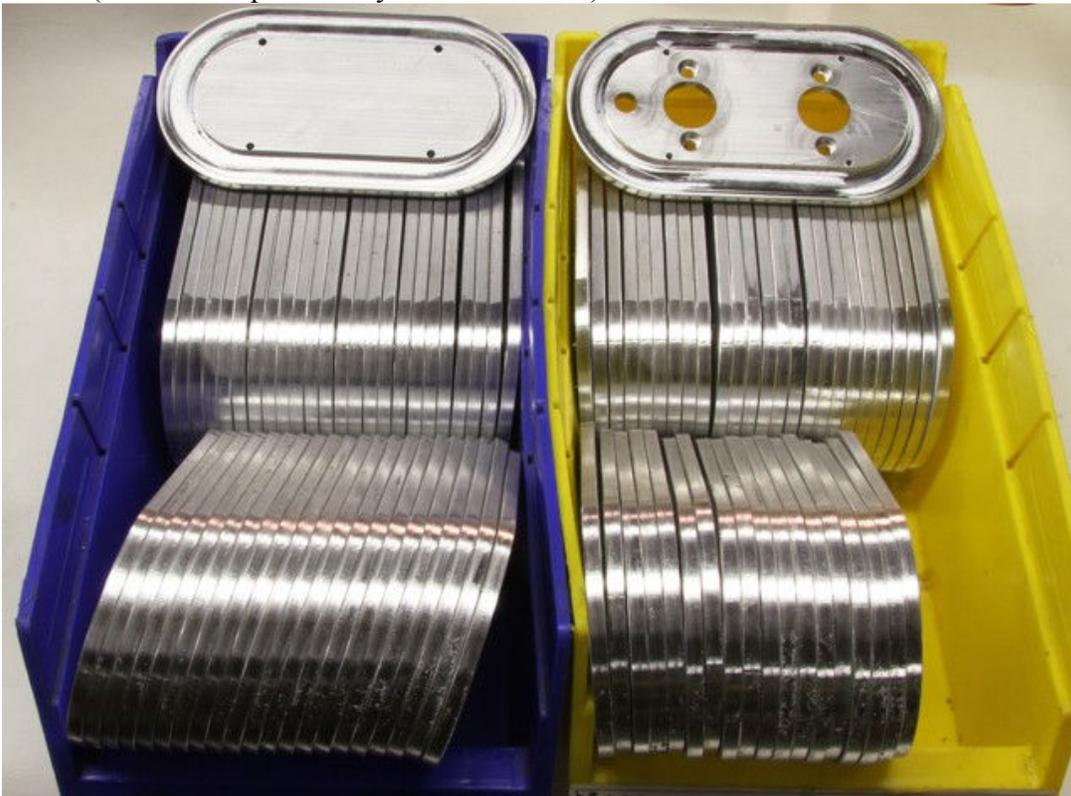
Pic #2 (Air cleaner parts ready for media blast)

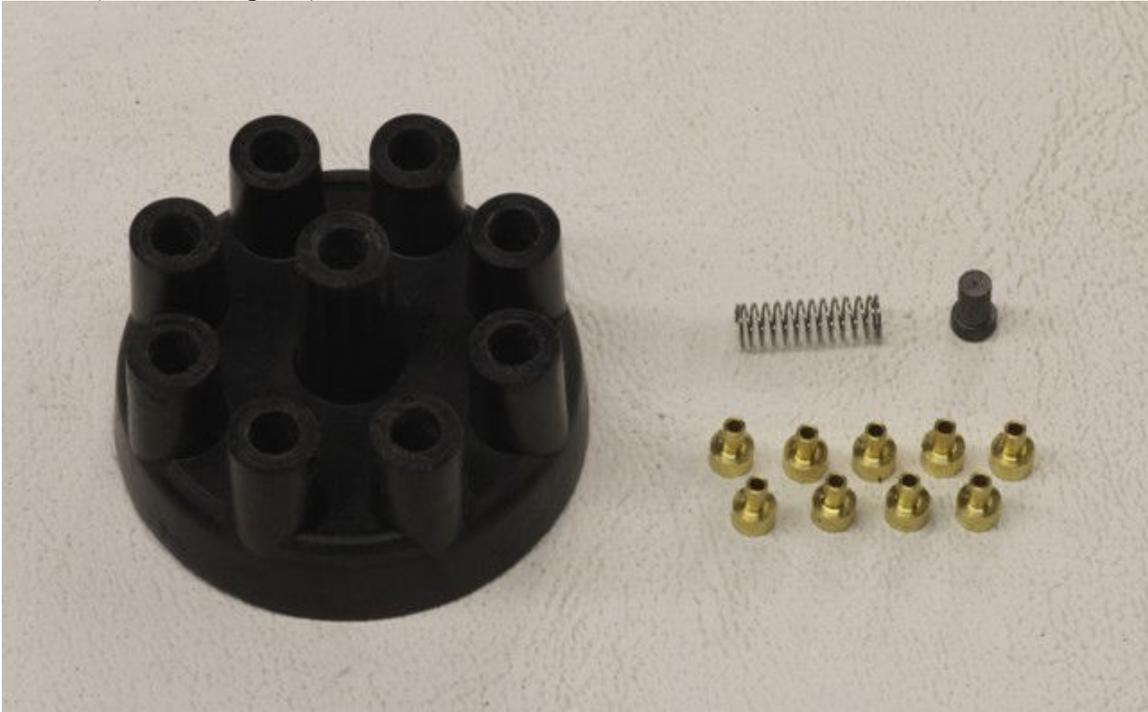
Pic #3 (Distributor parts)

The distributor caps are now finished and ready for installation. Picture # 3 shows just how many parts go into each cap. The very small gray part in the upper right hand corner is actually the graphite center electrode, which is spring loaded and maintains contact with the rotor in the center of the distributor. Once all the wires are cut to the exact length and installed into the cap, then each end has the metal spark plug contact crimped in place. This is followed up with a spark plug boot to cover the metallic end. Keep in mind; distributor cap has 9 wires, 9 brass contacts, 8 metal ends, one graphite contact, one spring, and 8 boots. If you multiply this, times 40 engines, it is easy to understand the difficulty of building a production run of engines. Can you imagine how many parts will be needed for my next run of 125 engines? I am exhausted just thinking about it.

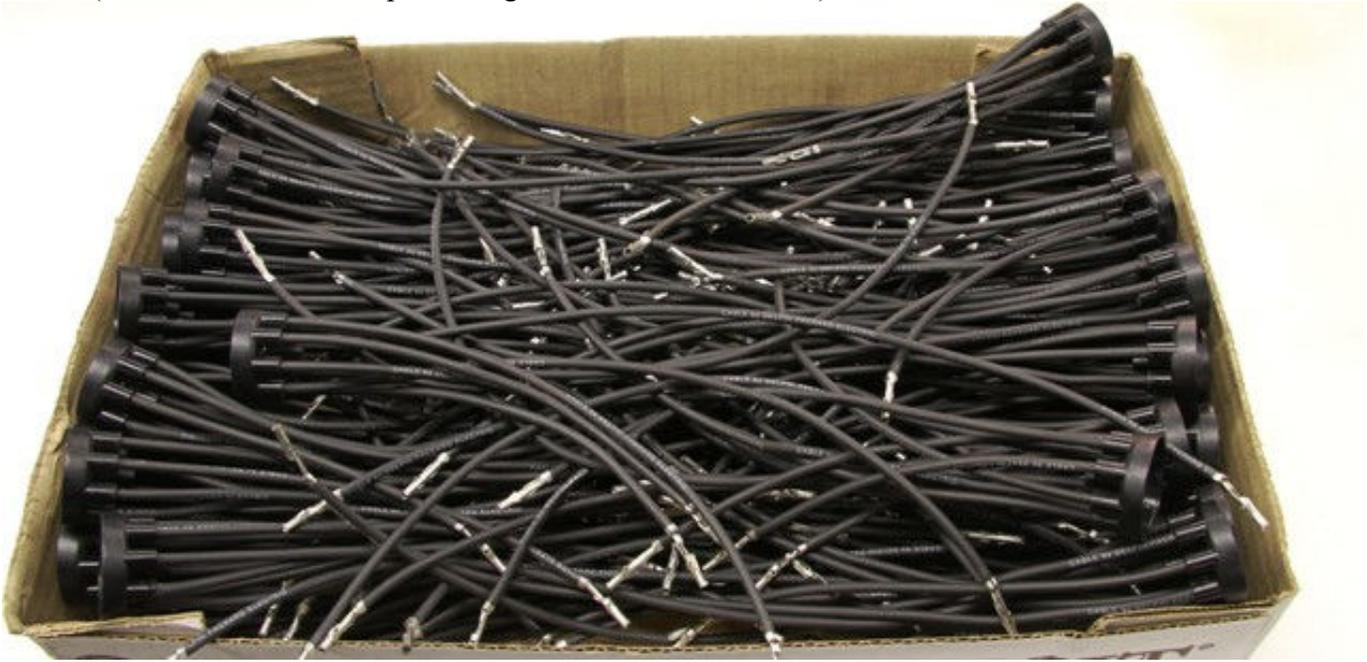
Pic #5 (Finished distributor caps waiting for boots to cover ends)

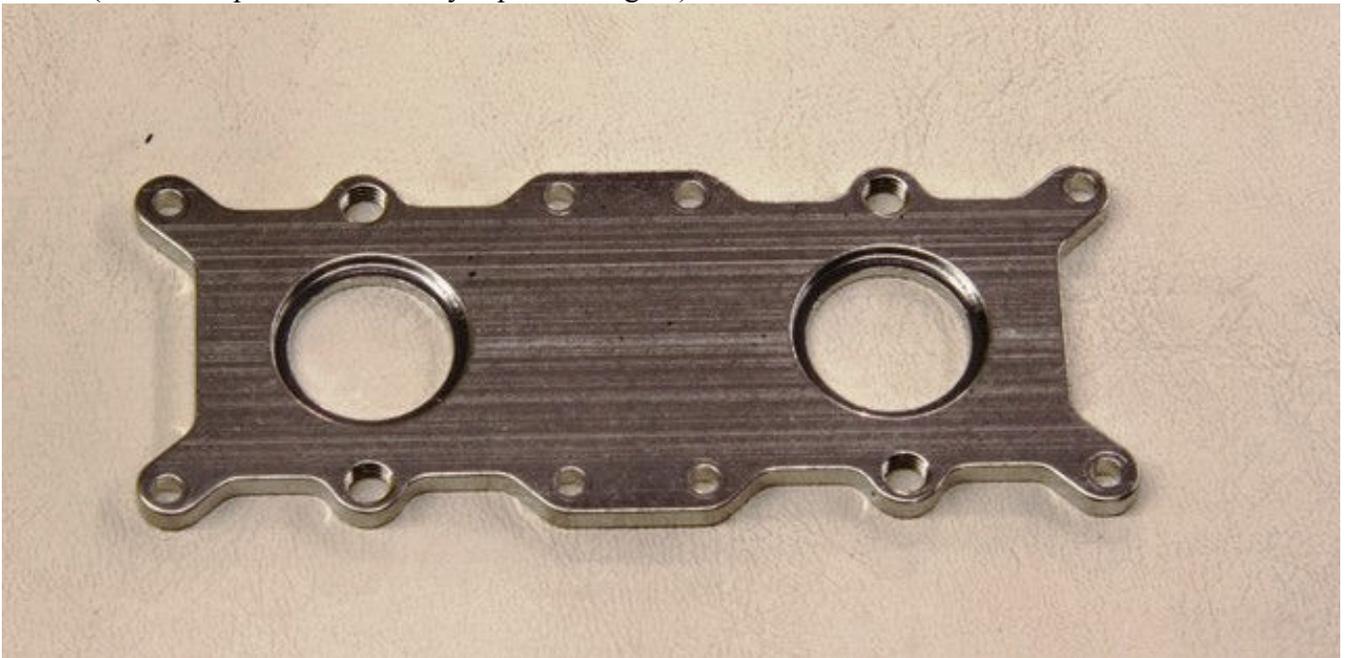
Pic #8 (New base plate for normally aspirated engine)

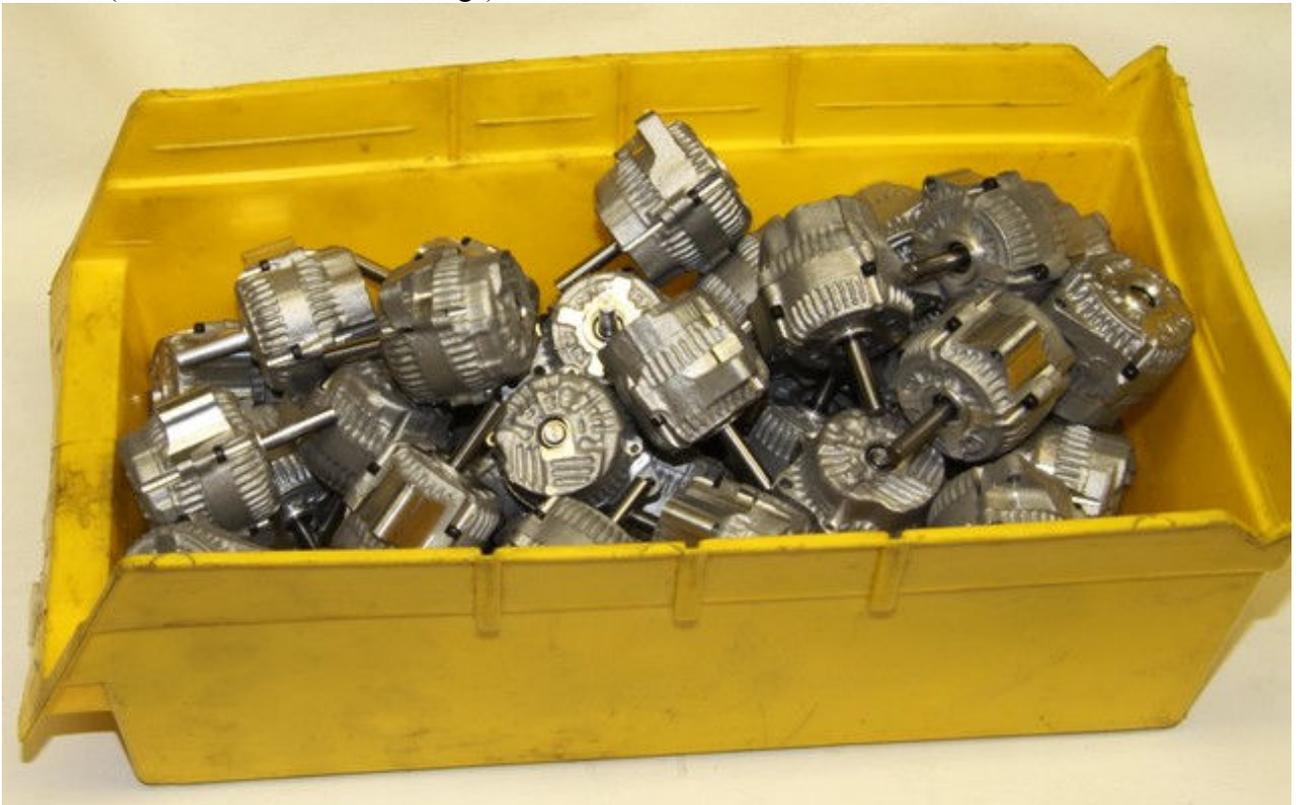
Pic #10 (Finished Alternator housings)

The alternator halves, bearings, shaft, and internal spacer, have been assembled – which make a completed unit. All they need now is to have the toothed pulley put into place.
