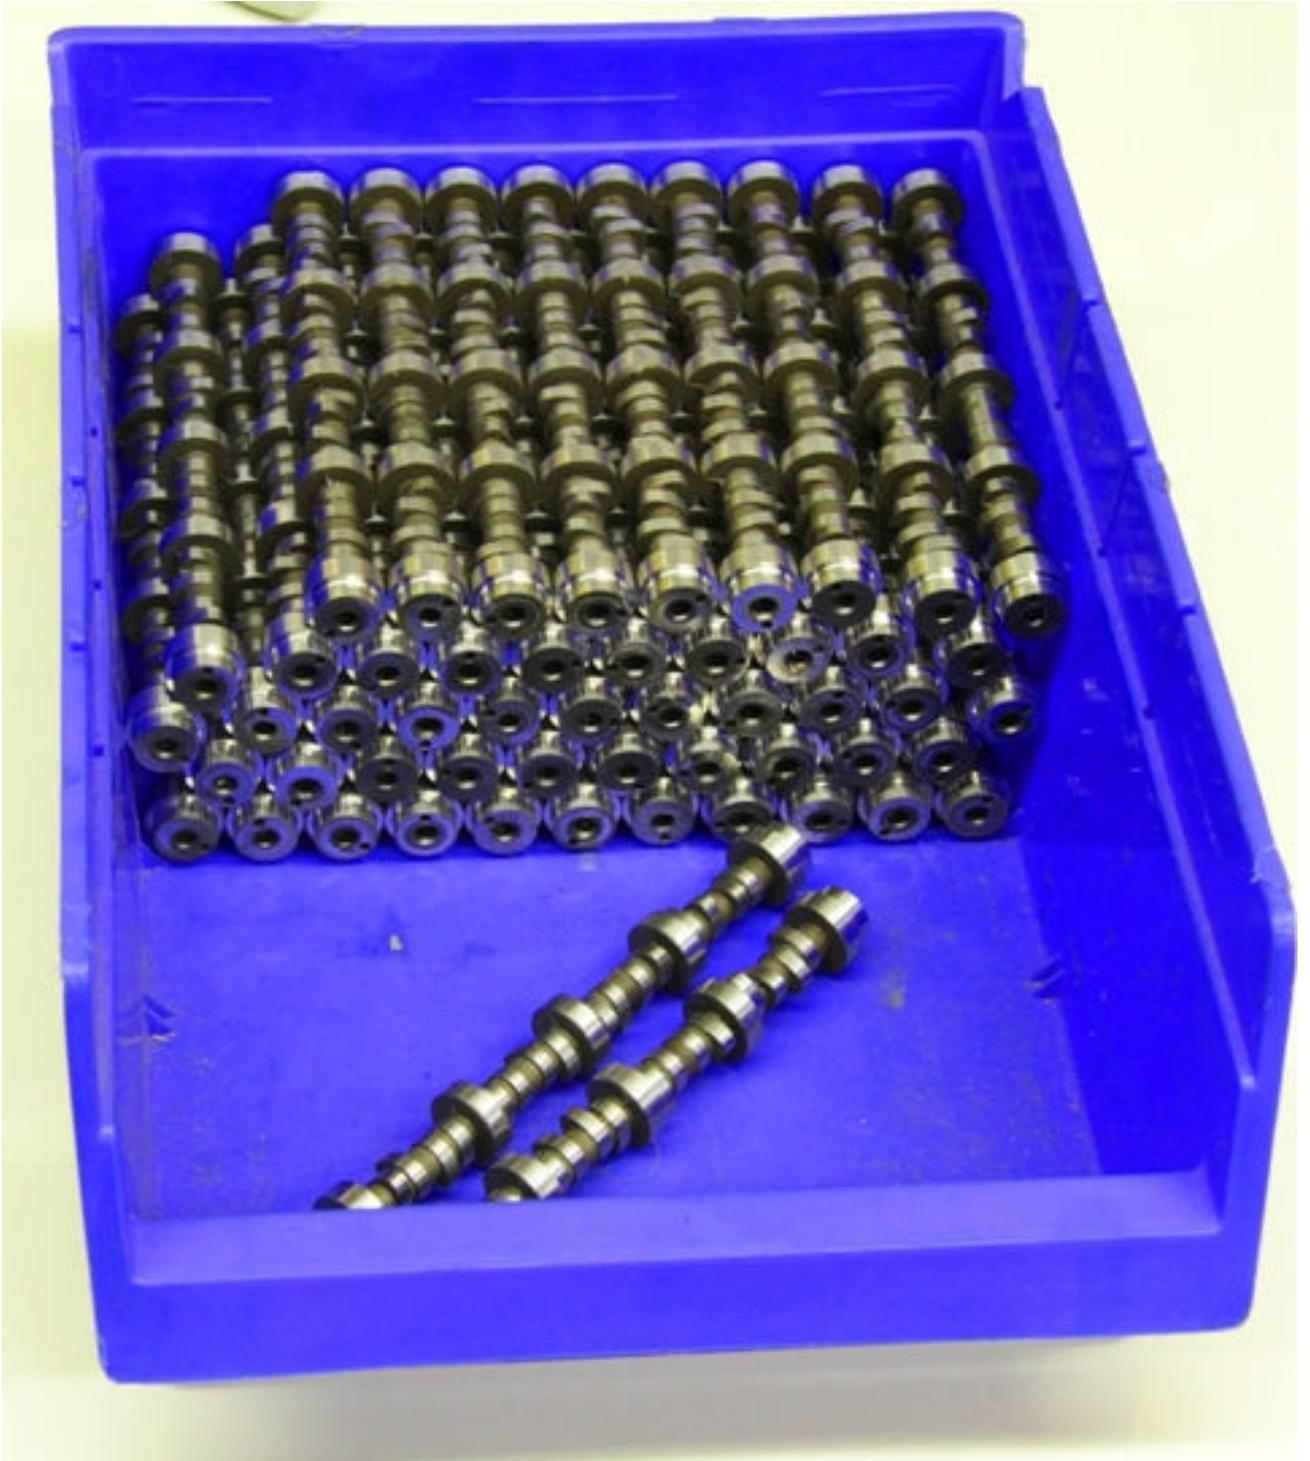
As you can see from picture #1 all of the camshafts are finished and ready for installation. If you remember for a previous update, all the camshafts had the lobes ground, but now the bearing surface is finish ground. This is a relatively simple operation but each bearing surface had to be checked during the grinding operation so that there was less than .0005 difference from end to end. Since the camshaft runs directly in the honed aluminum block, you can readily see how important this operation is. Not only were the bearing surfaces ground but one end must be ground to receive the timing gear.

Pic #1 (Finished and ready to install Camshafts)

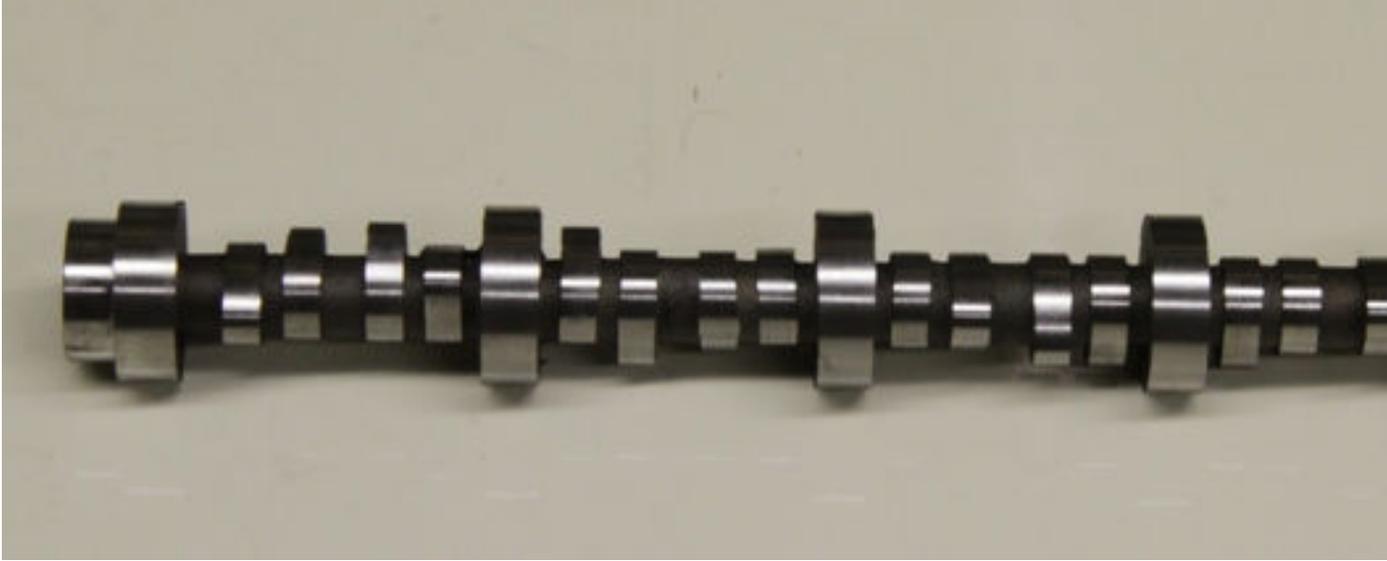
Pic #2 (Finished Camshaft)

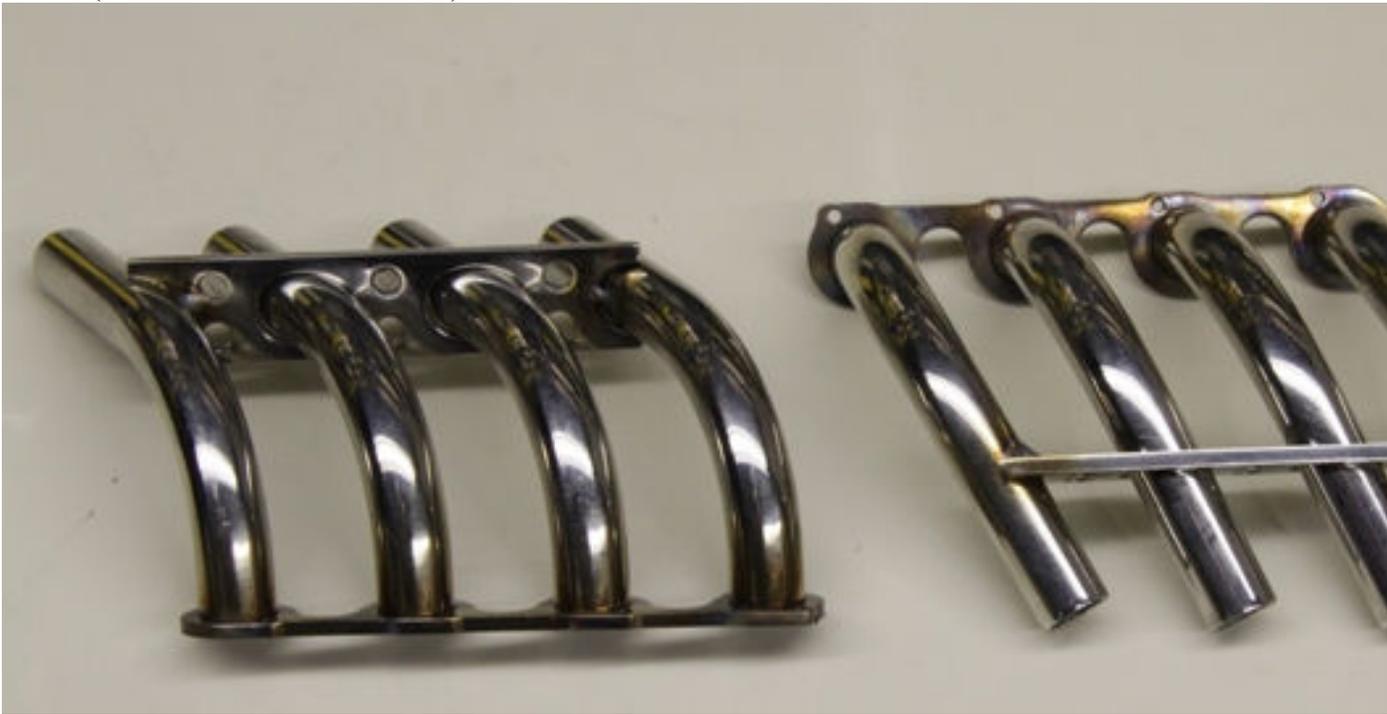
For those of you who are going with a stock exhaust, the optional polished “Zoomie” style headers are finished. Pretty neat, Huh. Notice the spreader and machined exhaust flange.

Pic #3 (Polished "Zoomie" headers)

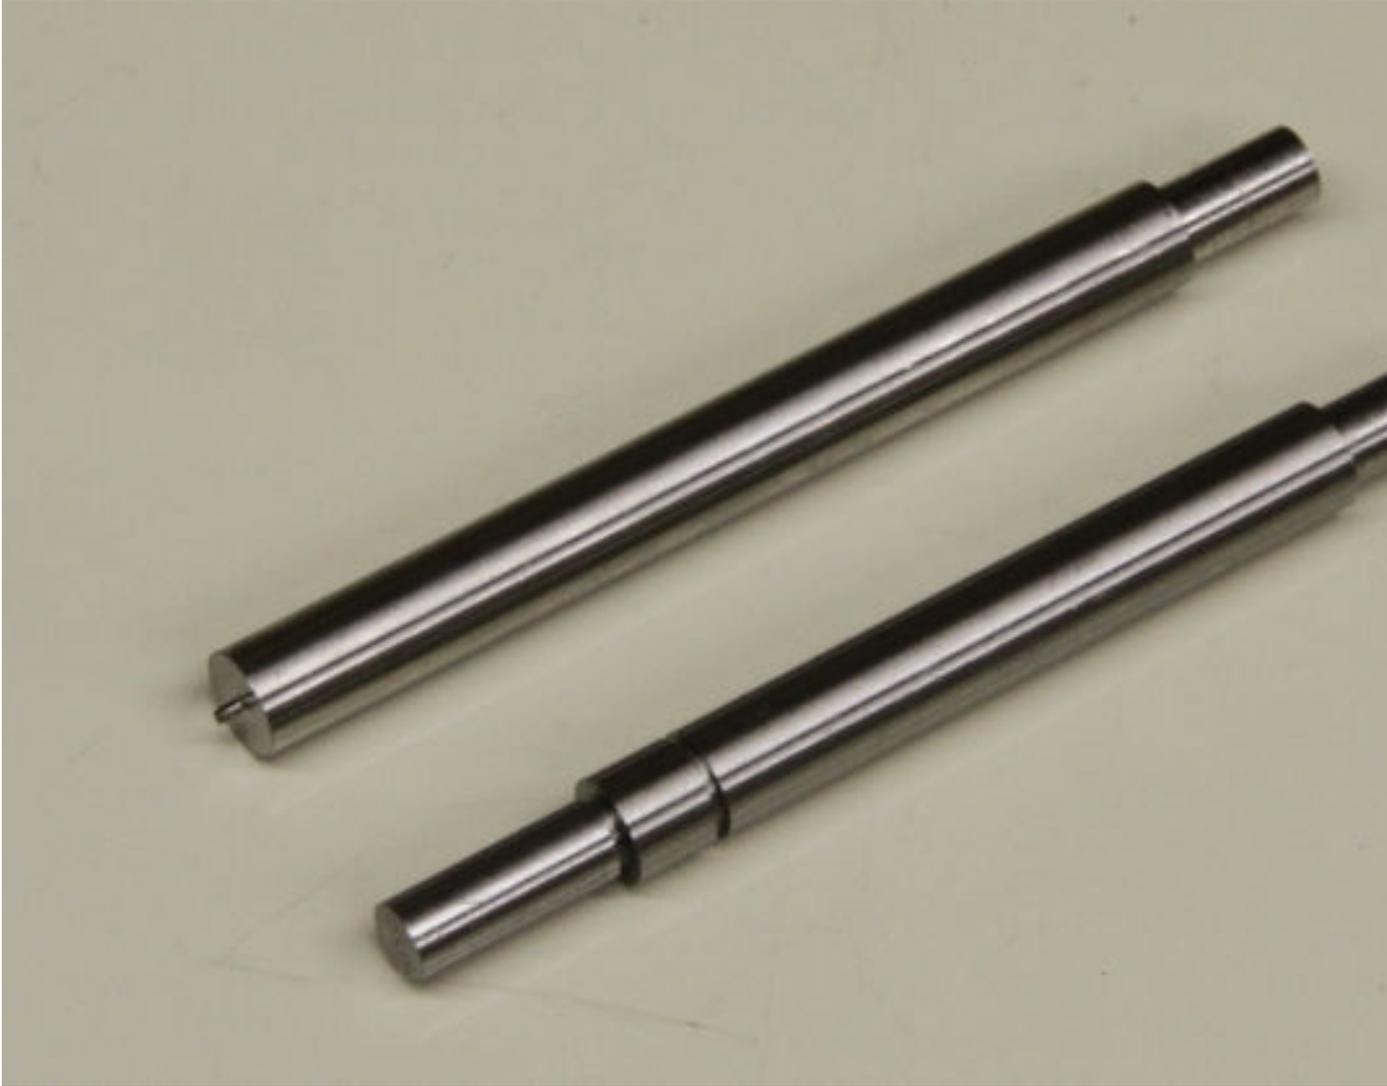
Picture #4 & #5 shows the finished distributor shafts. In a previous update, I showed you a basic distributor shaft, but now the rotor end is finished and the grooves which hold the shaft in position are also finished. It is critical that the shaft not move up or down so the exact spacing between the rotor and distributor cap will be maintained. Imagine how much damage would happen if the rotor came in contact with the cap. Not a pleasant thought.

Pic #4 (Before and after distributor shafts)

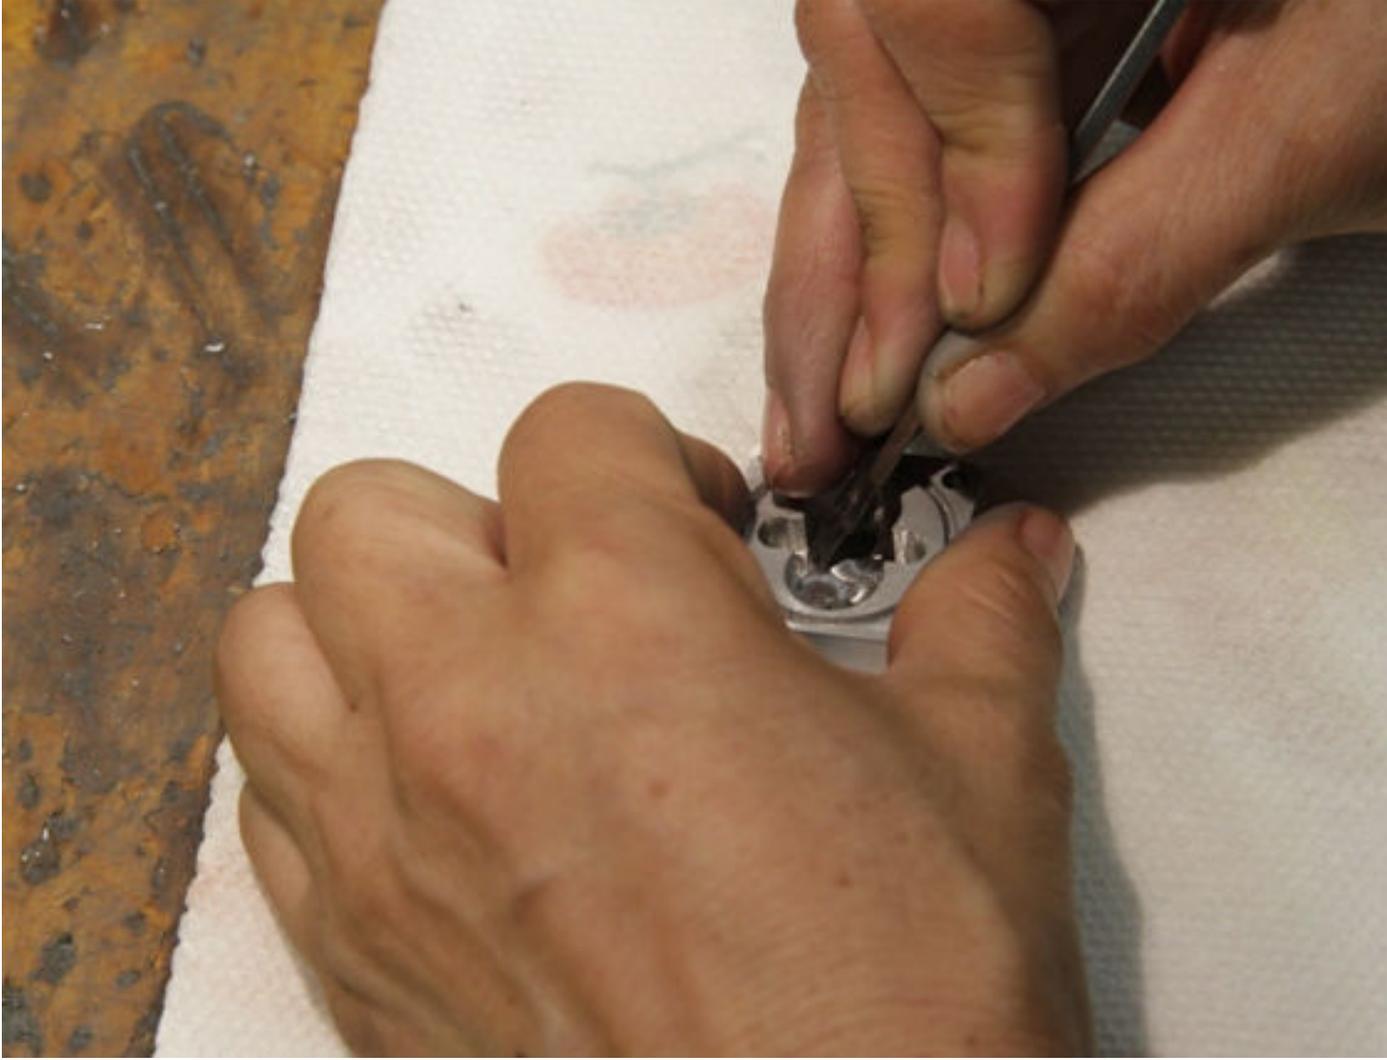
Remember when I said that parts needed to be de-burred, such is the case with all the oil pump components. Each item has to be individual check and cleaned as necessary. During the final assembly of the oil pump, each item will be check again and then rechecked. Each pump with then be thoroughly tested for flow and pressure before installation.

Pic #8 (De-burring oil pump housing)
