Everything is going great for this next run of engines. Finally! As always, I need more time but because of the CNC programs, jigs and fixtures from the previous run, things are doing much better. There is always the small “tweak” of a programs or slight modification of the holding fixtures, but this is to be expected, as I try to get all the pieces finished for sub-assemblies.

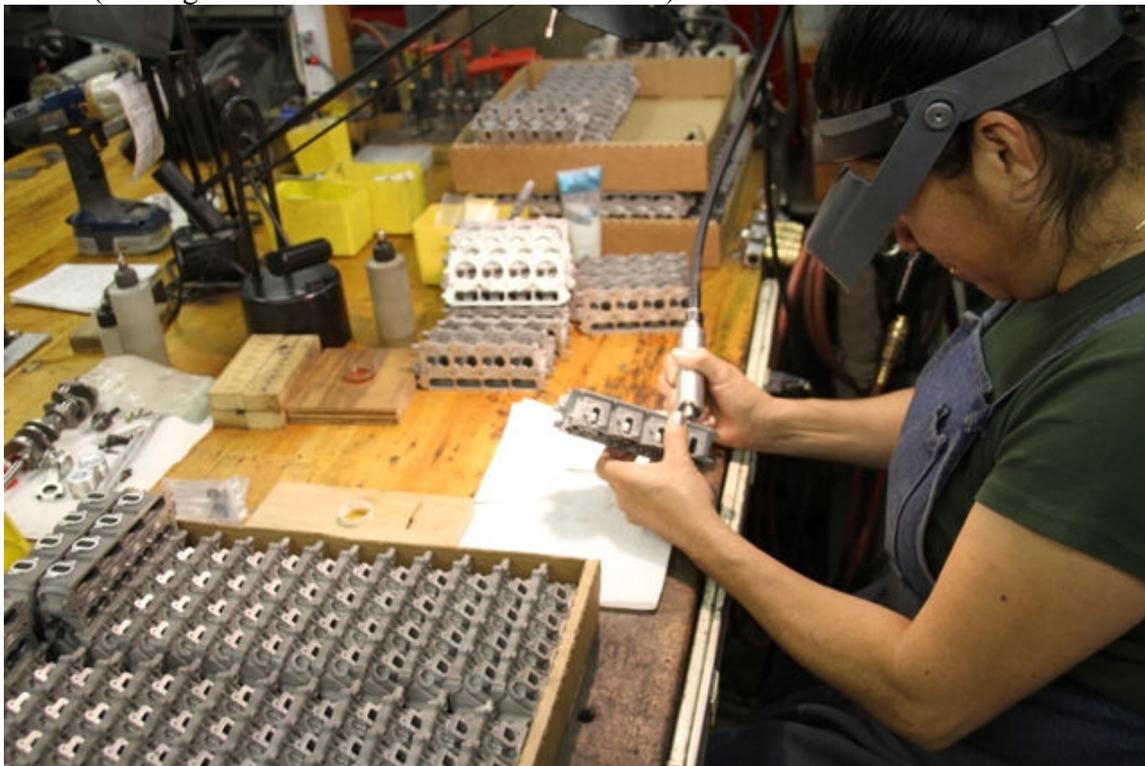
Pic #1 (Cutting valve seat with diamond coated tool)

On my last update I explained, the valve seats had been installed – and all went as planned. The valve guides have been pressed into place and then a special tool is used to cut the seat, so that it is perfectly concentric with the valve guide. This is an absolutely critical step, which cannot be rushed. I then use a valve which has been coated in diamond to slightly grind the already tapered valve seat. Once I am confident the taper on the seats is correct, and then comes the laborious task of lapping each valve. This takes a considerable amount of time, because if there are any leaks, then compression is compromised, which results is less power from the engine. Only, one head at a time is lapped. Each valve is place in a numbered holder, then the head is thoroughly cleaned and each valve seat is rechecked. After the head and valves are perfect, then each valve stem is oiled and placed in its respective location, after which, the “high hat” which holds the “O” ring seal, is installed. Next comes the valve spring, followed by the new valve spring retainer and finally the “split keepers” are installed. Keep in mind there are over 160 head and each has 8 valves, which must be perfect! Once again, it is easy to see why it takes so long to do a production run of engines.

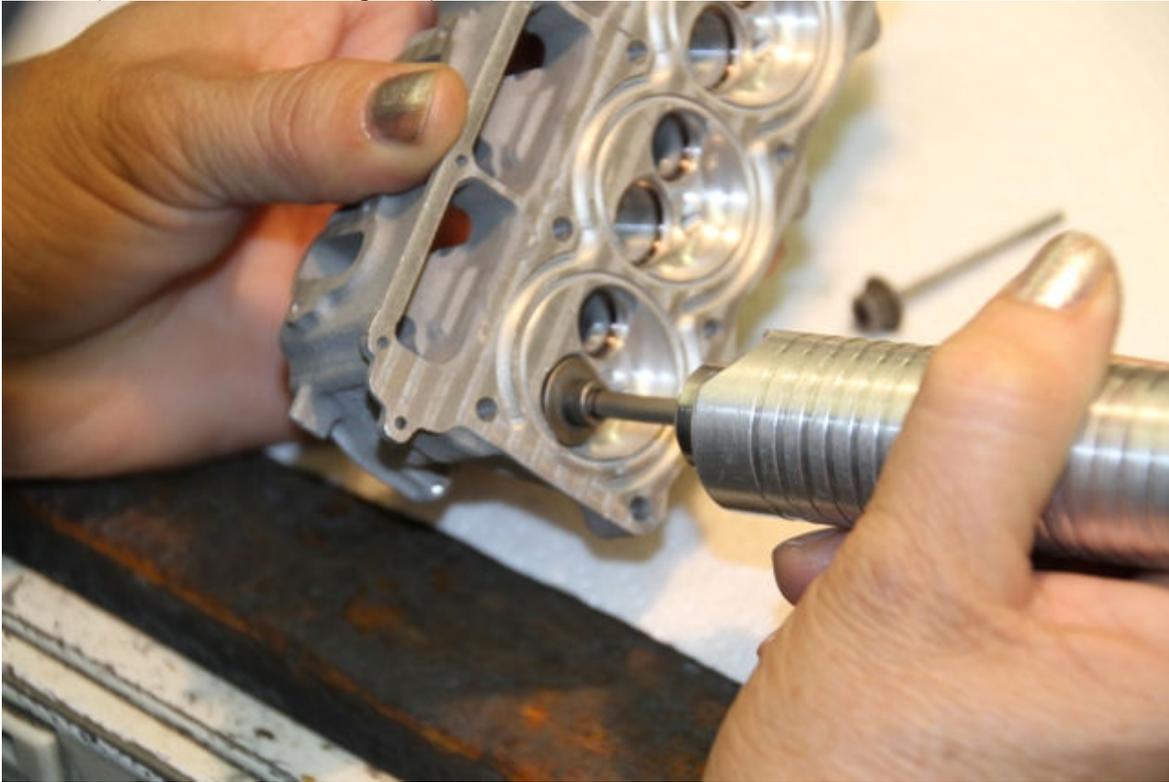
Pic #2 (Diamond tool cutting seat)

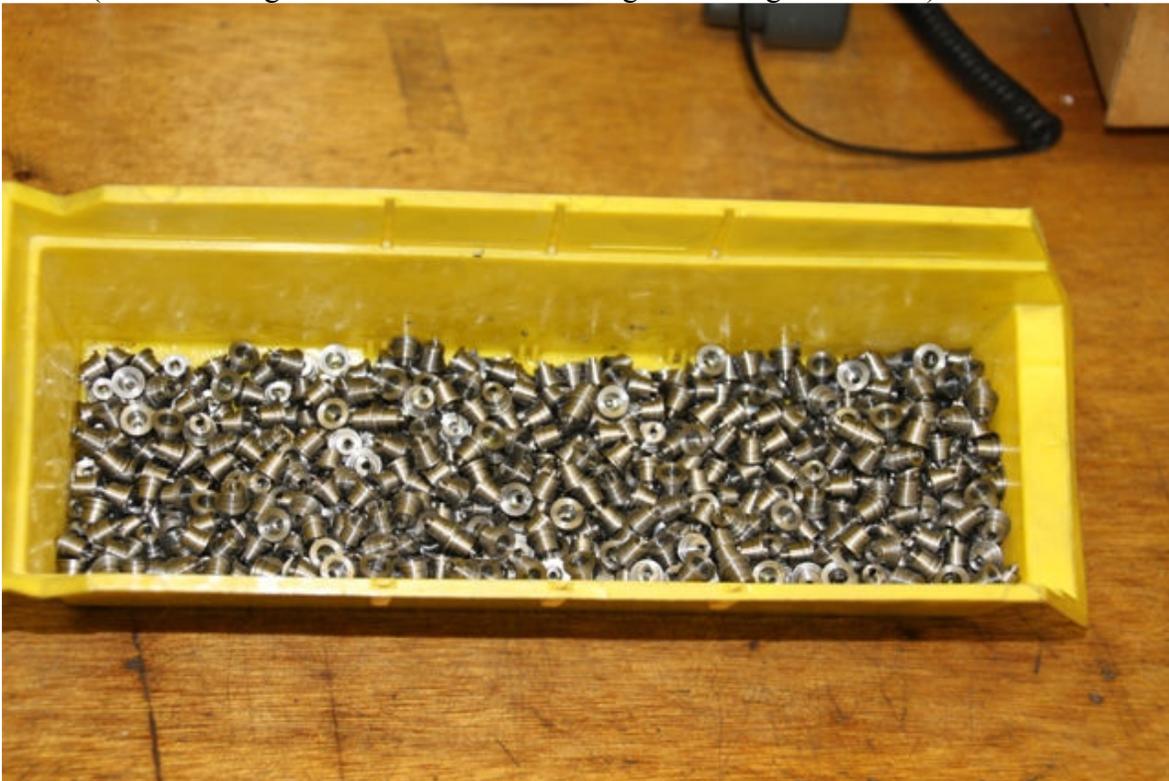
Pic #3 (Finished "High hats" which hold "O" ring for sealing valve stem)

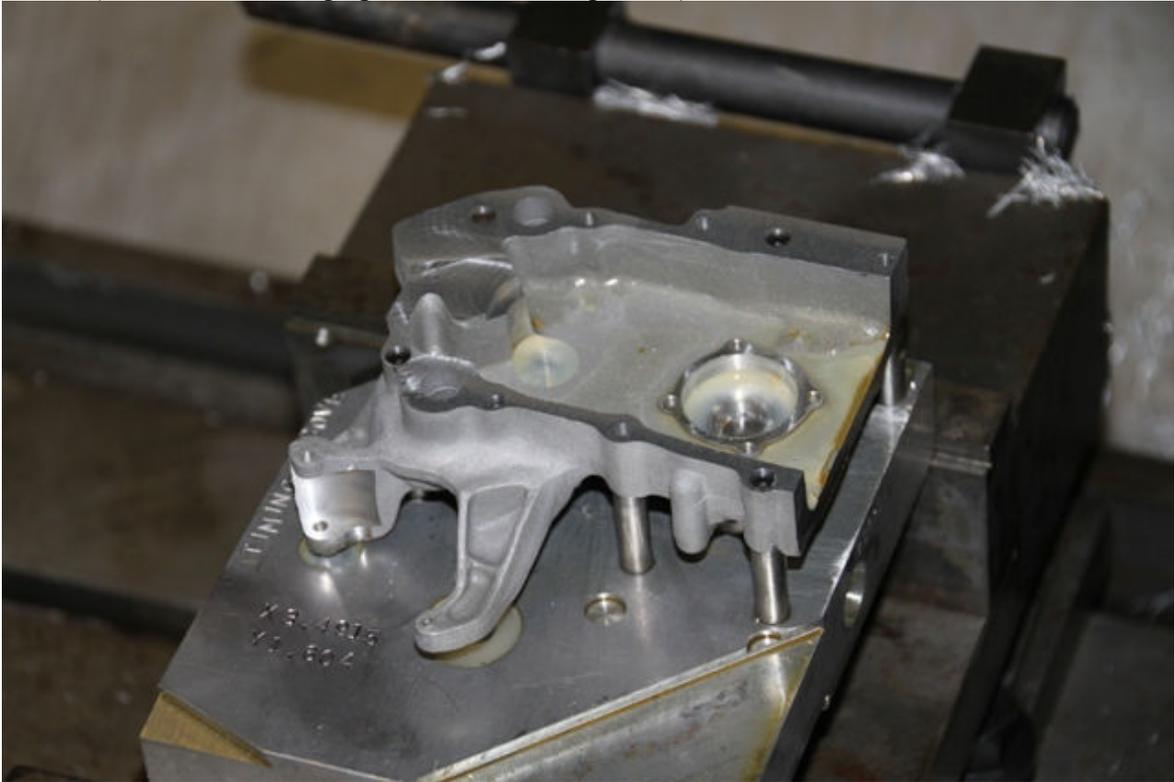
Pic #4 (Second machining operation for timing cover)

While all this is going on, the initial machining operations have started on the timing cover. When I say “initial” this simply means there are 8 other operations to follow. I will keep you updated as to the progress.

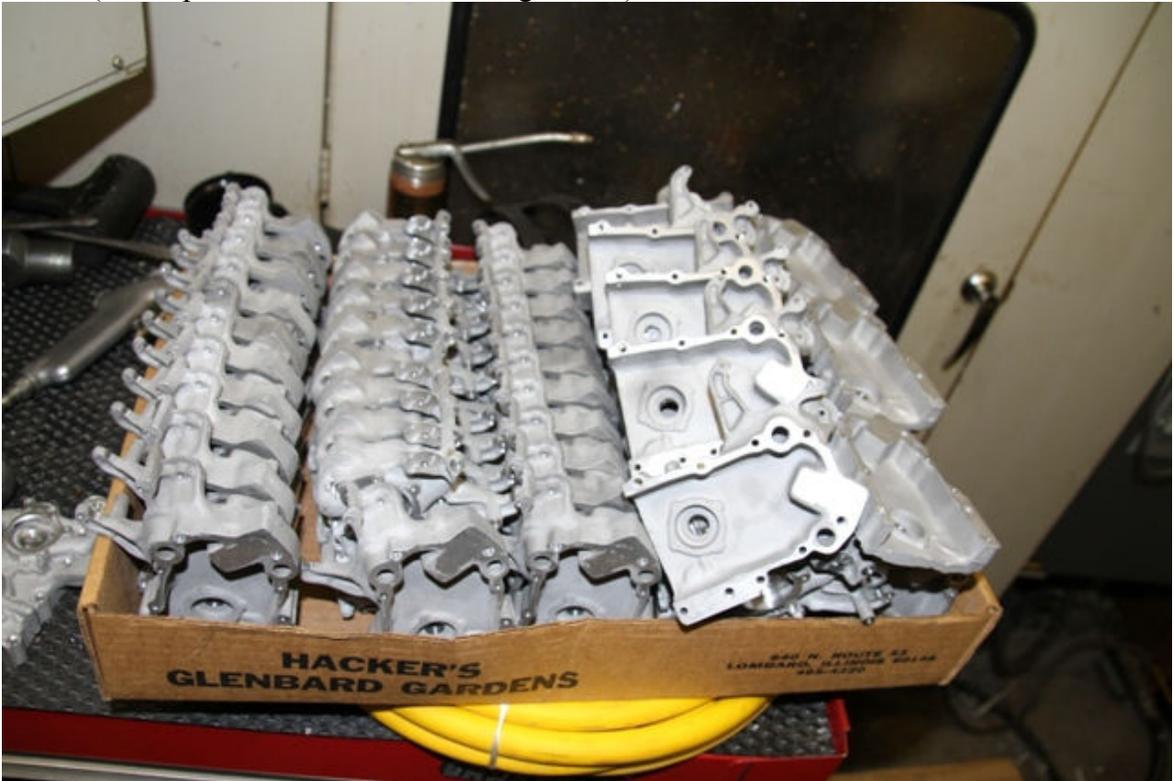
Pic #4 (First operation finished for timing covers)
