(10 Dec 2007):

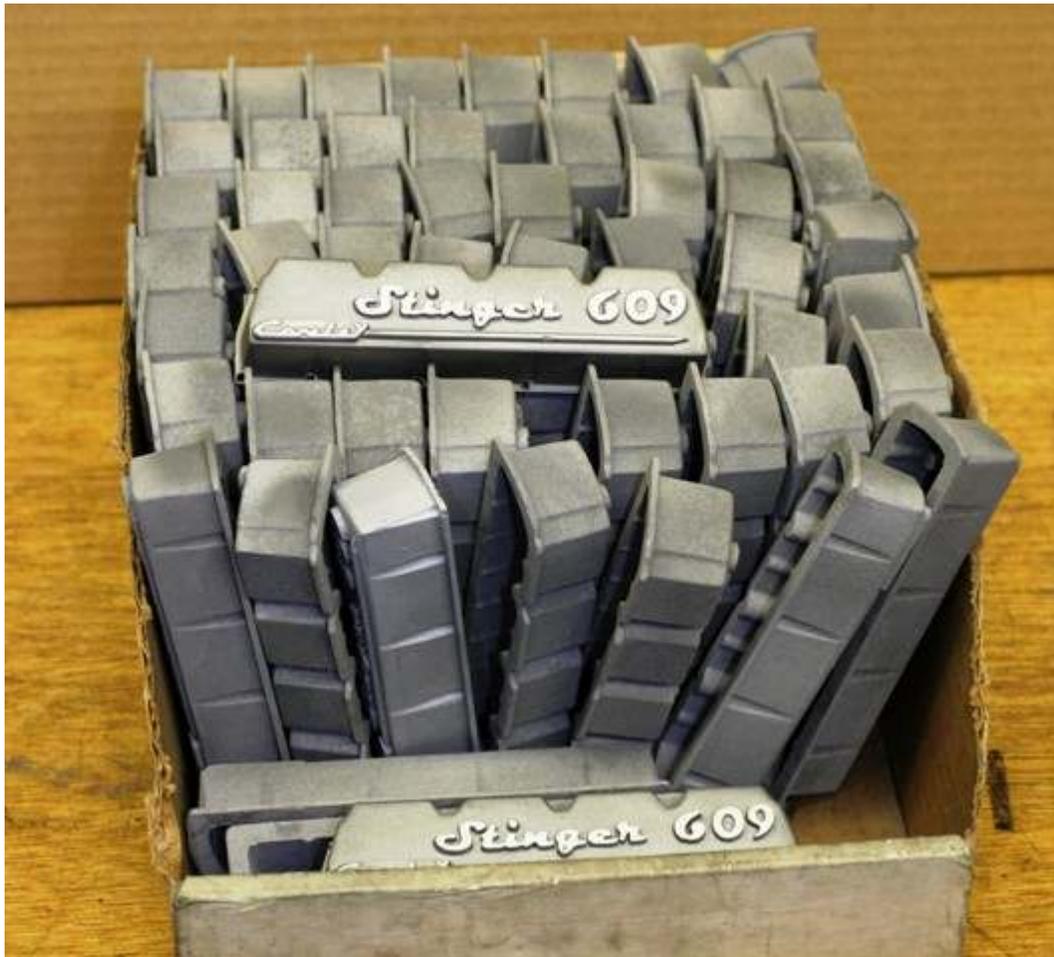
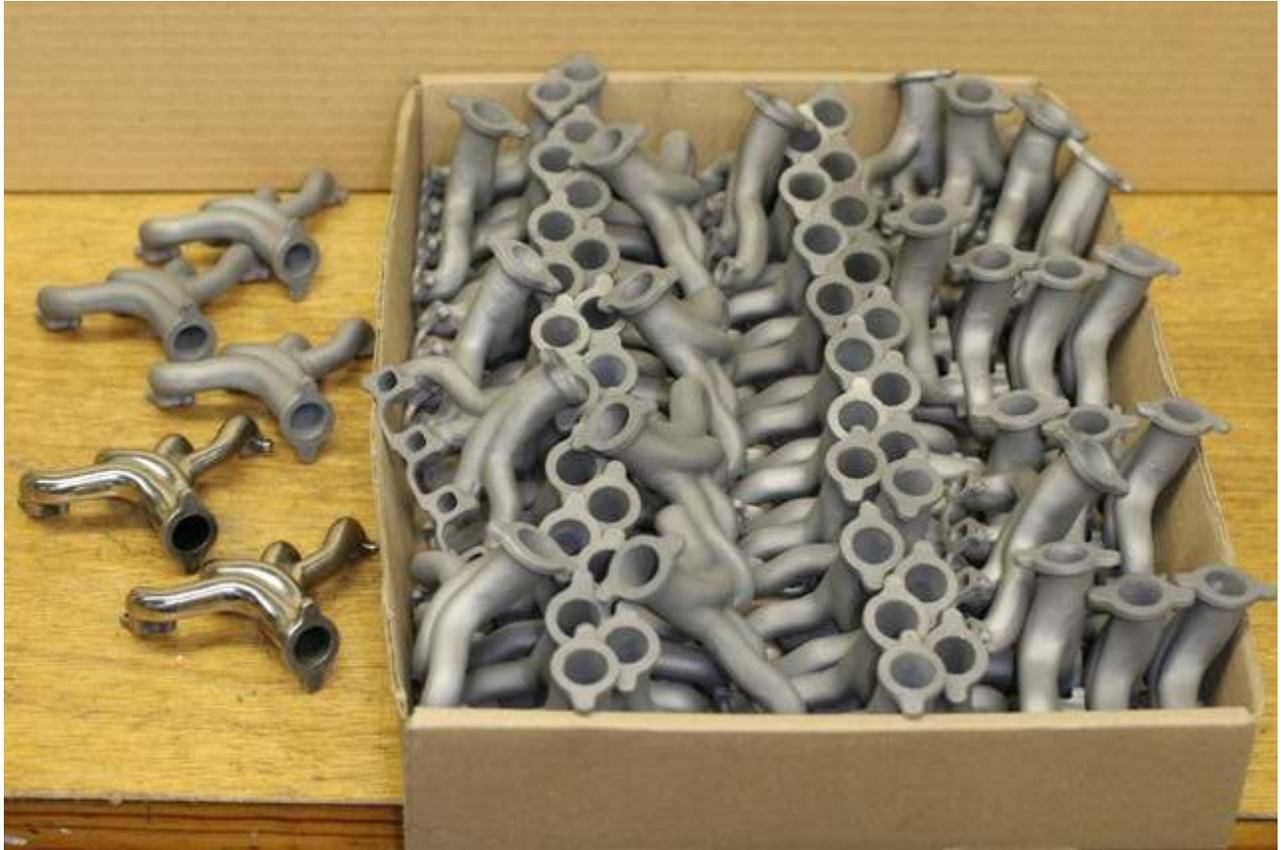
As you can from the top two photos, the castings for valve covers and exhaust manifolds are in stock. There are several trays of the same parts. Once all of the casting have arrived, they will be sent out to be heat treated. The molds for the exhaust manifolds were very difficult to make because of the parting line that is needed. For those of you who are not familiar with a "parting line", it is a line around each part which allows the wax pattern to be able to be removed without breaking. The exhaust manifold is a complicated part, with no straight lines. The core has the same problems. Oh, one more thing, wax and metal shrink and different rates and the size each master parts must be made to allow for this shrinkage. If everything is not calculated correctly, then parts do not align. So much for the castings, the third picture from the top shows the new oil pump bracket. The one on the left is the prototype, the one on the right, being the finished item. What looks like a simple item, is in fact, quite complicated. The valve body (far right), not only allows oil into the filter, but includes an adjustable pressure relief. This

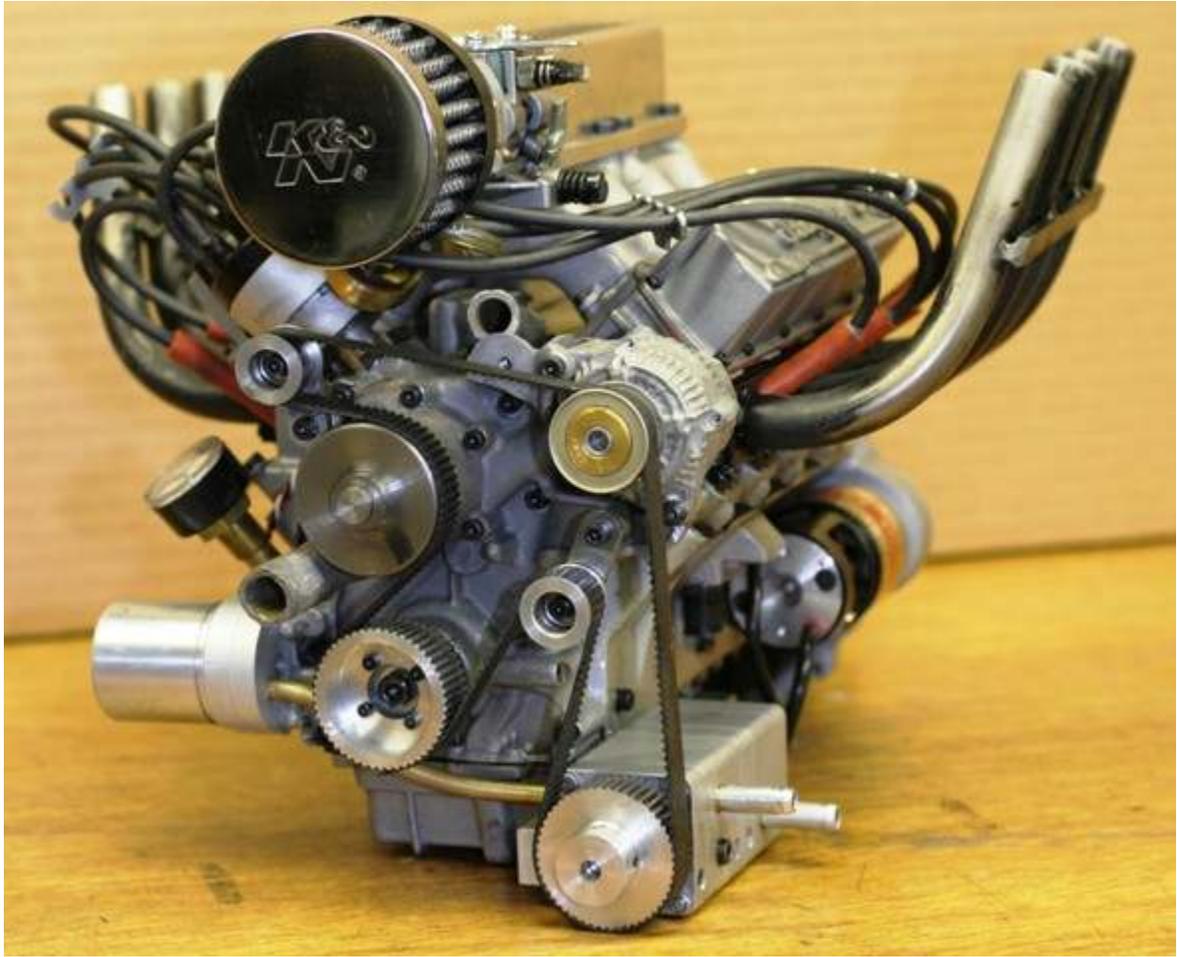
is extremely important, because of the high pressure the new pump is capable of producing. The fourth picture is the finished shows a close-up of the entire unit. Once again, many hours when into the development and testing. Because of the accuracies that are needed for this part, the CNC programs had to be triple checked. The bottom two pictures show the new oil filter bracket installed on the engine. You will also notice a "new look" for the front of the engine. At first glance you may not see the difference, but if you look at my home page, you will see the changes. The modifications were made after several of my customers had made a comment about the aluminum piece that supported the lower idler, looked out of place. After about three weeks of work, I feel that the change was justified. There is an old saying that goes " you cannot see the forest because all the trees are in the way". Until it was brought to my attention, I really did not see the obstacle. What may look like a simple change, took a tremendous amount of time and CNC programming. If you look closely the two idle pulleys were changed and incorporate a flanged on either side to make sure the belt stays in the center. Not only these changes, but any changes must be made before a lot of parts are cast, machined, and in placed in stock. This could be a very expensive proposition. This is why I try to explain that sometimes things take longer than anticipated and no matter how much you plan, it is sometimes difficult to schedule the amount of time that is needed for a particular project. This is especially true on a new engine.
