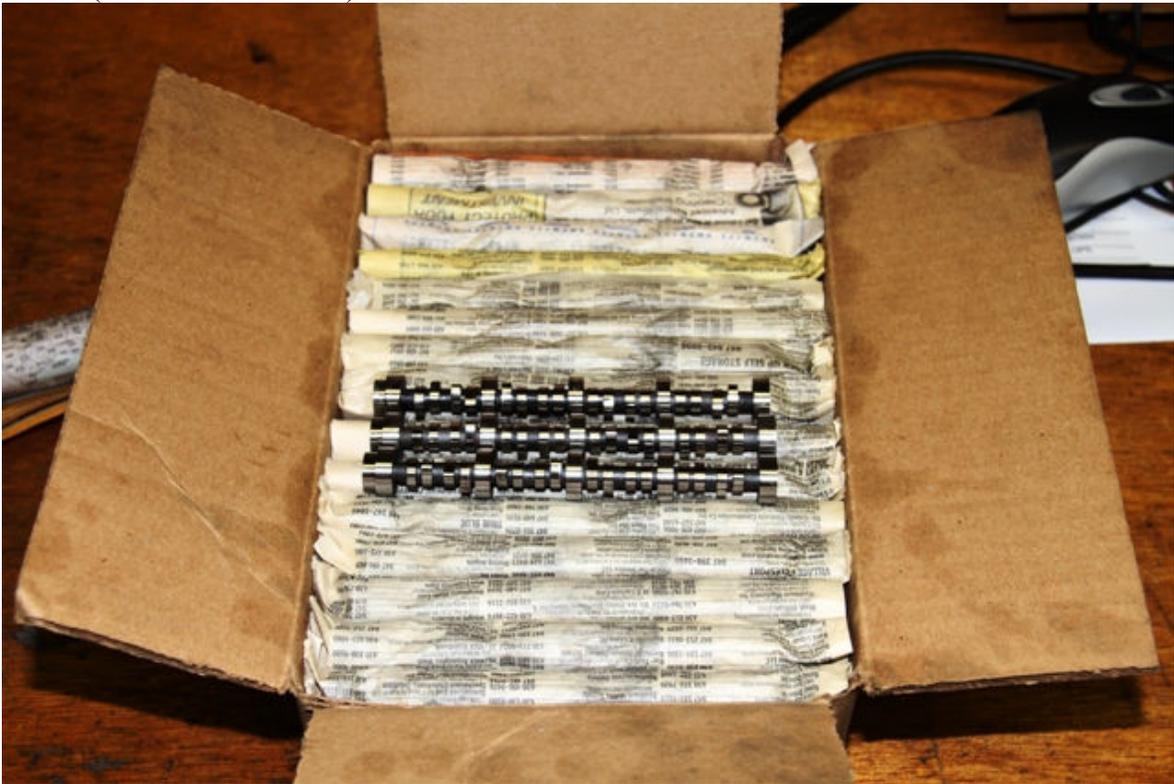
Pic #1 (Finished camshafts)

It is now Saturday morning, September 15 and thought I should do a quick update before I get started. As always, so much is happening that it is difficult to know where to start. In all honesty, it is almost impossible to think that it has been over a month since my last update. Everyone has heard or read this numerous times in the past, "I cannot understand where the time goes". If the days were 48 hours long, then I could get some real work finished. Anyway, everyone should be glad to know the camshafts are finished and ready to be installed. All surfaces are ground and as the picture shows I am holding a finished camshaft. Unfortunately this does not give a good representation of just how many are wrapped in newsprint to keep them from rusting and maintain the surface finish. Staying true to my commitment to maintaining a good inventory of parts, there are actually about 85 camshafts in the box. I also have over 20 additional in stock from the first run. Although I have never replaced a camshaft, nor do I expect to do so, it is reassuring to know that I have extras in stock.

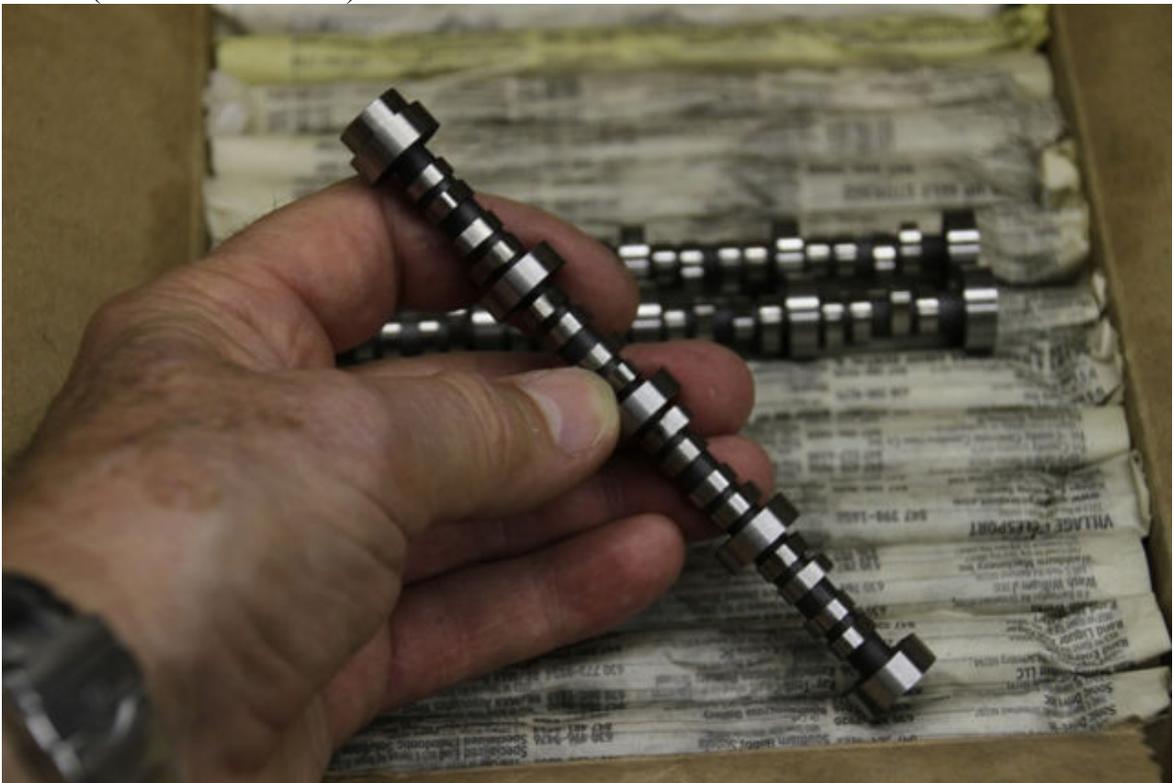
Pic #2 (Finished camshafts)

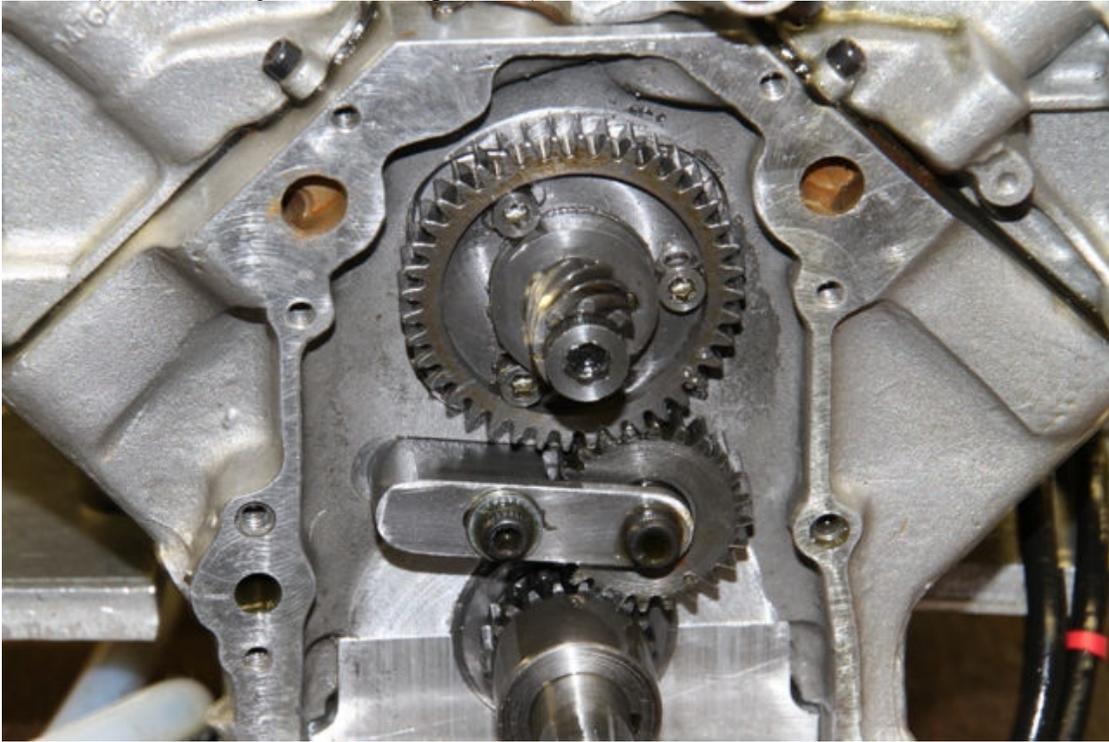
Pic #3 (New cam adjustment components)

Going hand-in-hand with the finished camshafts, is the newly designed camshaft adjustment assembly. The reason for making the change is very simple – it greatly improves the accuracy of the camshaft timing and also makes it faster to assemble. The automotive degree wheel is used to set each camshaft - as the saying goes "By the numbers"! Now, there is zero chance of being off. No matter how accurate I was in the past trying to stamp timing marks in the exact location, it was possible to be off a small amount. What I mean is that one tooth of the camshaft gear is equal to 9 degrees and one tooth of the corresponding crankshaft gear is equal to 18 degrees. Knowing this, it is easy to see how the camshaft timing could possibly be off a small amount. When this would happen on the first run of engines, I would simply change the entire camshaft or change the timing gears until it was correct. You can see how time consuming this process could be. Anyway, the gear on the left in Pic #5 is a classical "Conley Screw-up" and is the result of what happens when I have a laps in memory and give the CNC machine the wrong distance from the cutter to the top of the part. Working late at night can sometimes have devastating results. And no, it is not going to be fixed and installed in someone's engine, Ha. Ha.

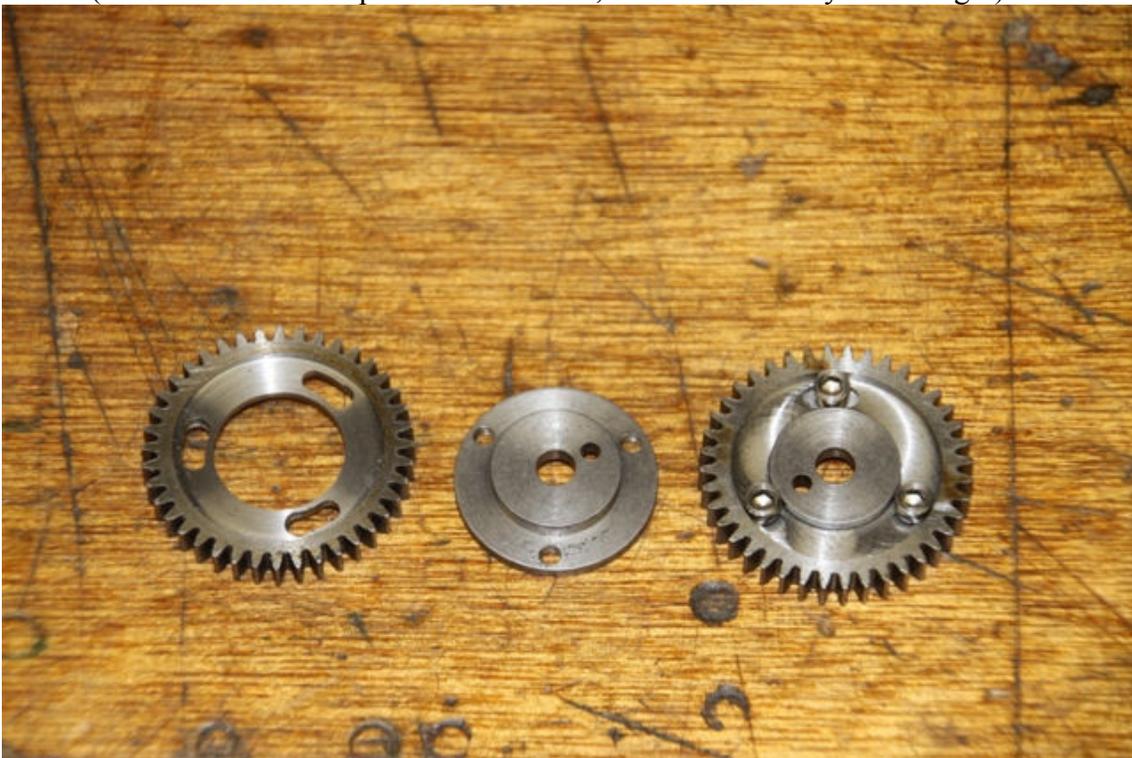
Pic #4 (Two individual components on the left, finished assembly on the right)

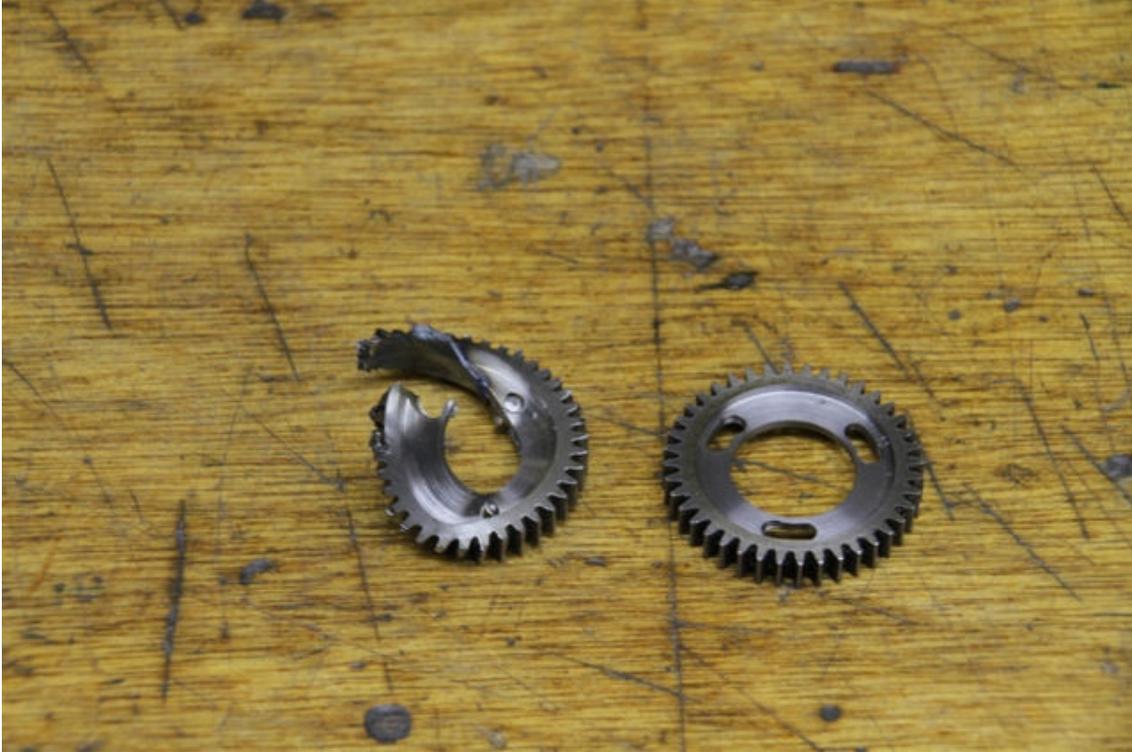
Pic #5 (Conley screw-up)

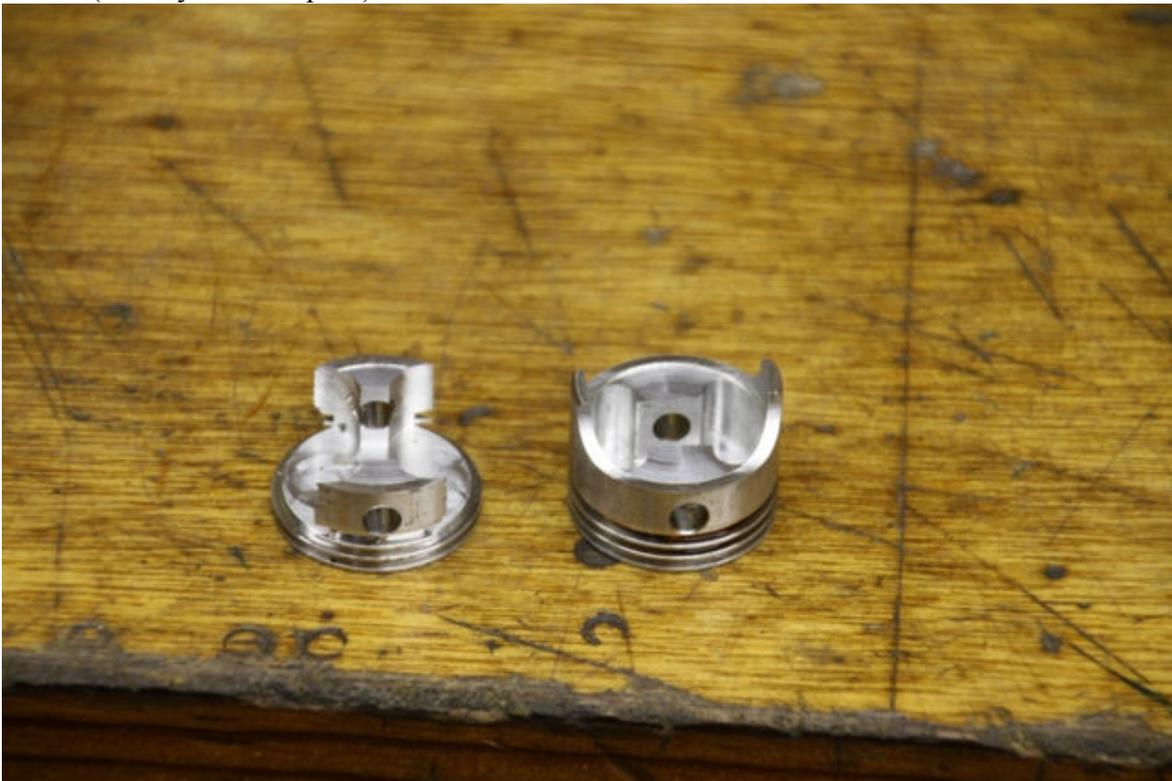
Pic #6 (Conley Screw-up #2)

No, Pic #6 is not of a newly designed piston, but rather shows what happened with a cutter is replaced with the wrong diameter. I do not often make these kinds of mistakes but I show them to let everyone one know, that making engines is often difficult and always mentally demanding.

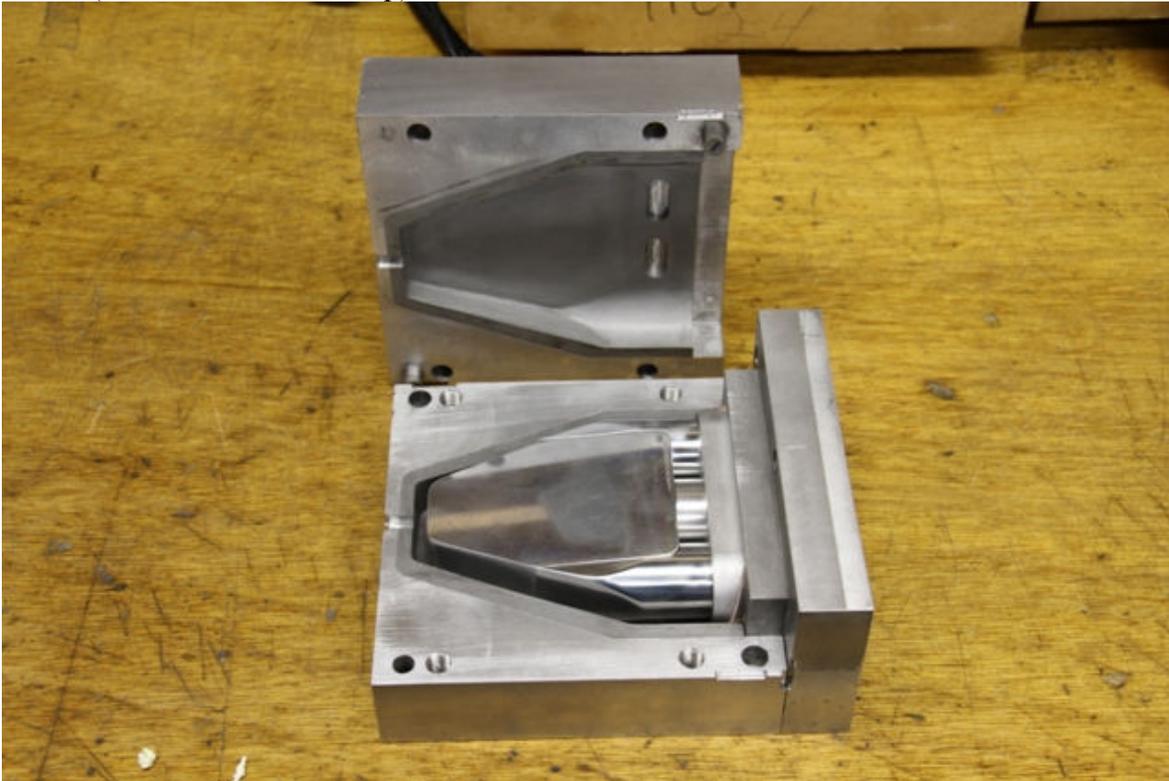
Pic #7 (Mold for new air scoop)

The final pictures show the much anticipated scoop "bug catcher" for the engines. At the request of several customers, I decided to make the mold and do it correctly. As you can see the scoop is in one piece. Designing the mold was very, complicated and time consuming but the net result is a very detailed and smooth part. These waxes will go to the foundry on the 18th of this month. Once the finished castings are returned, then I will give everyone an update as to the delivery time and cost. If everything goes as planned there will also be 3 "butterflies" that will be timed to the carburetor control linkage. As you can see, this is just a small amount of things that make up my day-to-day schedule. As the saying goes "Welcome to my world"

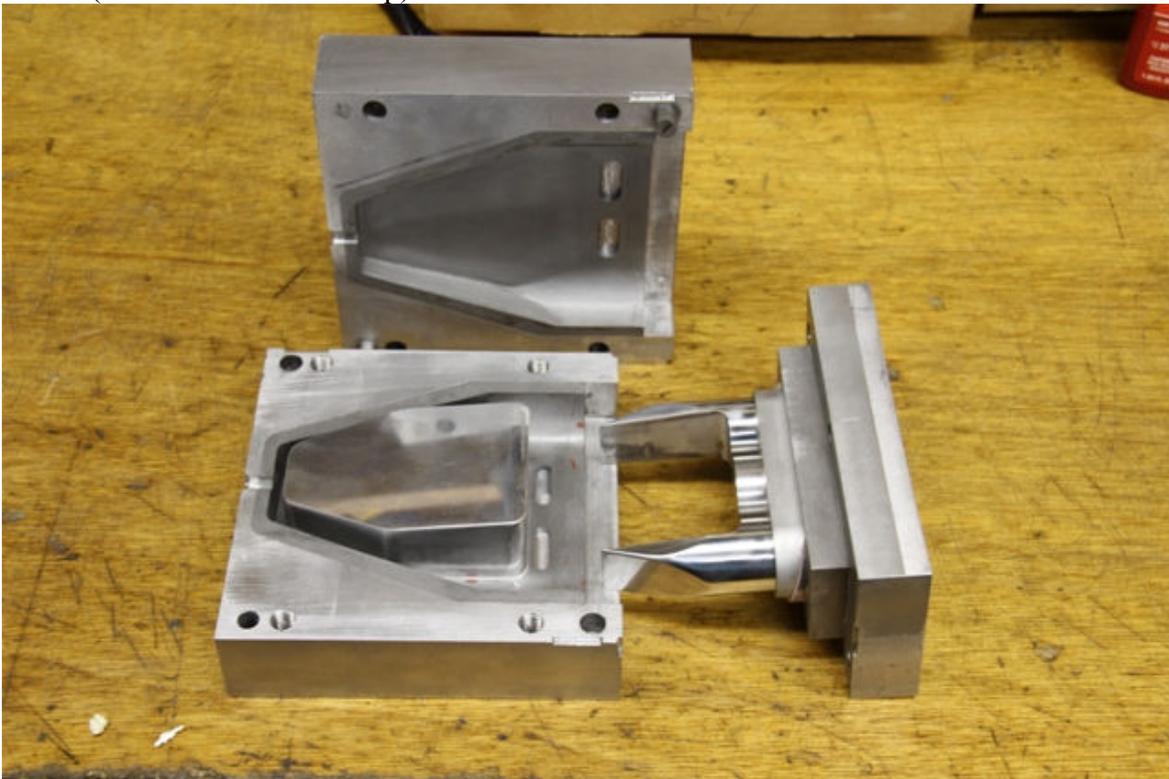
Pic #8 (Mold for new air scoop)

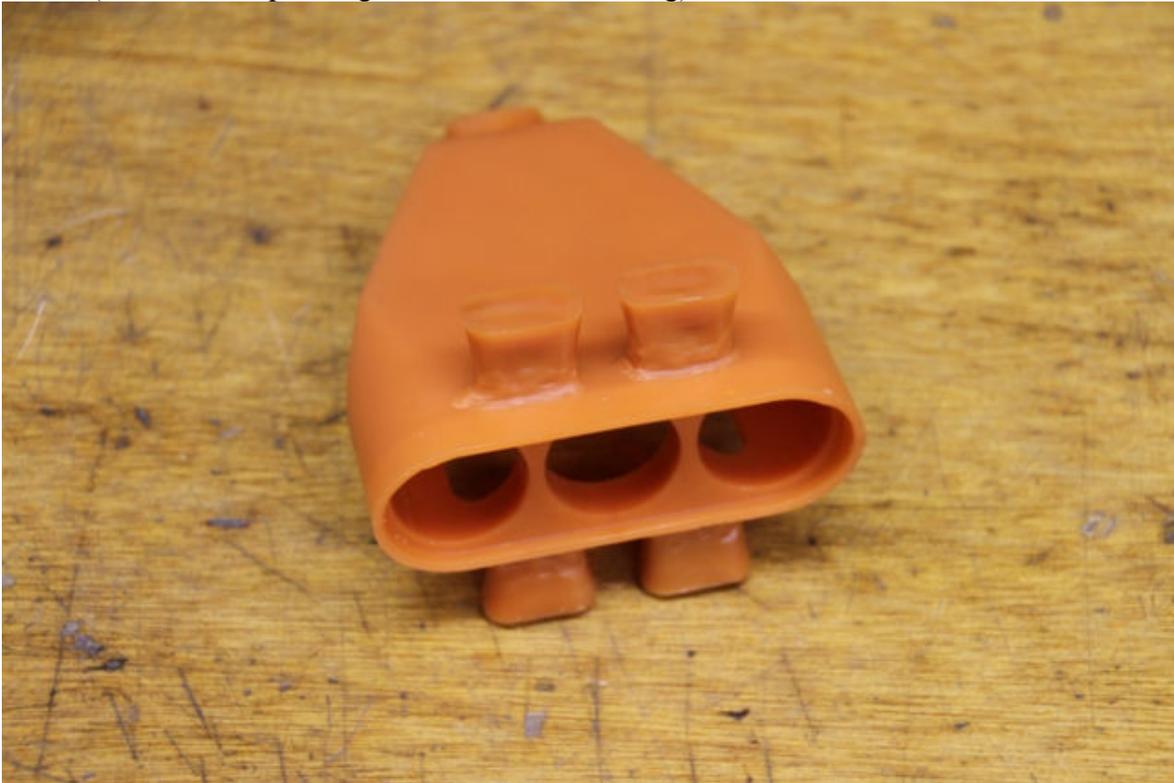
Pic #9 (Wax air scoop with gates attached for casting)

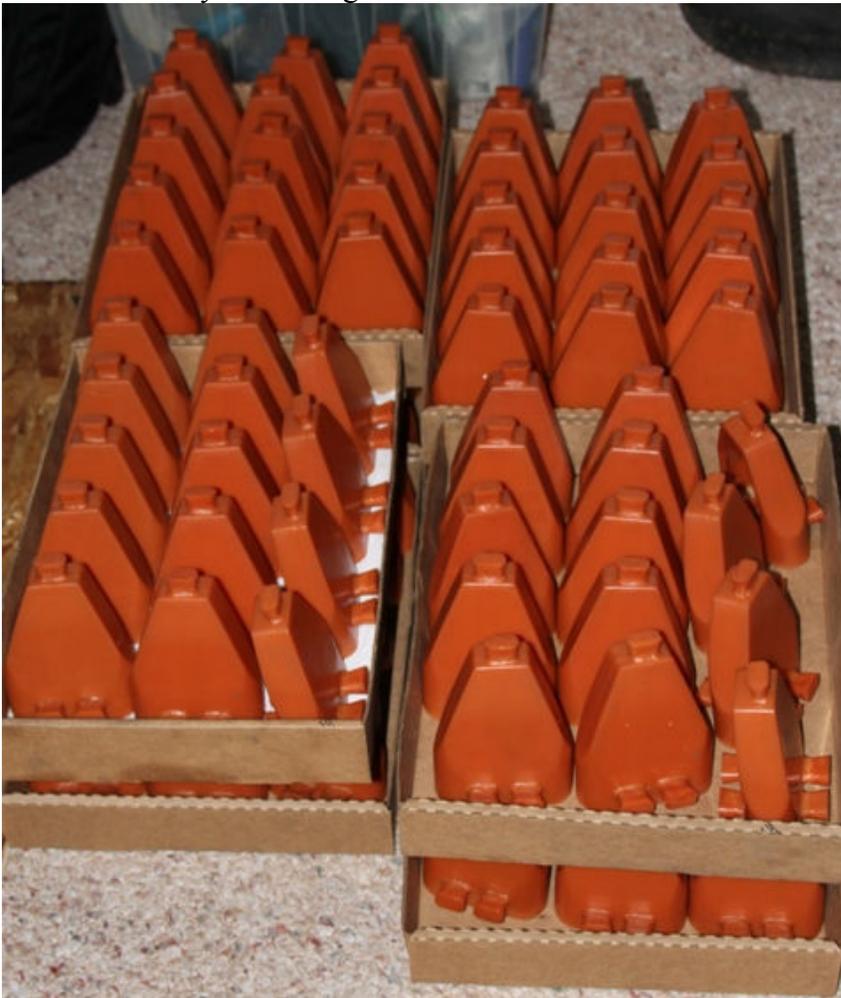
120 waxes ready for casting
