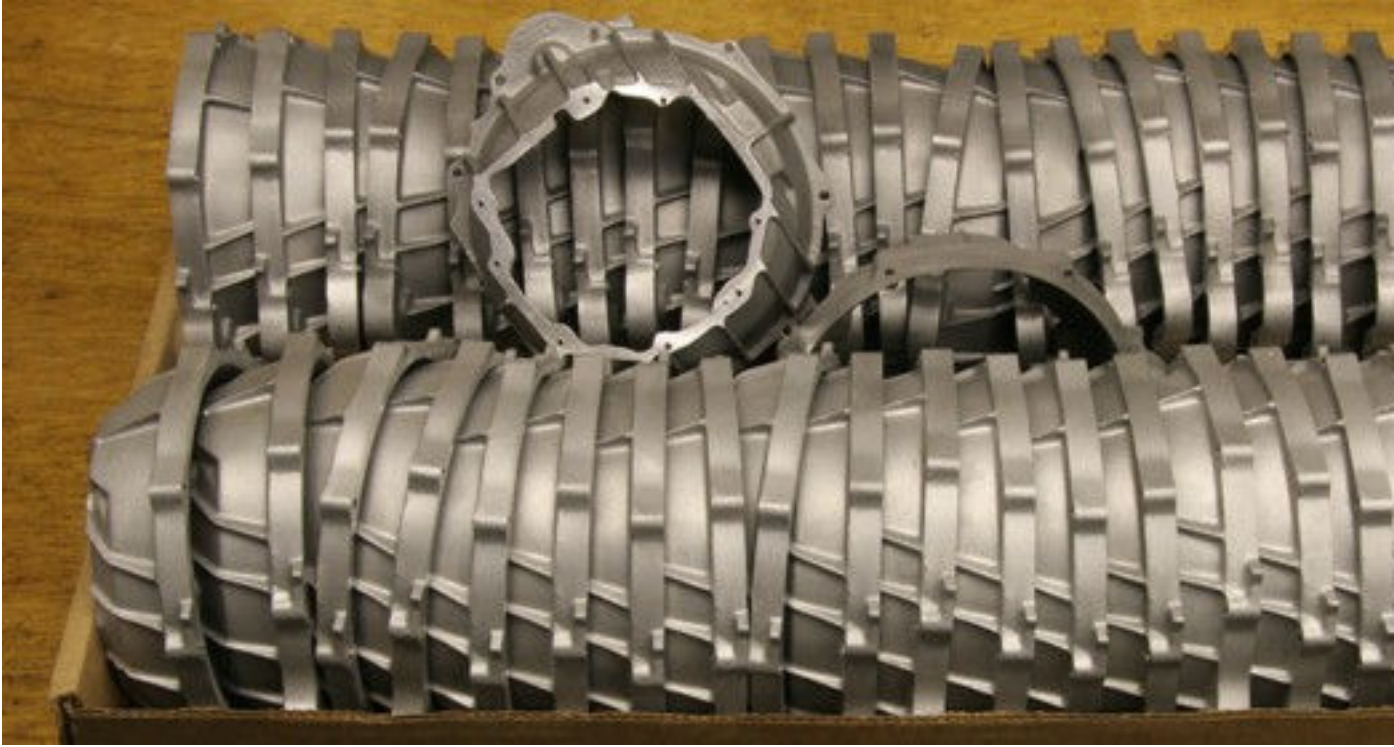
Pic #1 (Finished Bellhousings)

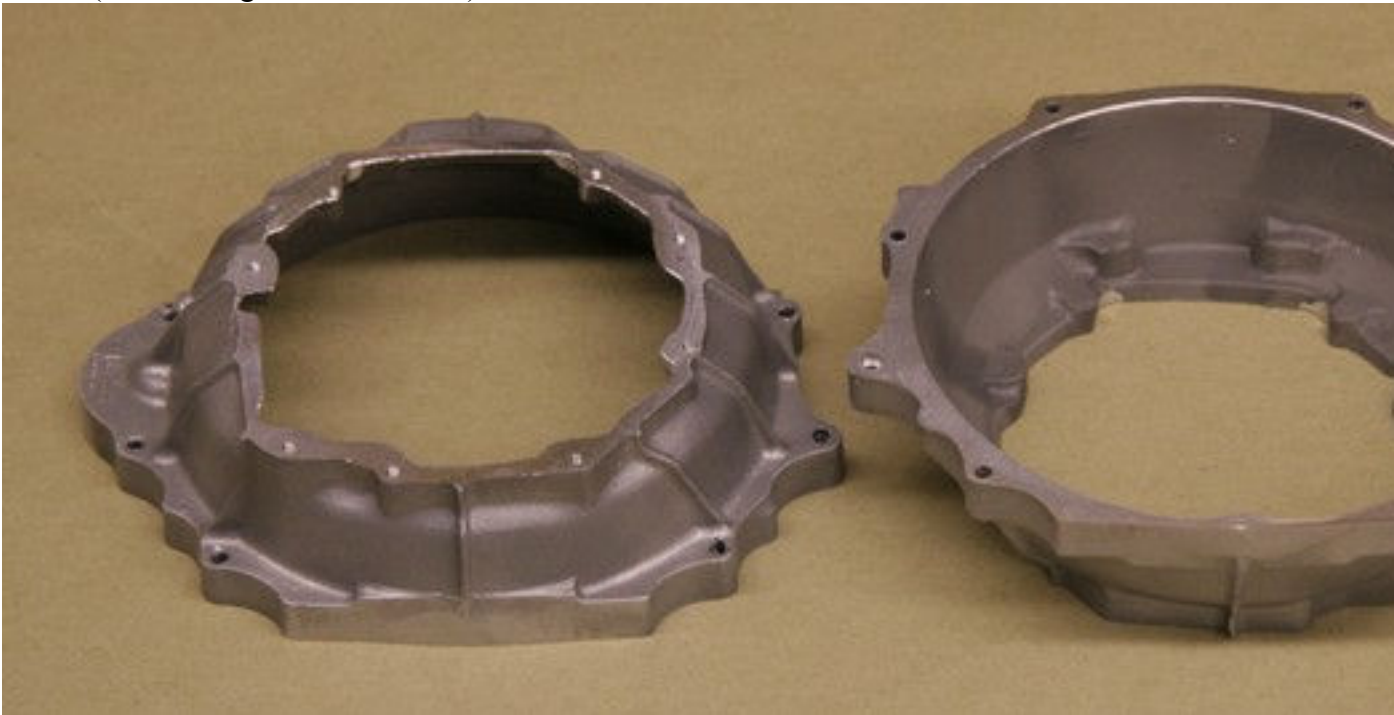
Pic #2 (Bellhousing - front and back)

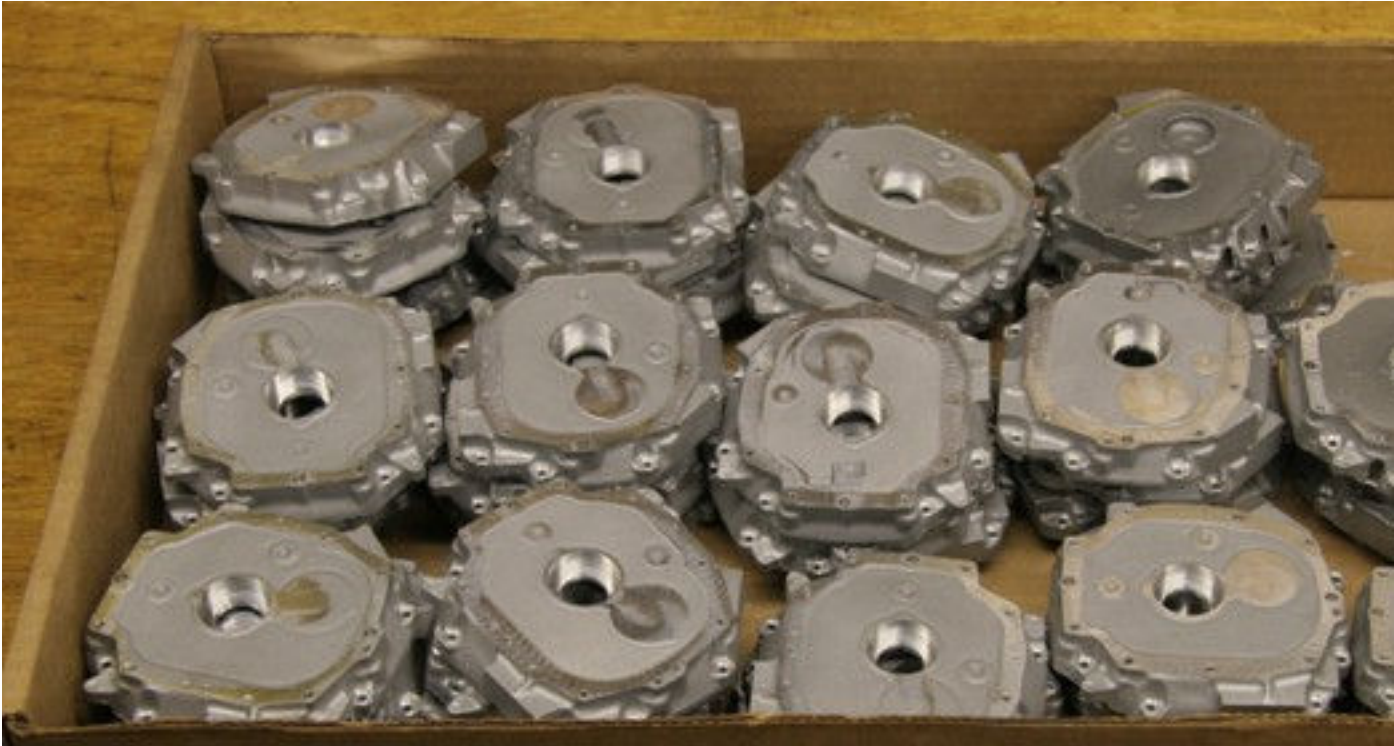
Pic #3 (Finished transmission adaptor plates)

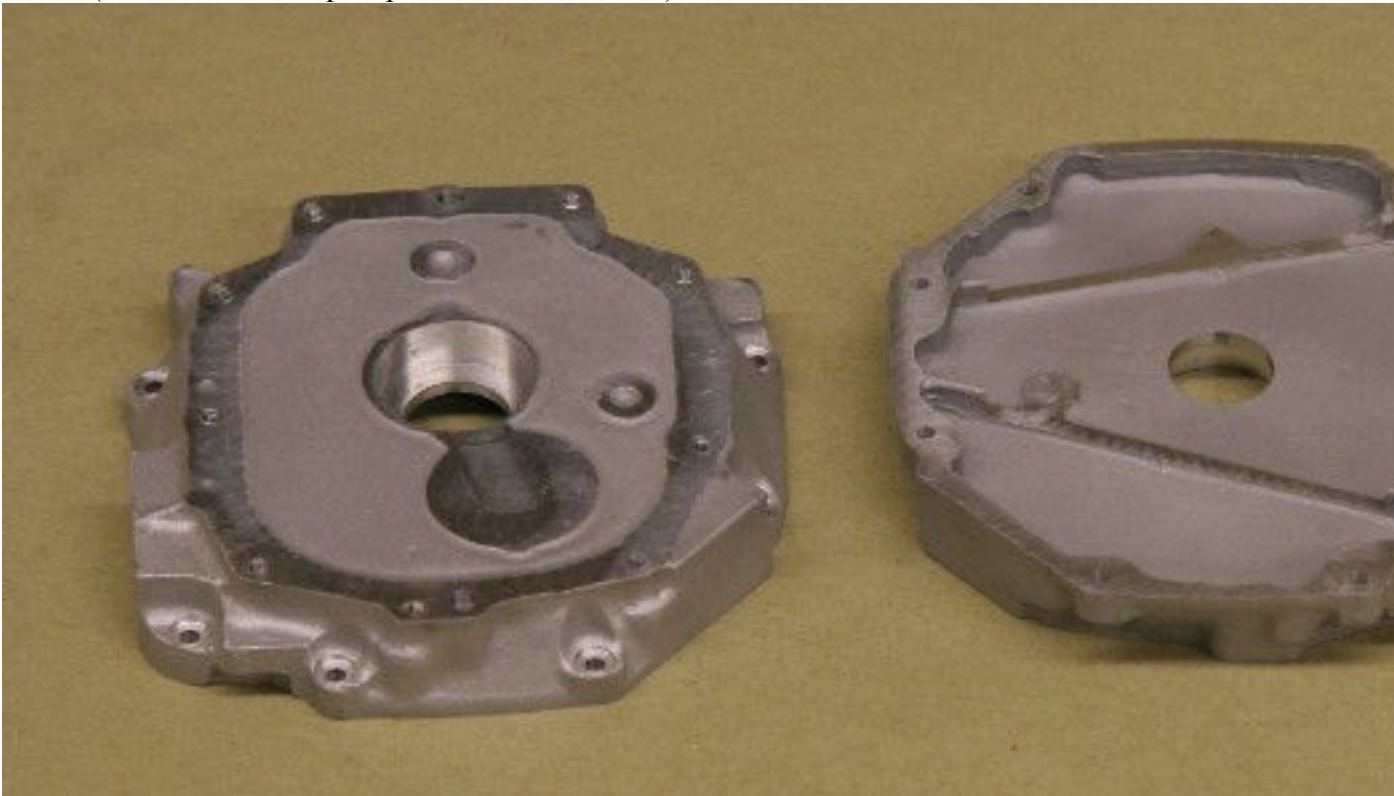
Pic #4 (Transmission adaptor plate – front and back)

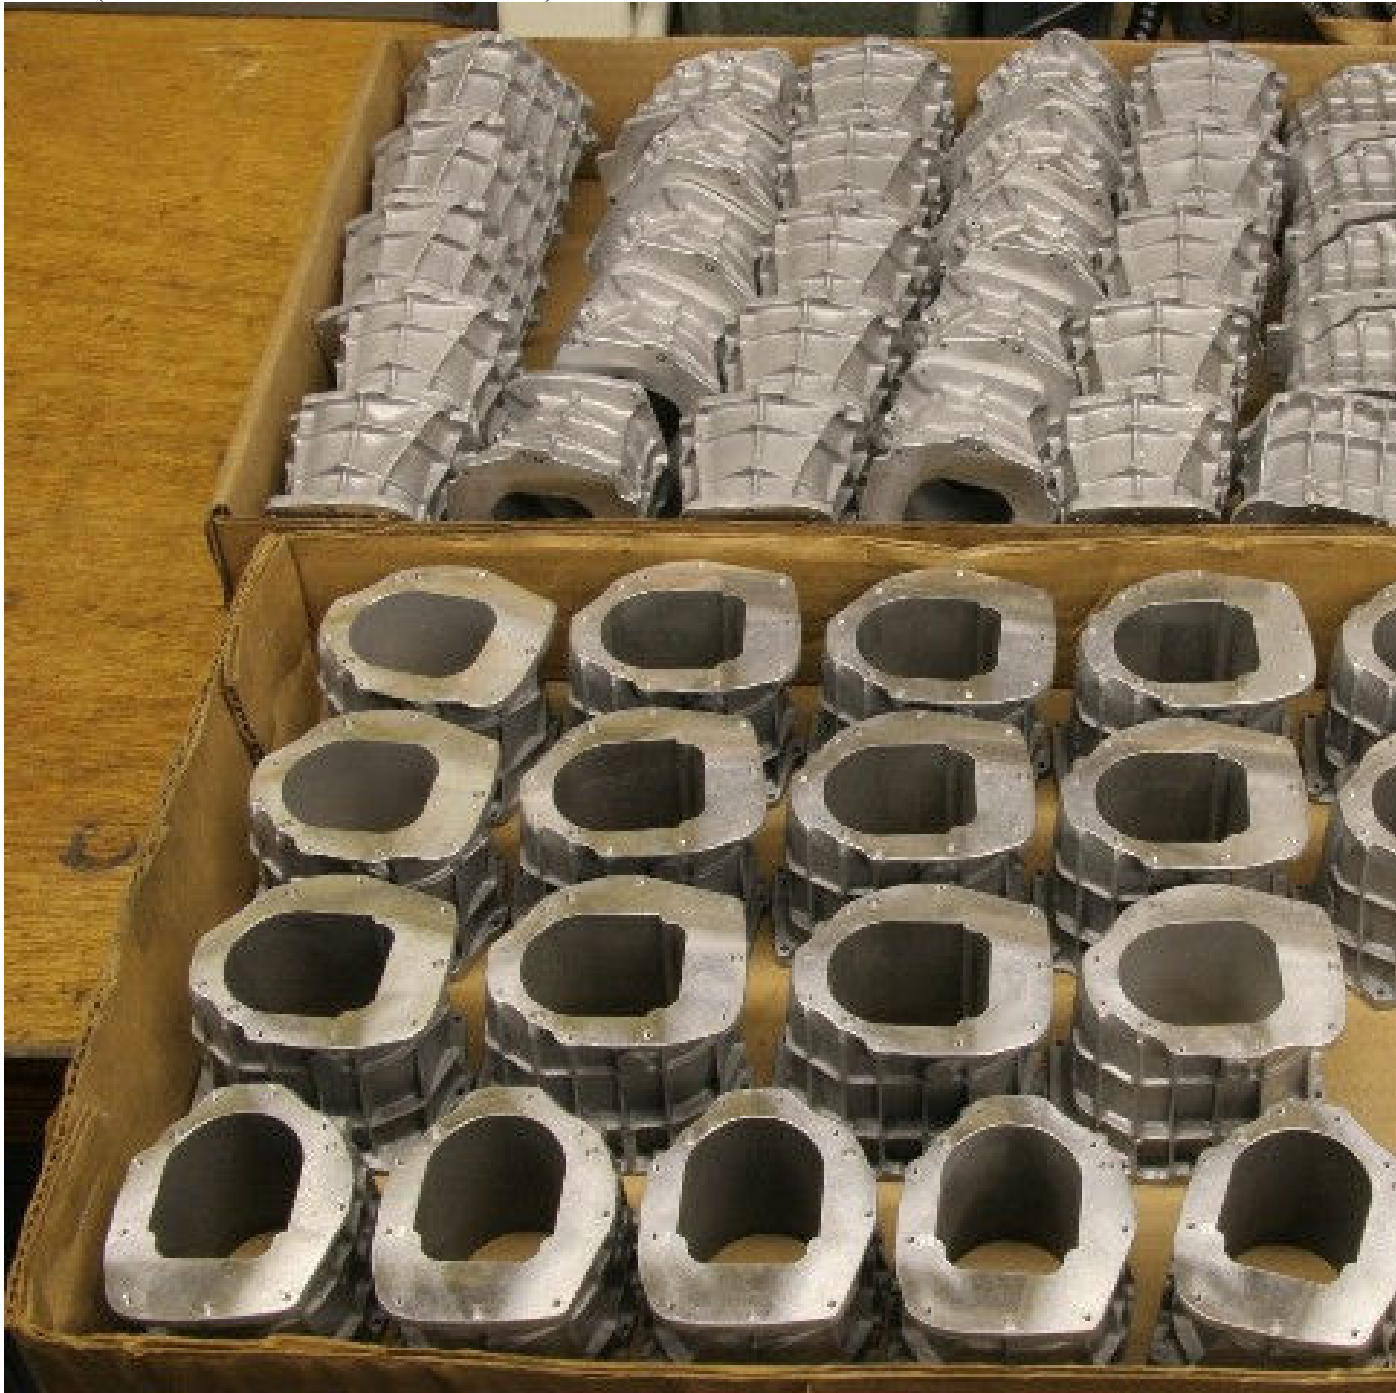
Pic #5 (Finished transmission center cases)

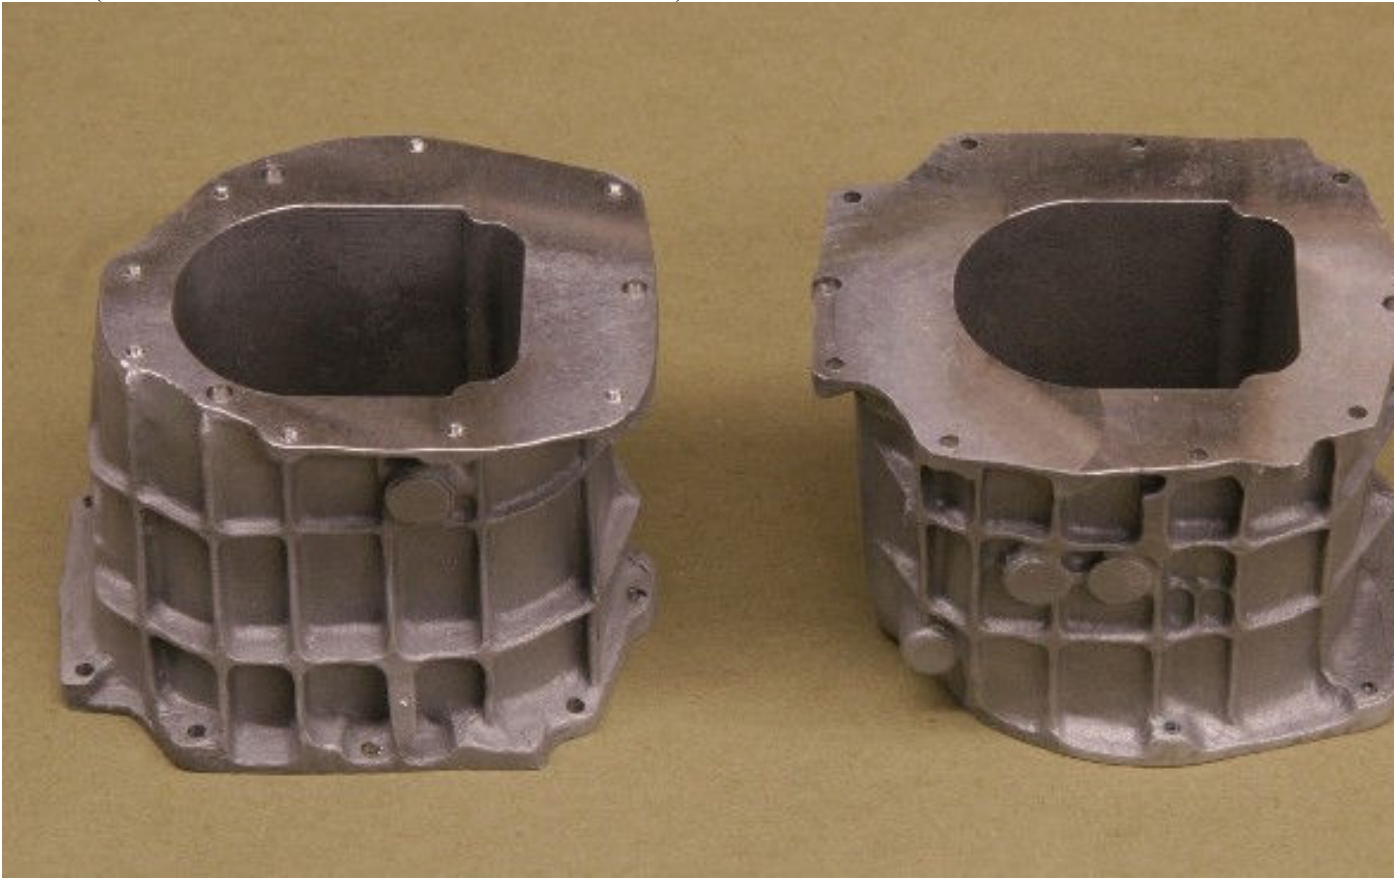
Pic #6 (Transmission center section – front and back)

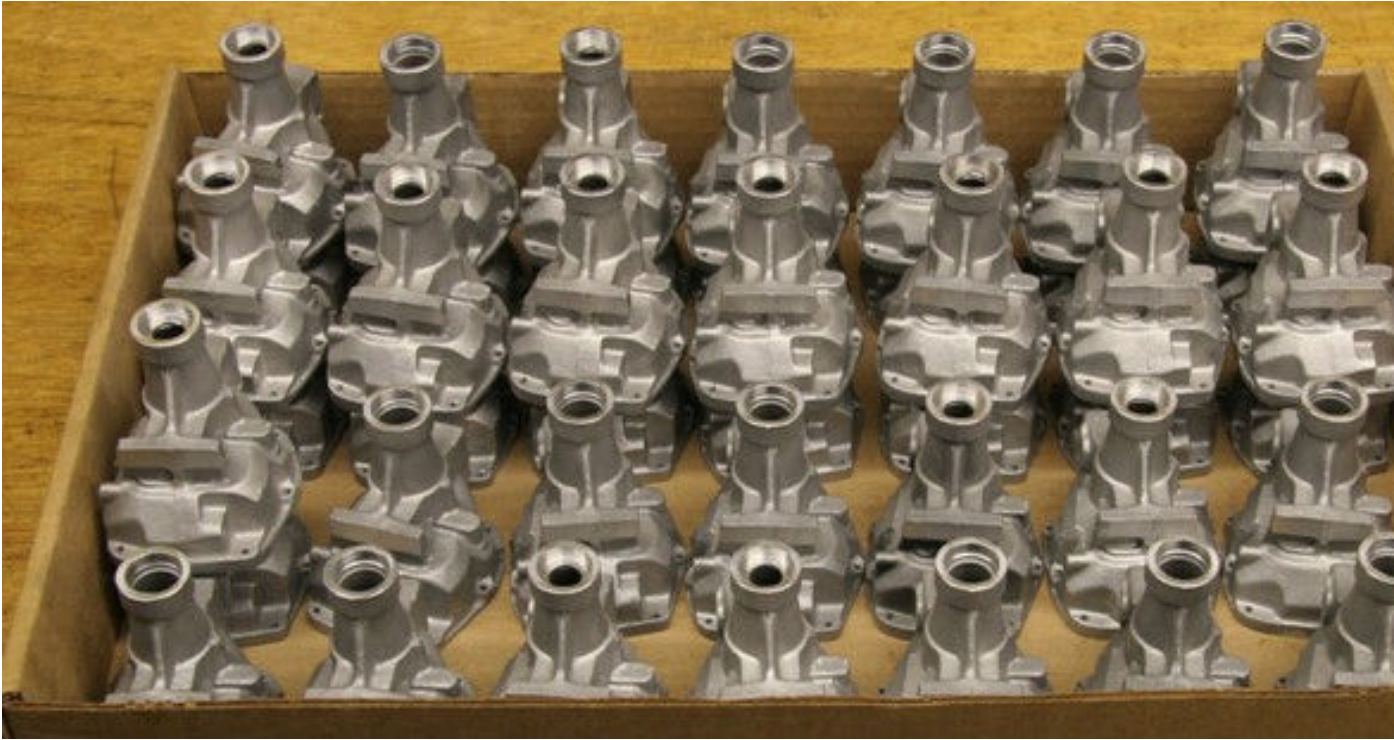
Pic #7 (Transmission output housing)

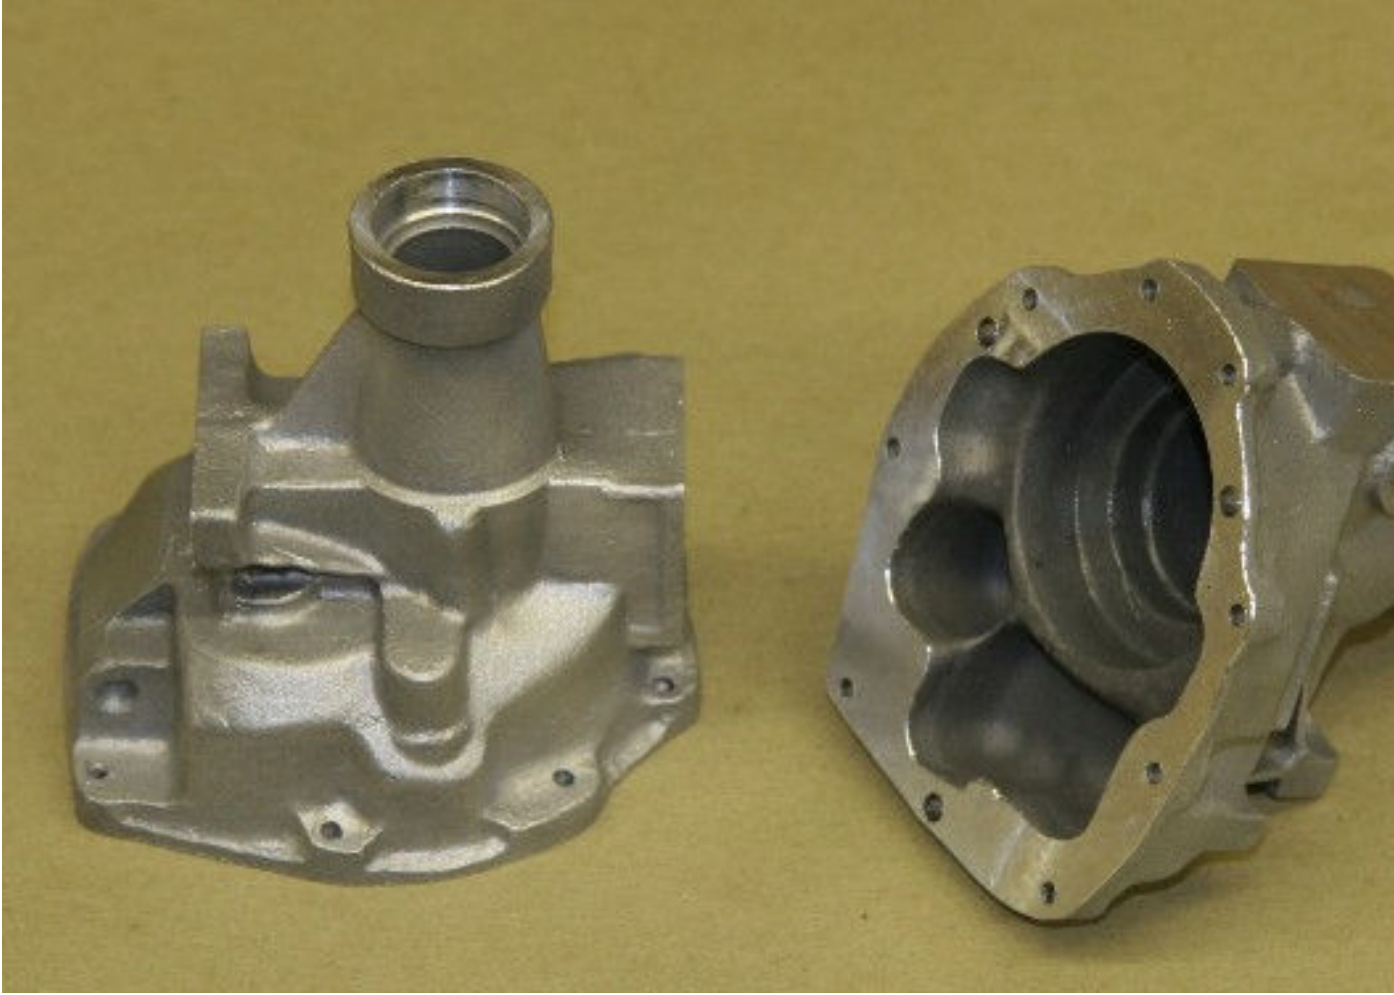
Pic #8 (Transmission output housing – front and back)

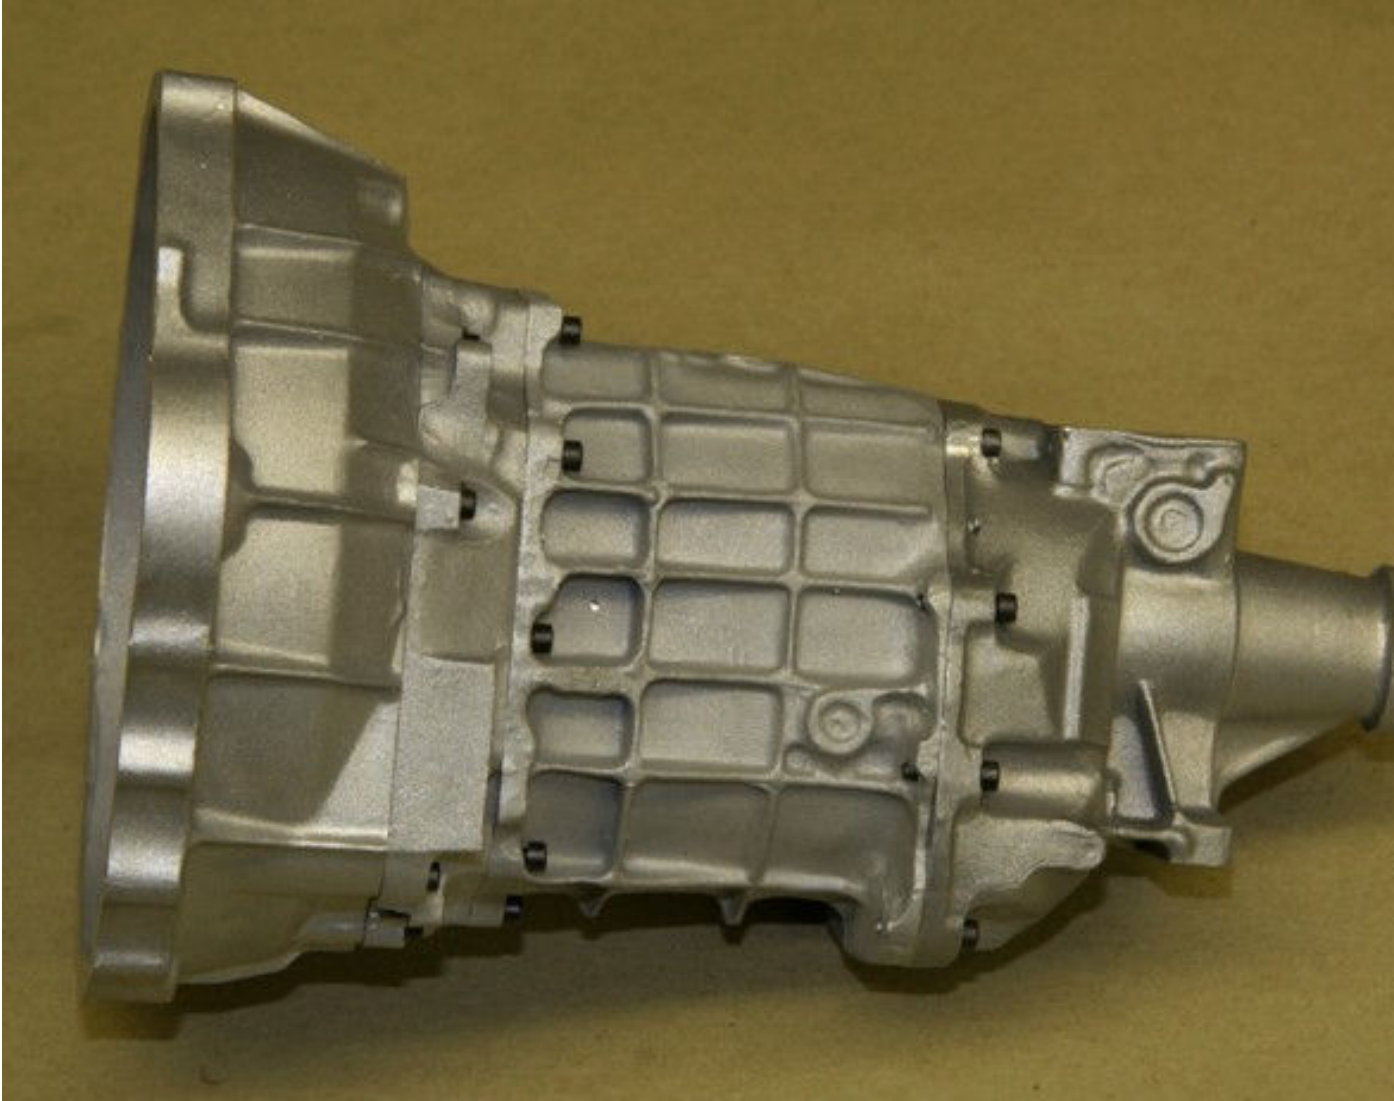
Pic #9 (Assembled transmission)

So much for that, as you can see from the pictures all of the casting for the transmission are finished and ready for assemble. Just to give you an idea of how much time is needed, on my previous engine there was a transmission case which only had five holes and a bellhousing which had eight holes. Just two pieces! Because of my attention to detail and my never ending quest to make a model as realistic as possible, four individual components were needed – bellhousing, adaptor plate, transmission case, and output housing. Just to give you an example of what I am talking about, just the transmission case has 22 individual holes - of these 9 are clearance holes, 8 are tapped 2-56, and 5 are drill and reamed for .125 dowel pin alignment. If that were not enough the center distance must be exact, which is the reason for the dowel pins. If each piece were off by only .010 (about the thickness of 3 human hairs), by the time everything is put together the output shaft would be off center by .040. Not so good!
