I cannot believe it has been so long since my last update. A lot has happened and I will try to bring everyone up to speed. First of all, I had my left knee replaced about 5 weeks ago. Needless to say that I was unable to get in the shop to take pictures and for about 3 weeks it was difficult, just to get around the house. The surgeon had me on some quite strong medication which made me unable to run machines or even set them up. Just trying to concentrate on the computer was a challenge. With continuing physical therapy, everything is getting better, but it is a slow recovery. Prior to going into surgery, I made sure the employees had plenty of work to keep them busy. Not only did I lose over 4 weeks of work, but now I have to make that time up, somehow. So much for the trivial points! I am sure everyone is now wondering how the engines are progressing.

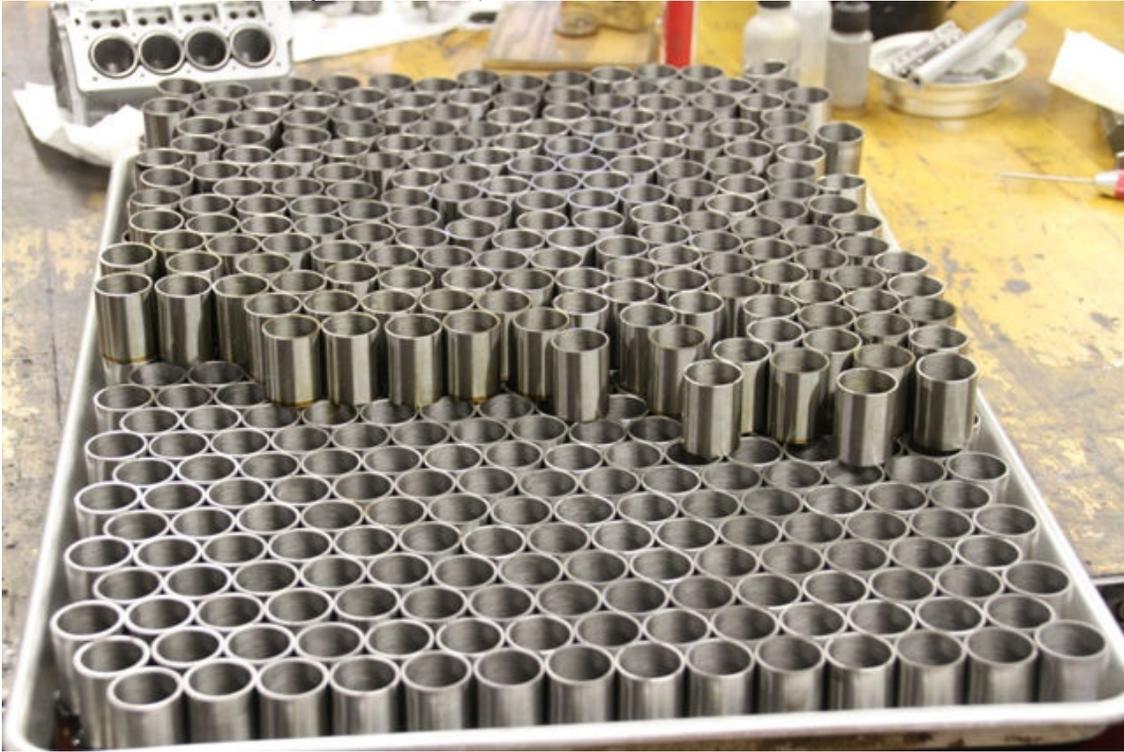
Pic #1 (Finished honed cylinder liners)

As you can see there is a large box of cylinder liners which were finished – I thought. After honing over 550 liners, I discovered that somehow the calibration gauge was not setup properly or something had moved. What this means is, the bore in all the liners was .001 too small. This may not seem like a lot, but it is quite important that everything be made according to the prints. The only thing that could be done was to re-hone all the liners. No problem, just time. When I had the rough liners made for me, I knew that amount of material ordered, would be very close, but never thought there would be any problem. As you can imagine, several of the liners did not get honed to the exact dimension and were subsequently rejected. Getting additional stock is not a simple operation. I first need to order the cast iron stock, which was then, sent to be heat treated or stress relieved. If this is not done the cylinders end up being slightly oval in shape and cannot be corrected or used. After heat treat, the stock must then be sent to the machine shop and wait for their time to make the liners. As you can see, this process can take quite a long time. Anyway, after the liners were finished honed again, a count was taken and there were not enough liners to complete the engines. I then had to start the whole process over again. This is not a big problem, but when a small amount of stock is ordered, the price is higher. The same is when only a small amount of liners are made. I hope everyone is still with me.

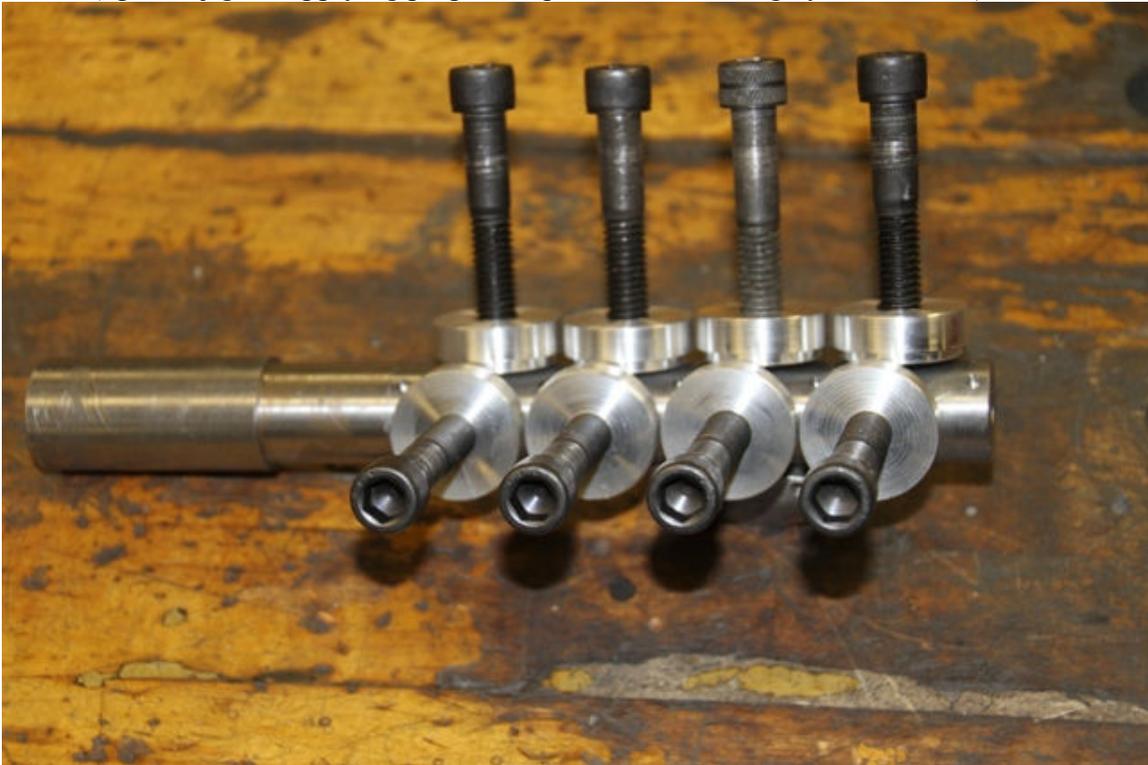
Pic #2 (Special jig for applying proper torque when installing cylinder liners)

If you look at the pictures, you will see a very unusual “V” shaped jig. This is used to torque each cylinder liner in place and allow the Loctite to cure. This is a very important operation, which puts a considerable amount of pressure on each liner. Once cured, then the exact height of each cylinder (deck height) must be machined. This is critical for the head placement, which allows for the intake to fit properly. Keep in mind there are two gaskets, which must be allowed for. Everything must fit exactly, close is not good enough!!!! Like I have always said “I would much rather explain a delay, than apologize for the quality”. This is an excellent example of what I am talking about.

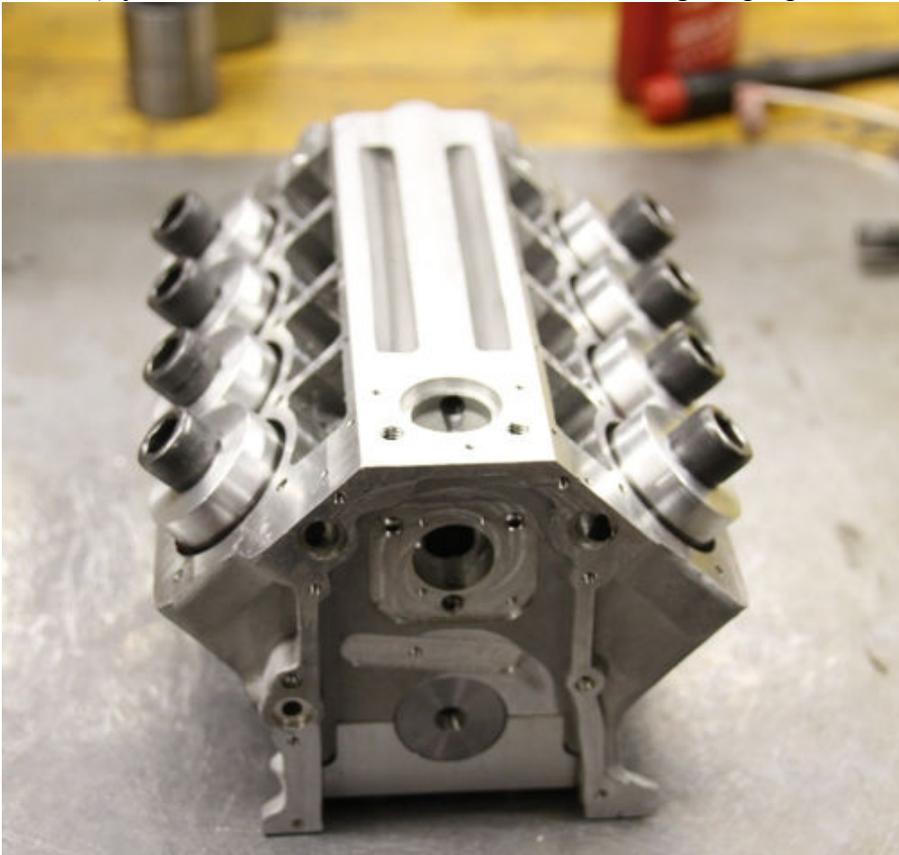
Pic #4 (Cylinder liners installed in block and allowing for proper cure on adhesive)

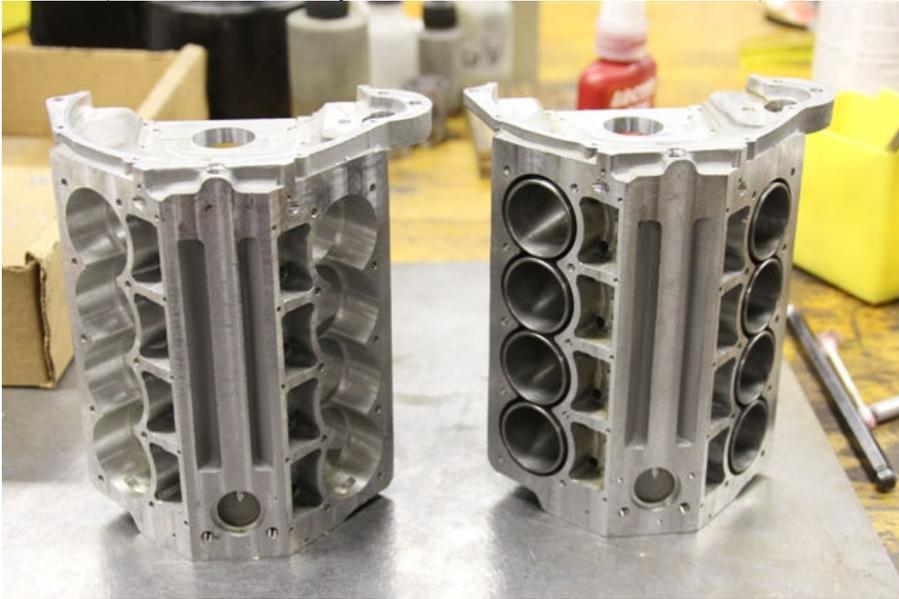
Pic # 5 (Before and after cylinder liners have been installed)

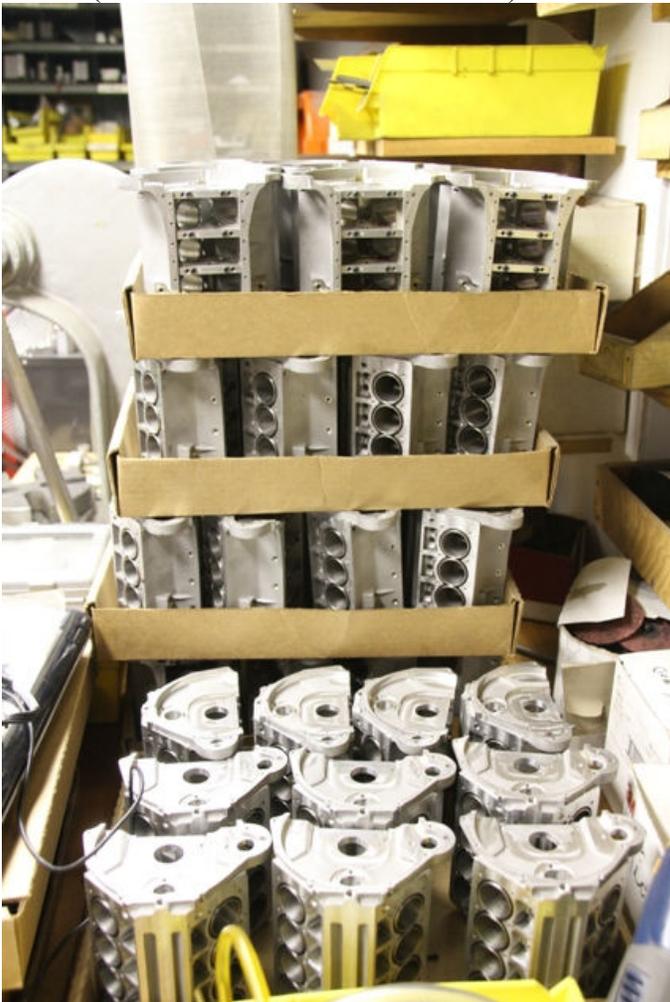
Pic #6 (Liners installed in all the blocks)

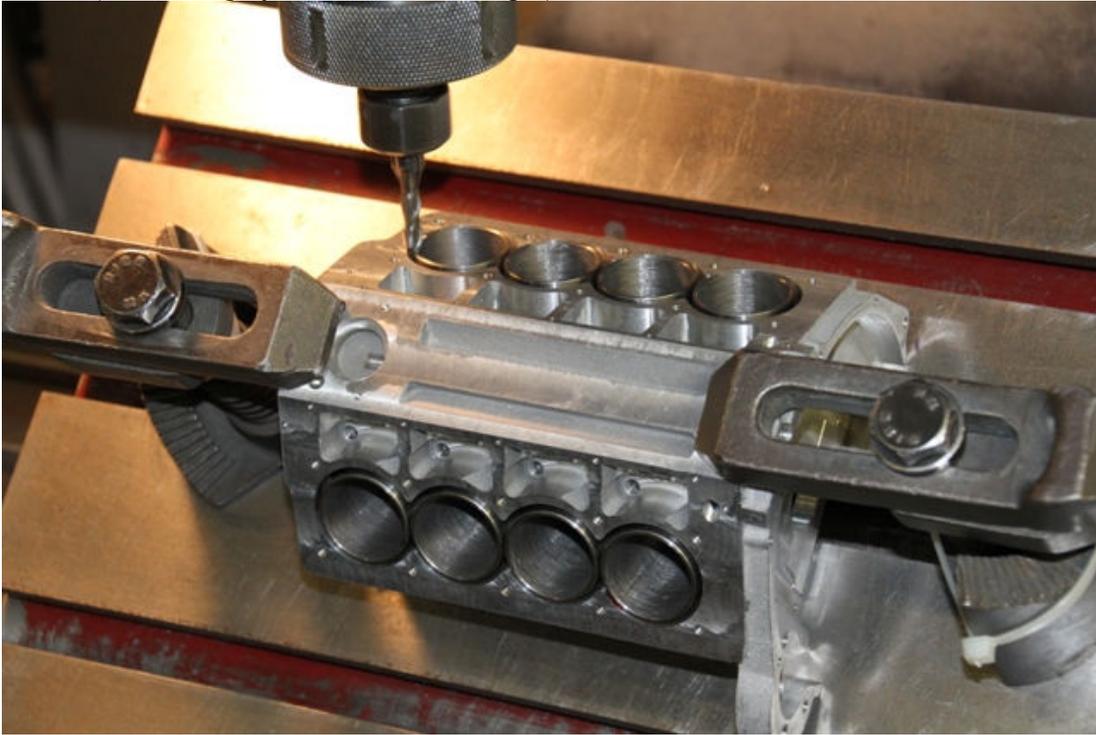
Pic #7 (Machining cylinder to exact height)

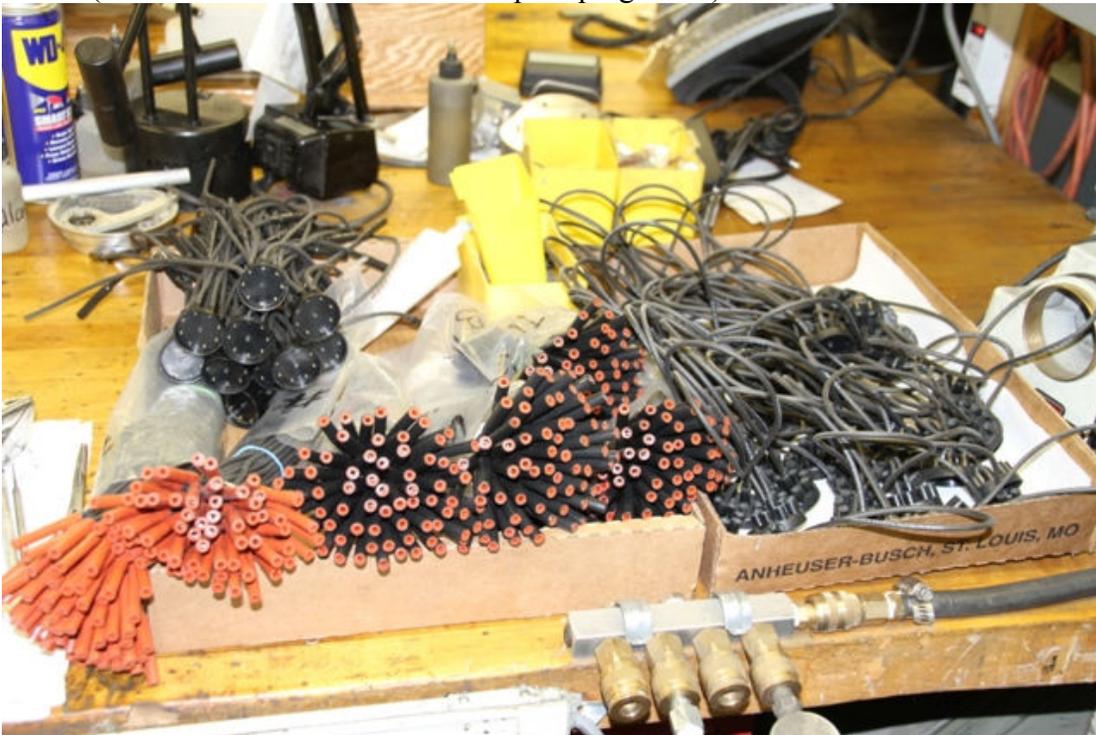
Pic #8 (New Silicone boot installed on spark plug wires)

The final pictures are of the new high insulating Silicone spark plug boots. These were added to eliminate the high voltage from possibility arching through the standard boots.
