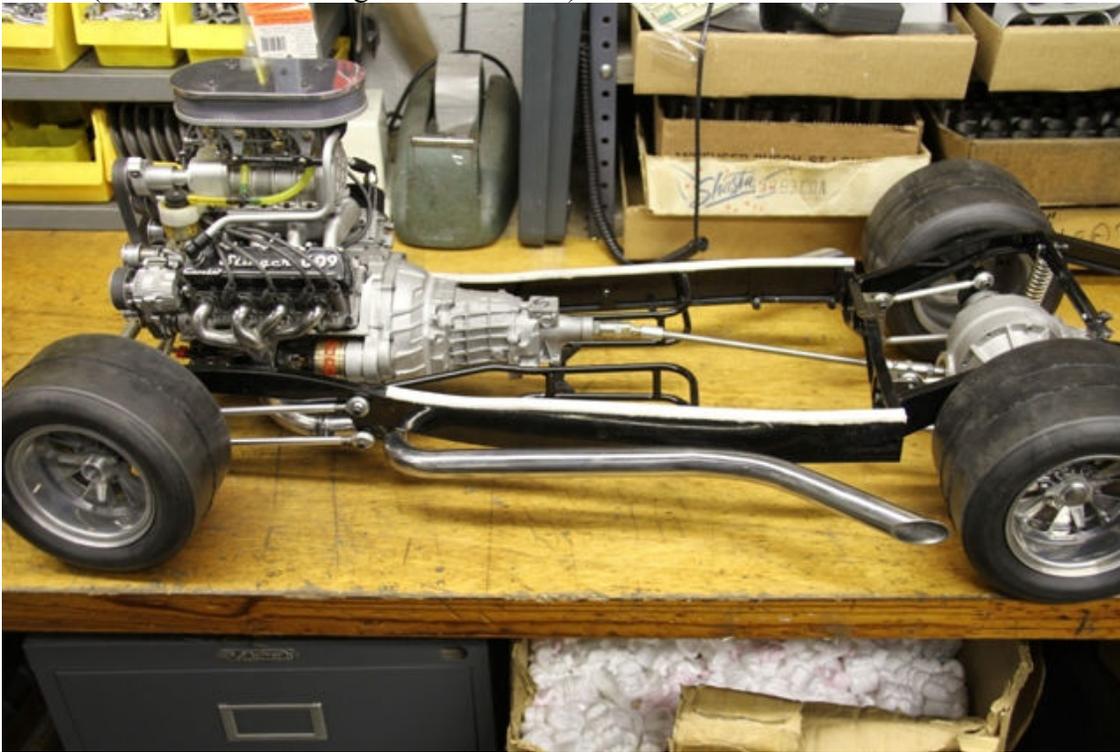
Pic #1 ( New frame with engine and exhaust)

So much for the sales pitch! The new changes on the 34 roadster were well received at the trade show, especially the new exhaust system and rear suspension. Just getting the exhaust to fit between the engine block and frame was monumental task, especially the driver's side. People could not believe that the doors and trunk lid latches, actually worked. If you look at the picture of the front of the engine, in the frame, it is easily to see how tight everything is. Although there is still a lot of work which needs to be done, like oil tanks, water tank, fuel tank, remote control, dash with simulated gauges, steering wheel, electronics, battery packs, etc., it is progressing as planned. As the saying goes "stay tuned".

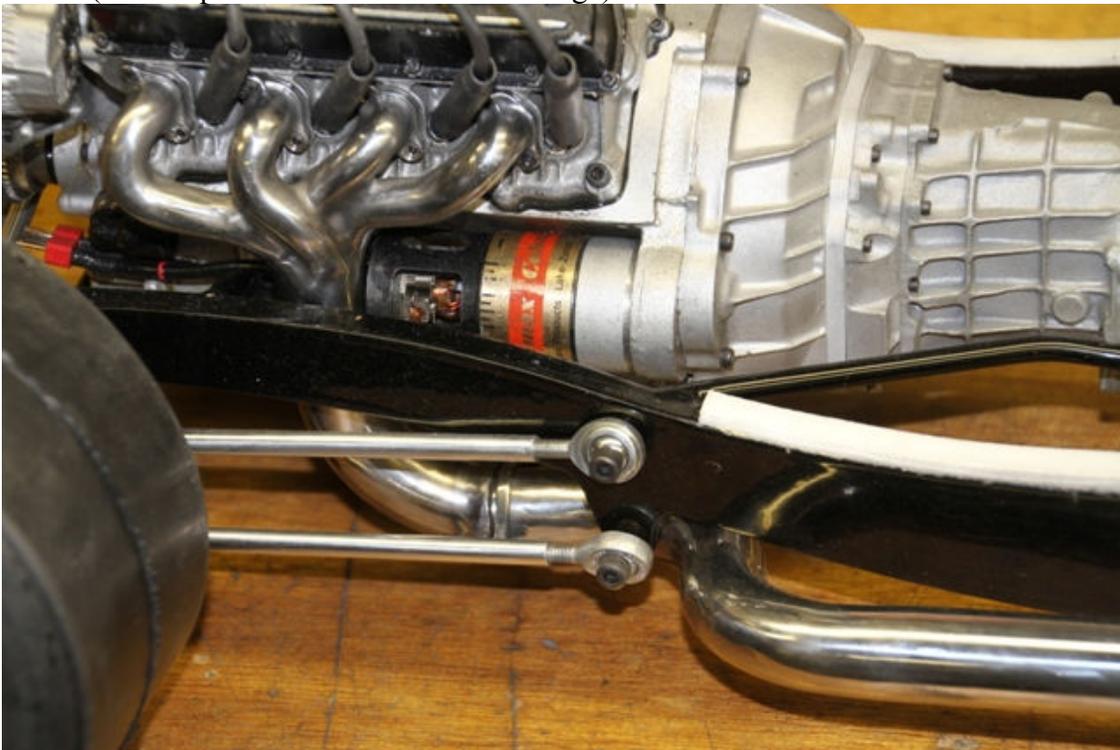
Pic #2 (Close-up of exhaust headers and flange)

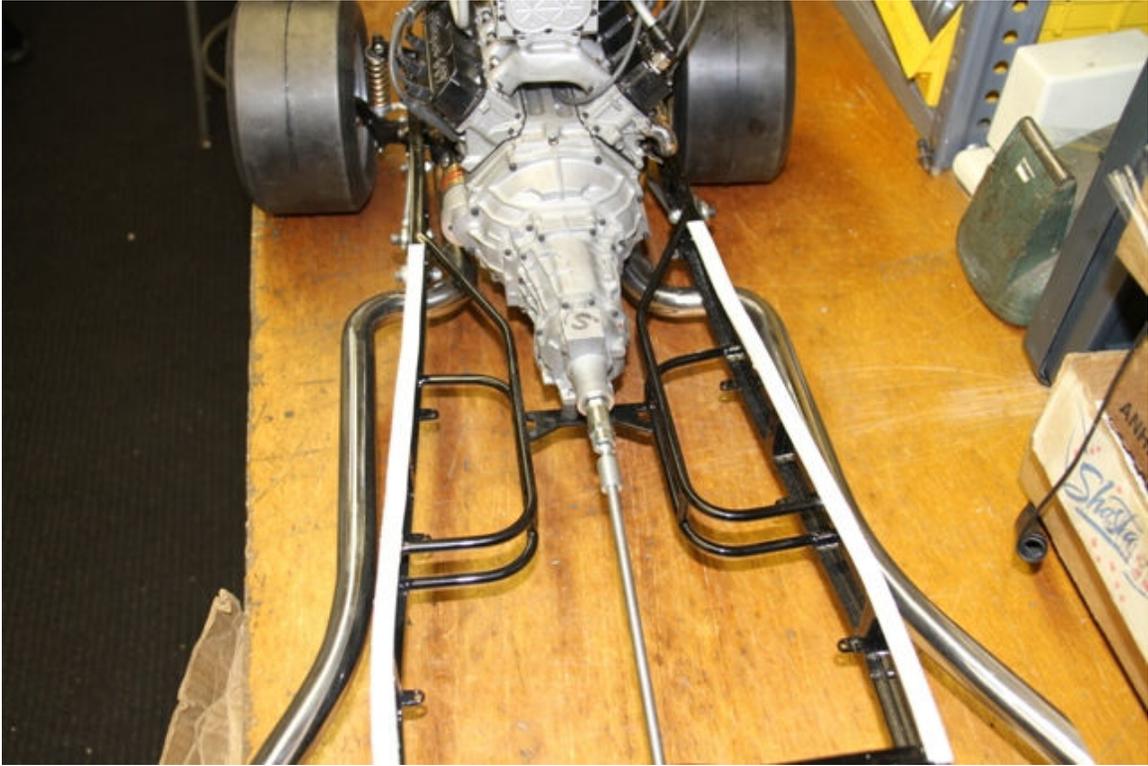
Pic #3 (Dual exhaust and oil tank cradles)

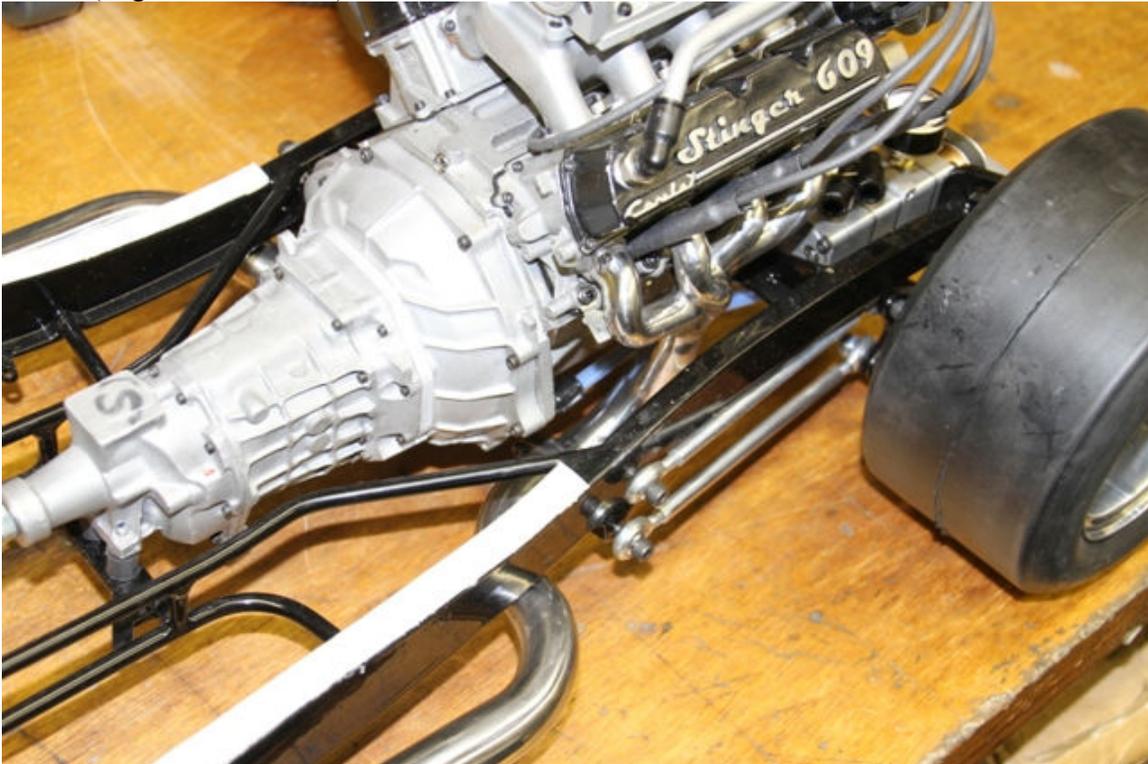
Pic #4 (Right side exhaust)

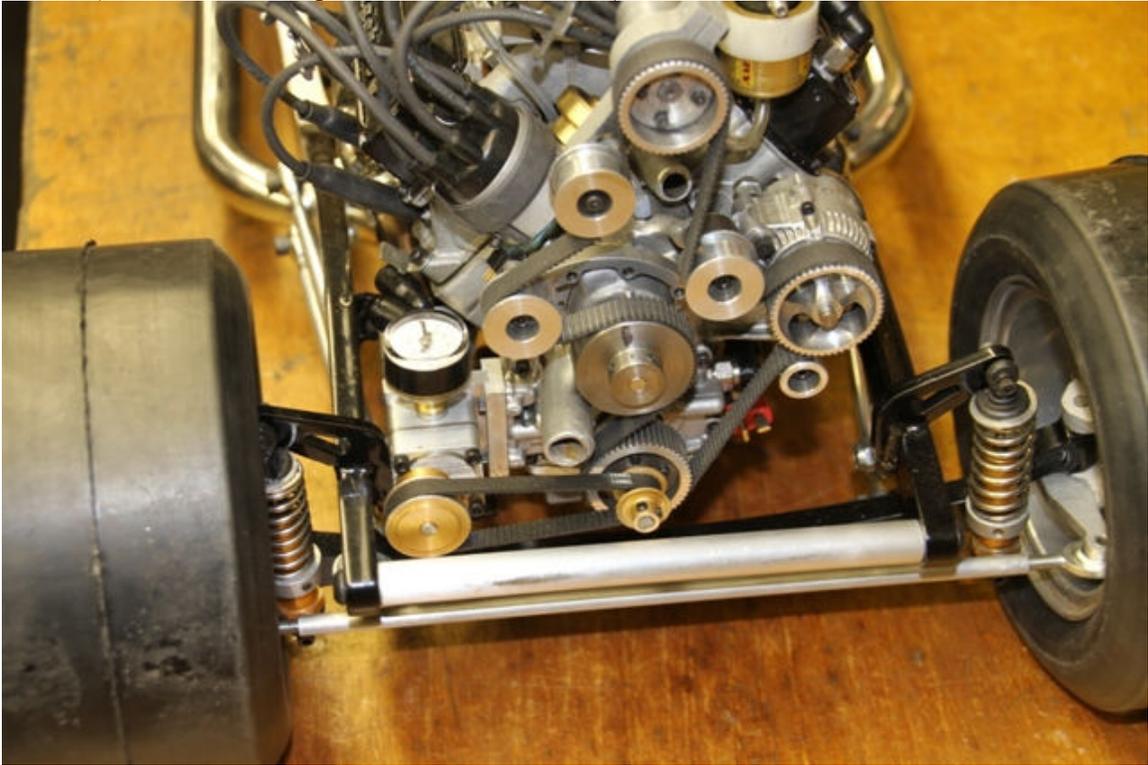
Pic #5 (Front view of engine installed in chassis)

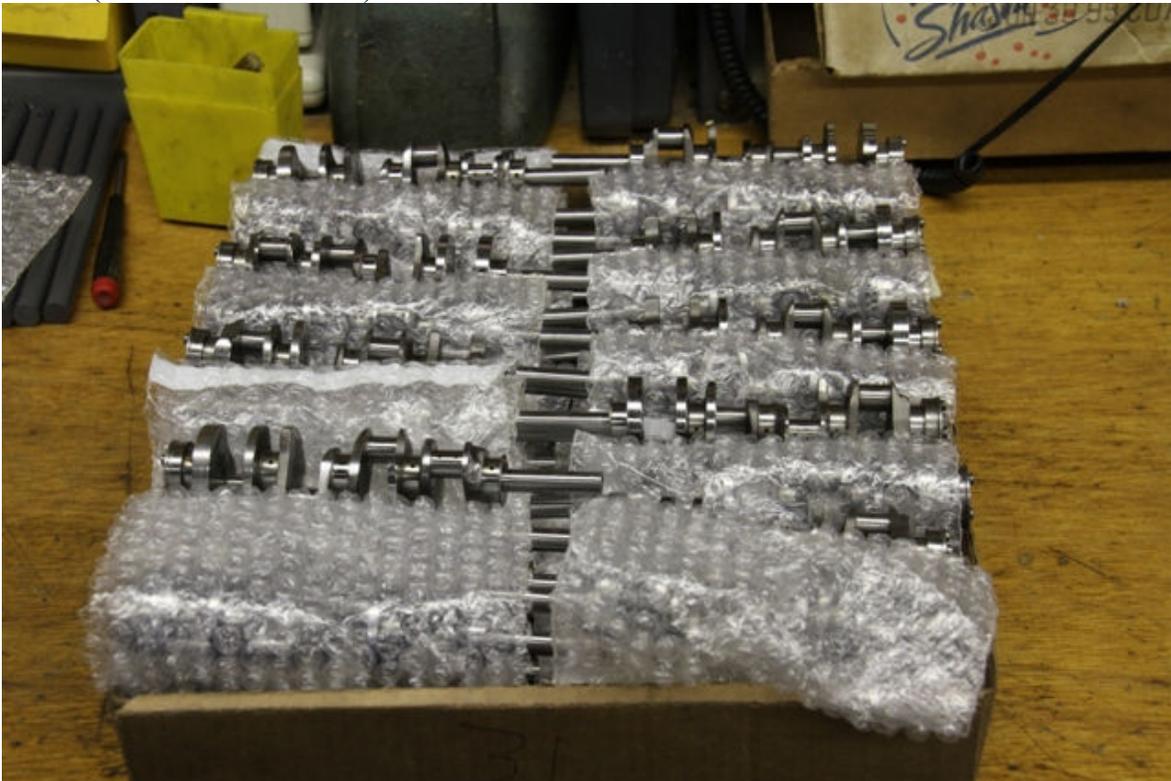
Pic #6 (Finished crankshafts)

During all this, work continues on the engines. The crankshafts are back from having the oil passages put in. This is done with a machine commonly called a "Hole popper". This is a process where the holes are actually not drilled but "burnt" to the exact depth. This is extremely accurate and can be done on an angle without deviation. It is my understanding that the hole can be done about 1" per minute. Keep in mind the oil passages only have a diameter of .057. If you have ever tried to drill a small diameter hole, on an angle, you can immediately see the problem. The only operation which needs to complete the crankshafts is a small notch in the front for the drive hub. They will then be ready for installation in the blocks.

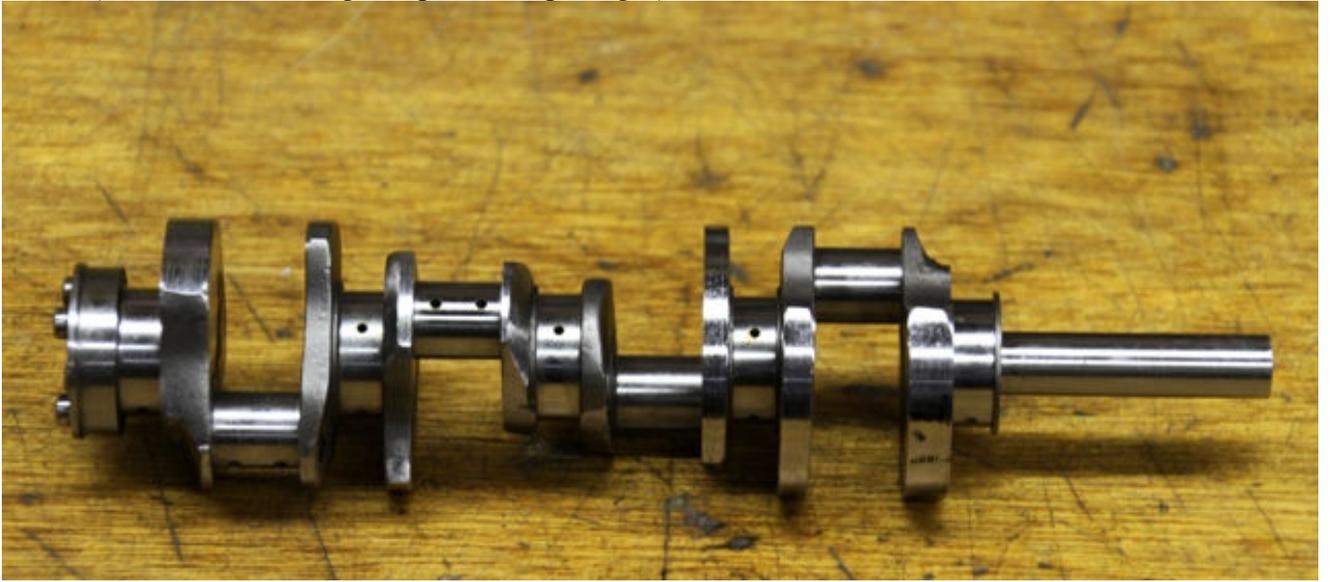
Pic #7 (Crankshaft showing completed oil passages)

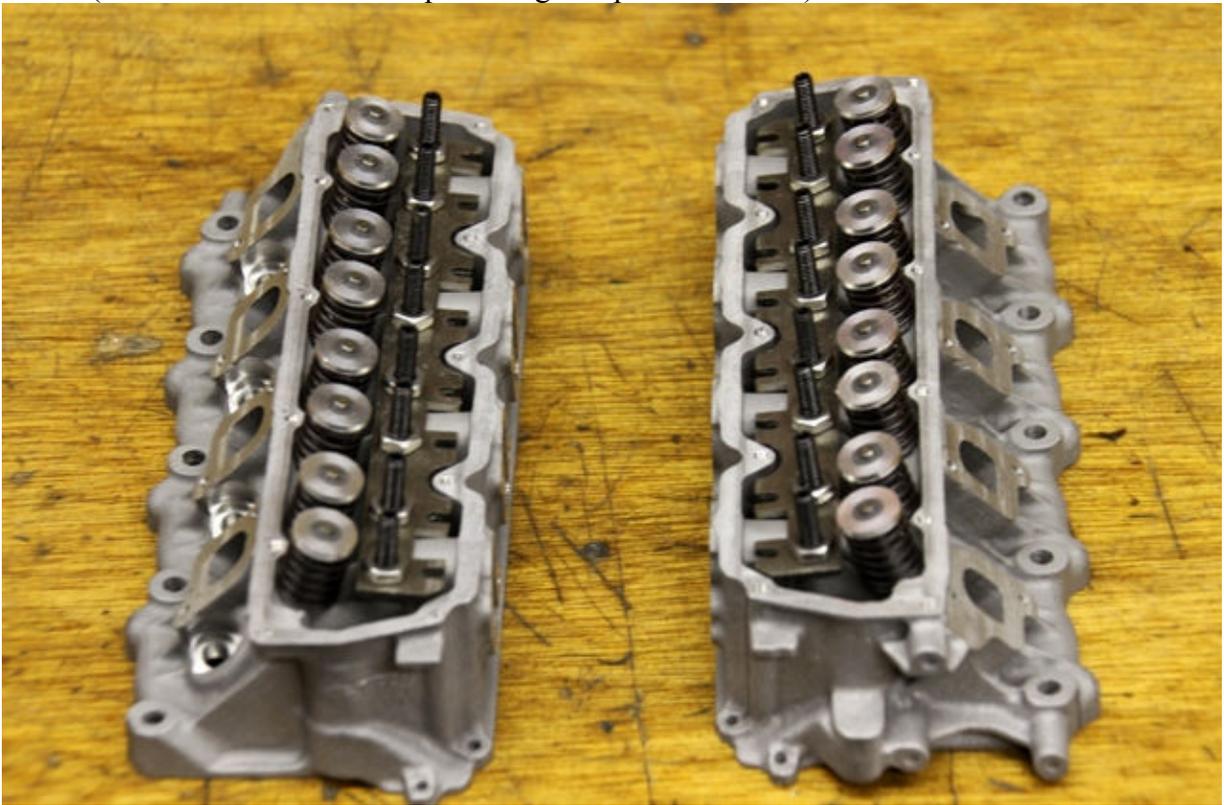
Pic #8 (Finished heads with new pushrod guide plates installed)

The heads are completely finished and ready for installation. As you can see the new pushrod guide plates have been installed along with the rocker arm studs. Once the heads have been installed, the rocker arm and pushrods are then put into place. Things are getting better each day.

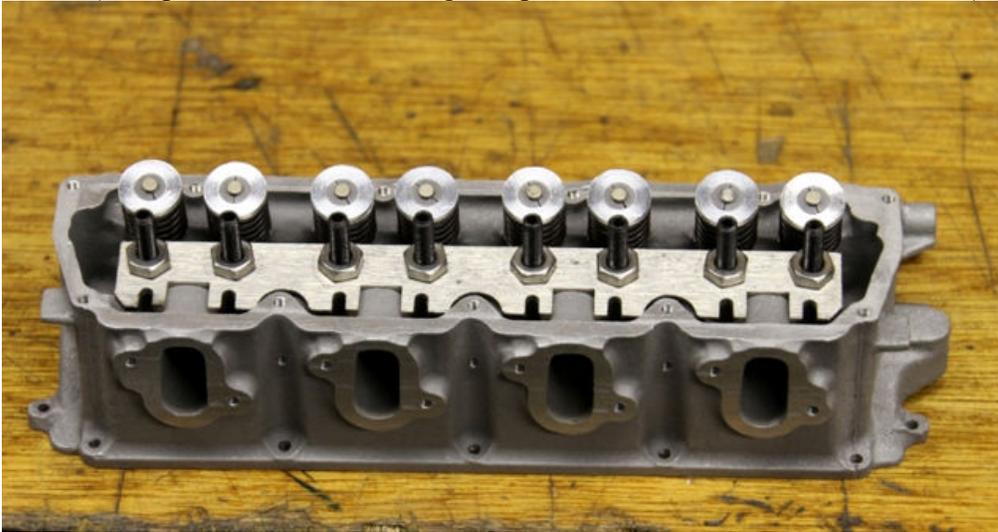
Pic #9 (Completed head with new guide plate and rocker arm studs installed)

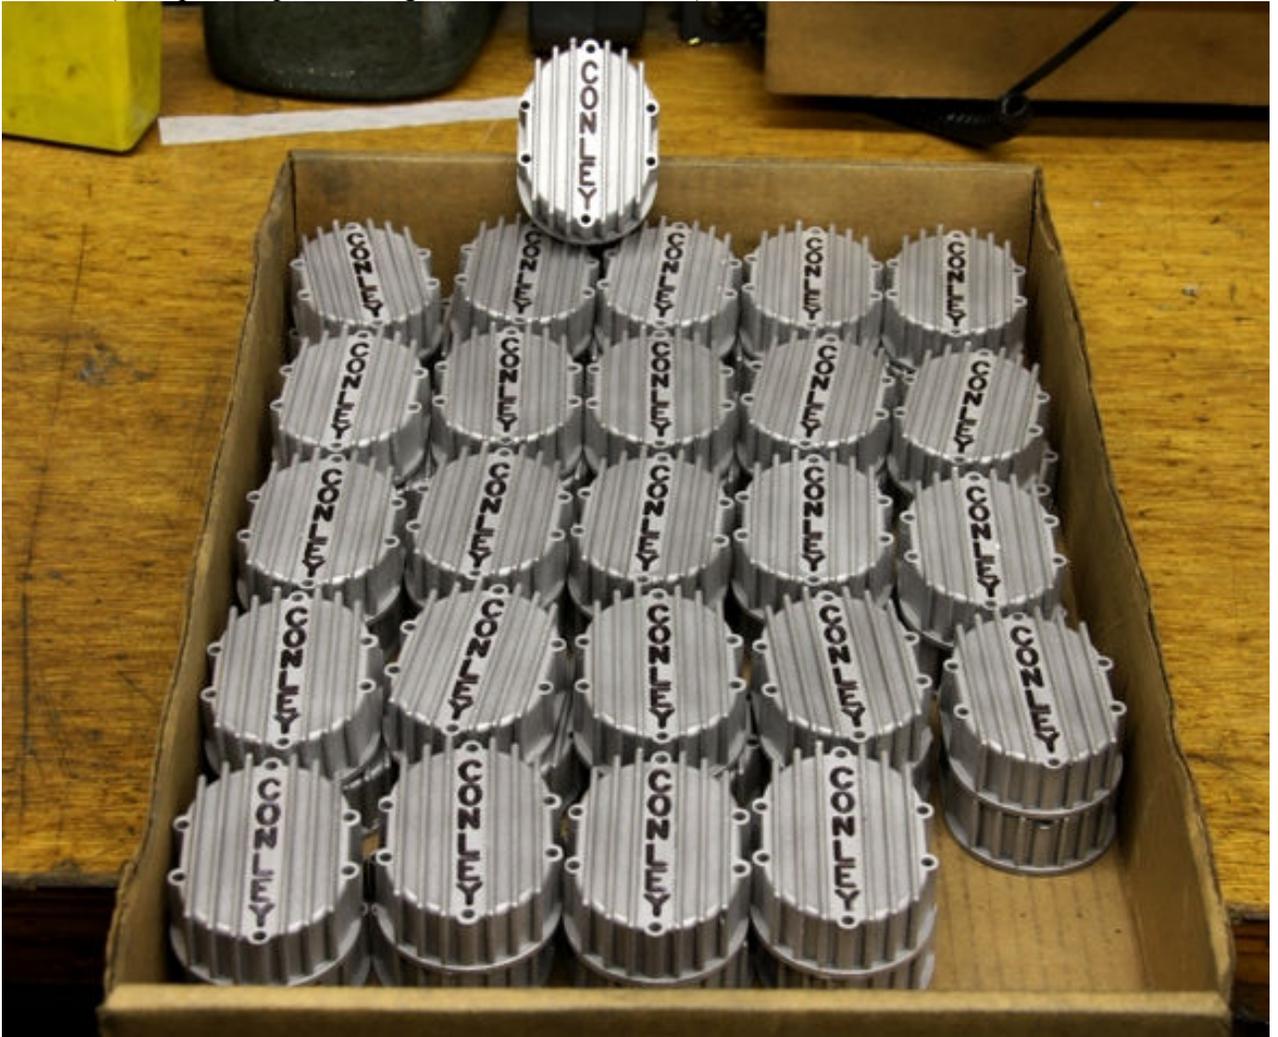
Pic #10 (Completed quick change rearend back covers)

If that were not enough, the back cover, for the quick change rearends are finished. The center sections are completed, as are the side covers. I need to get the gaskets laser cut and they will be ready for final assemble. I still do not have the completed disc brake assembly finalized – close but not finished.
