It is now 9:22 on Monday morning the 29th of March and after answering a stack of emails, taking a lot of picture, then editing those pictures I will try to finish the weekly update before lunch. As usual a lot of “things” are happening - some good, some not so good. In the not so good list is that a week ago on Sunday my CNC machining center decided it did not like the voltage that was coming into my facility and would not run. Keep in mind, on Sunday the chance of getting any help is virtually zero. Even the CNC lathe would not operate. When checking the line voltage I discovered that one leg was about 23 volts higher than the other two legs. This may not seem like a lot but the CNC machines do not like a voltage difference of more than about 5 to 7 volts between legs. Once again, after the problems last time with my local electric provider, I decided that spending any time with them was a lost cause. On Monday several hours were spent with the machine manufacturer and was told – again – that my voltage was not in “phase” and I would need to contact the electricity provider. Back to square one. Two more days spent with no luck. Finally I contacted a manufacturer of what is called

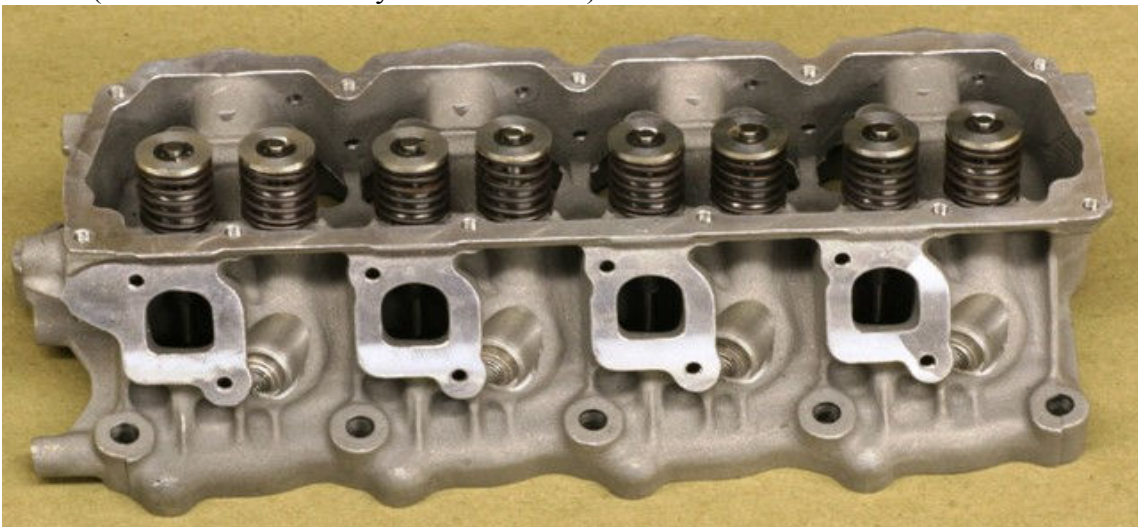
Pic #4 (Assembled head ready for installation)

Enough of that - now for the good news! The heads have all the valve guides and valve seats in place and the initial cutting of the valve angle has been done. No matter how accurate you are when the valve seats and guides are pressed into place there is always a small amount of mis-alignment. When this happens I have a special tool that cuts the angle of the valve seat. It has a “pilot” shaft that uses the valve guide as a center, and then slowly cuts the valve seat angle to make sure that both items are concentric. This is a critical operation, because if everything is not perfect, the valves will leak and everyone knows what happens then. If that were not enough work, I have a special valve that has been coated with diamond dust which further matches the angle of the valve with the seat. Once this is done then each valve is lapped with 1200 grit aluminum oxide. If you consider that I am making about 90 heads with 8 valves per head, as the saying goes “you do the math”. After all 8 valves in each head have been lapped; the head is thoroughly cleaned in a special wash tank then allowed to set in an ultra-sonic cleaning tank for a short period of time. While this is being done, every valve is cleaned individually and oiled. Keep in mind each valve must be kept in order and remain with the valve seat that it was lapped with. When all is cleaned, each valve assembly is put in place. This consists of a “high hat” which holds the “O” ring seal, “E” clip, valve spring, and “E” clip collet retainer. Picture # 3 shows just how many individual valve parts are needed for each head. More and more you will see how all of the previous parts start to “fall in place”. And finally a finished head can be seen in Pic #4, #5, and #6.

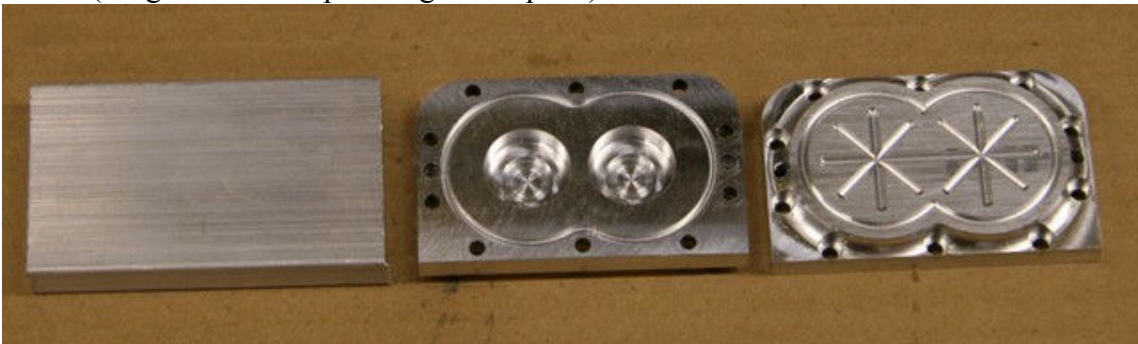
Pic #9 (Progression of supercharger rear plate)

The progressive jigs which are used for the supercharger gear housing, front plate, and rear plate can be seen in Pic # 7. I might add these jigs be exactly the same. While one complete set is being machined, the other jig is being loaded with unfinished parts. The entire program consisted of about 3,426 bytes of information, takes 22 minutes and 14 seconds to run and when finished I have three completely machined pieces – which is enough for one supercharger. The final three pictures show all of the finished pieces which have been glass beaded and ready for assembly. It is now 11:57 AM.

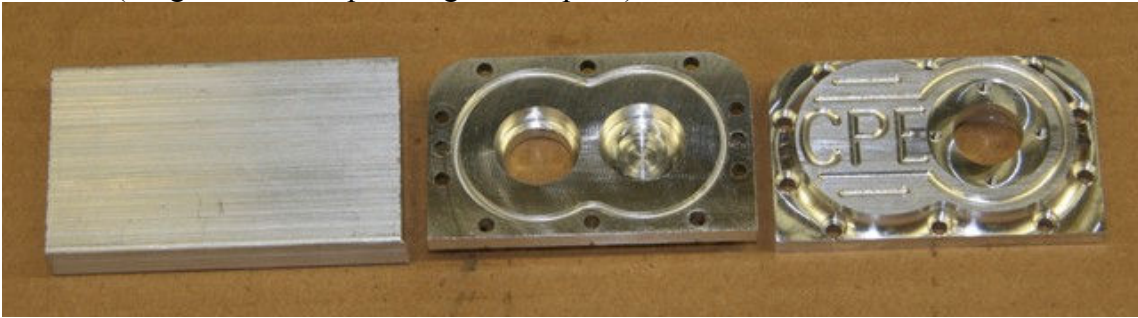
Pic # 10 (Progression of supercharger front plate)

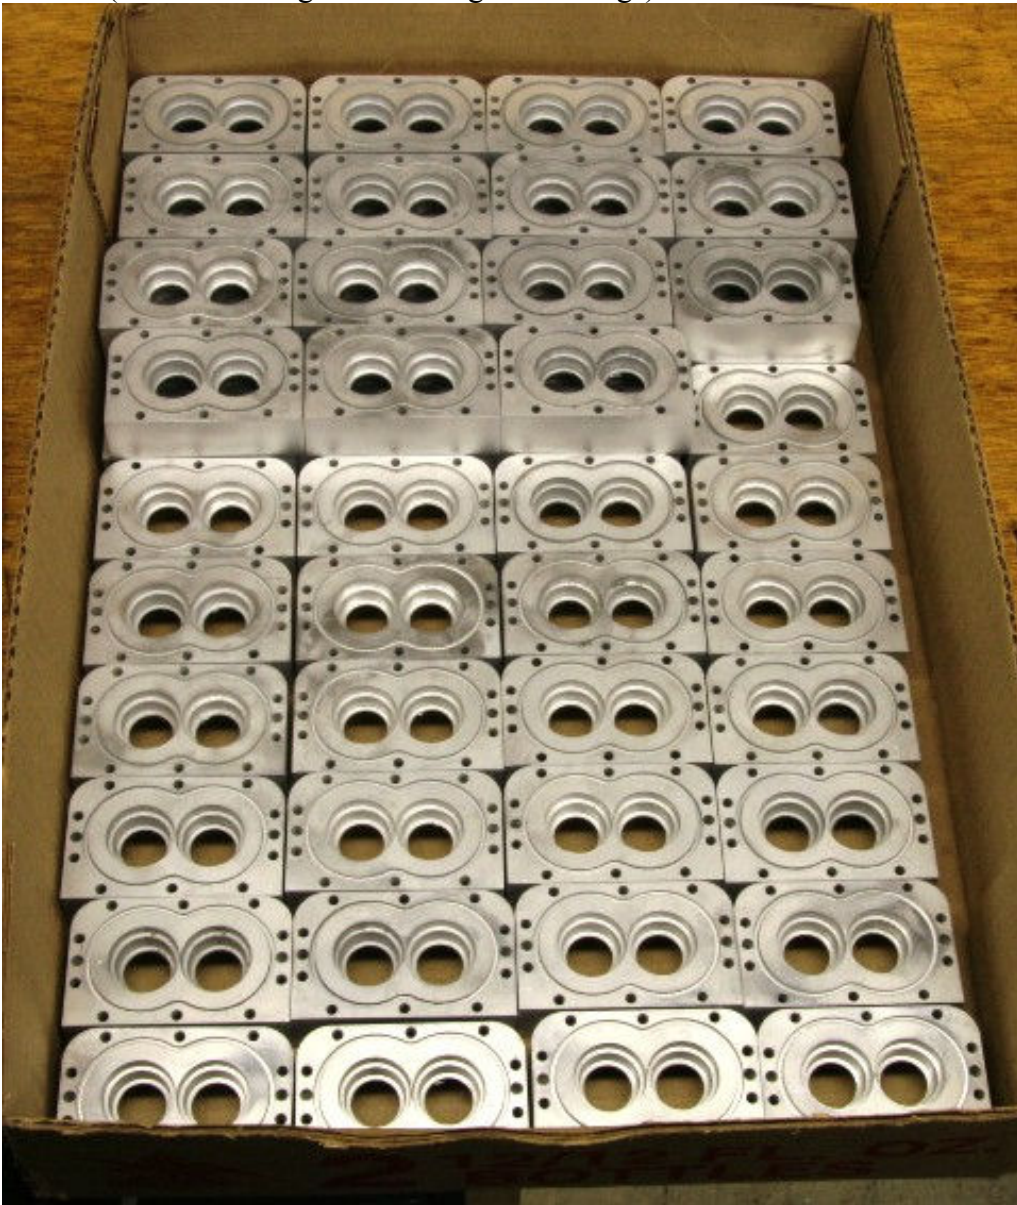
Pic #11 (Finished and glass beaded gear housings)

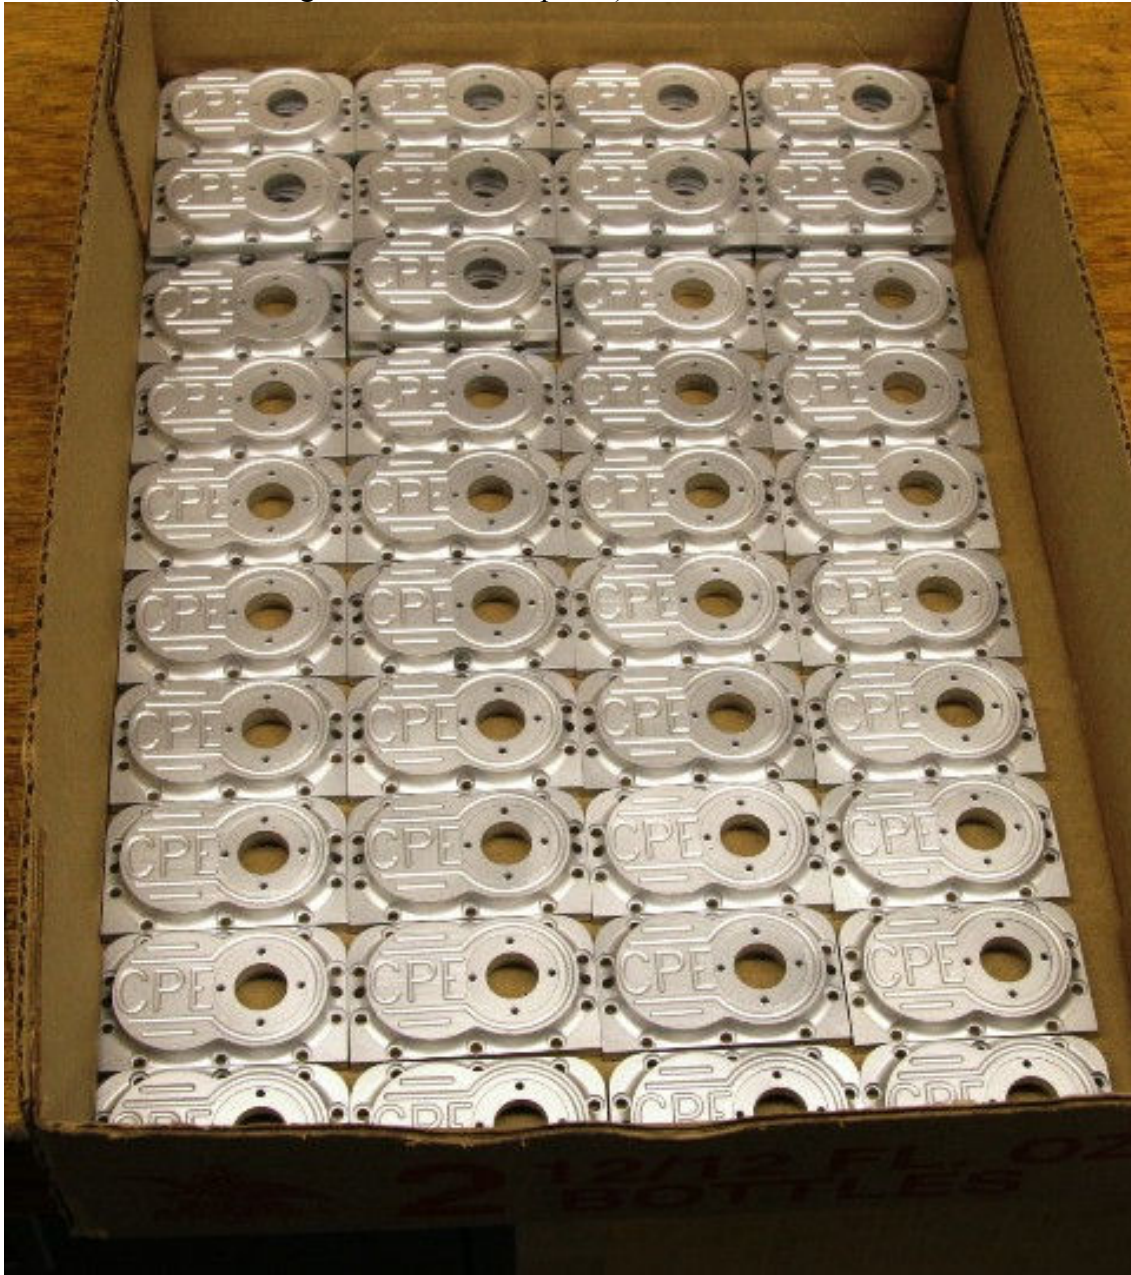
Pic #12 (Finished and glass beaded front plates)

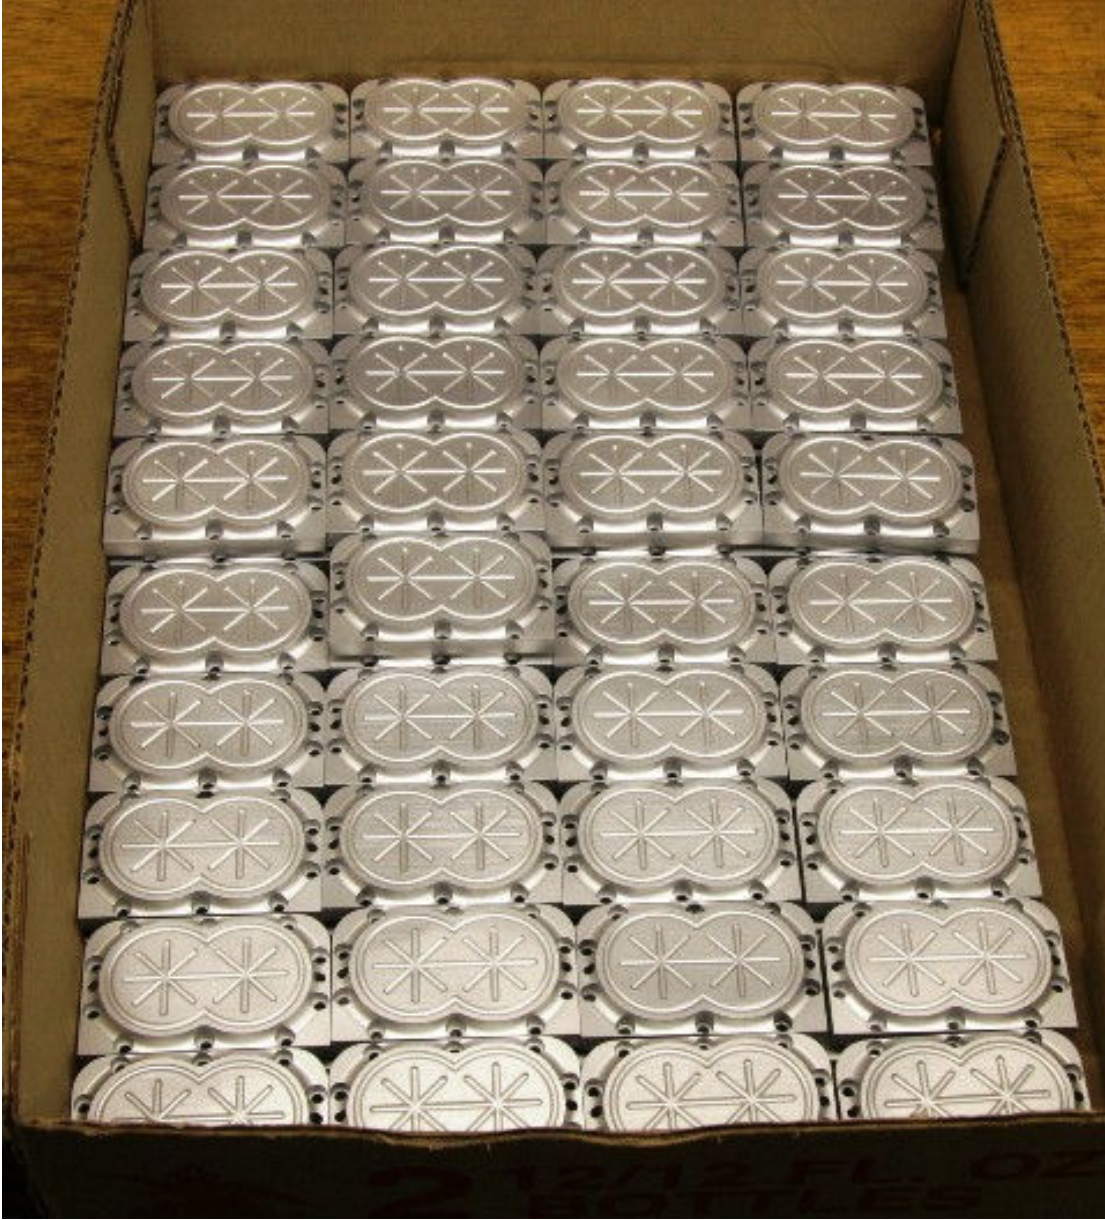
Pic #13 (Finished and glass beaded rear plates)
