● 25 February 2009

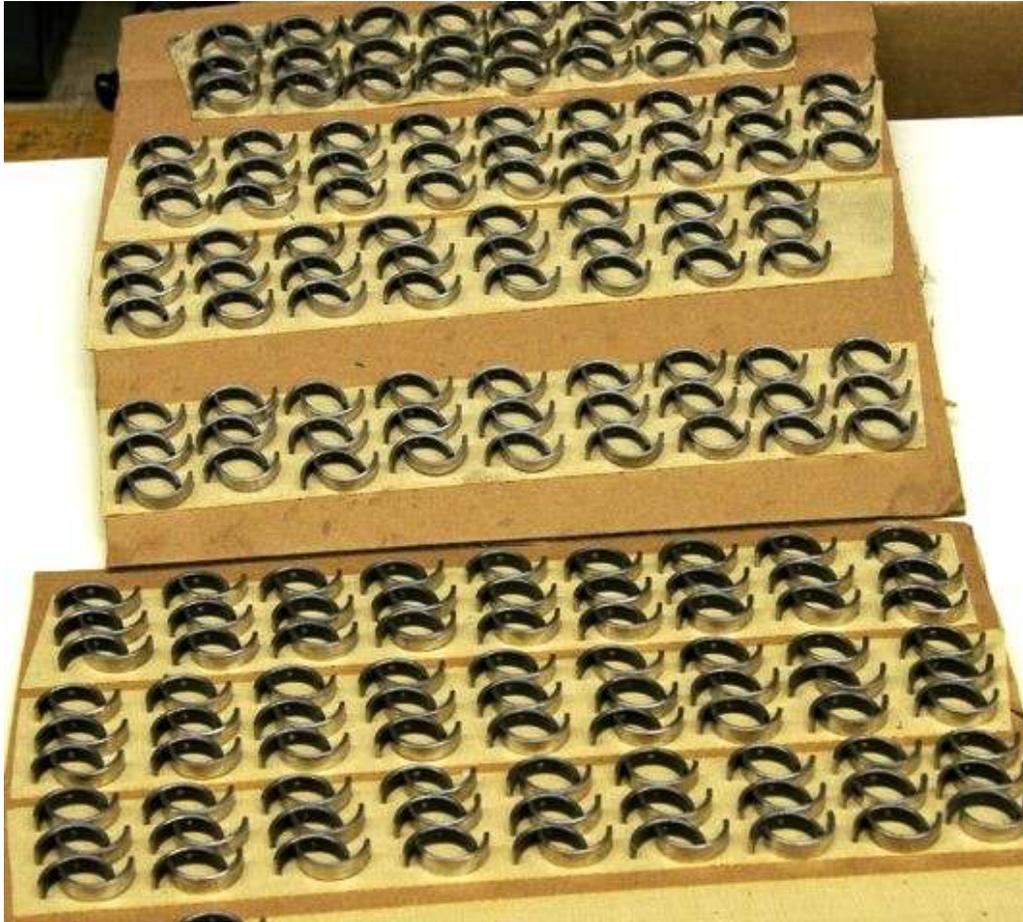
Pic #1

Another four weeks have gone by and a lot has happened. There is not so good news, good news, and great news. First, the not so good news - unfortunately, some things are out of my control. Just one example, shortly after my last update I was in the process of machining the main bearing inserts, when the CNC machining center decided not to turn on. After contacting the machine manufacturer and paying for two hours for a technician to come to my shop (\$145.00 per hour) it was determined that the voltage coming in to my facility was not correct. Without going into a long explanation, the electric company said it was not their problem, but should work with the machine manufacturer to solve the problem. Needless to say there is where the problem started. To make a long story short, almost 2 weeks later two isolation transformers, numerous lengthy phone conversations, and over \$2,200.00 spent, the machines are back in operation. When I say machines, I should also say that when I tried to run the CNC lathe on the same isolation transformer and it was discovered, much to my disappointment, the motor drive unit had been destroyed by the bad voltage. Unfortunately, it is impossible to get someone to repair the lathe and I had to spend my time to repair the machine. Without the CNC equipment in top operating condition, then it would be impossible to continue to make parts. As the saying goes "welcome to my world"! All was not lost during this time; there were other parts and components that needed my attention. Picture #1 is not "art deco" but rather finished main bearing inserts.

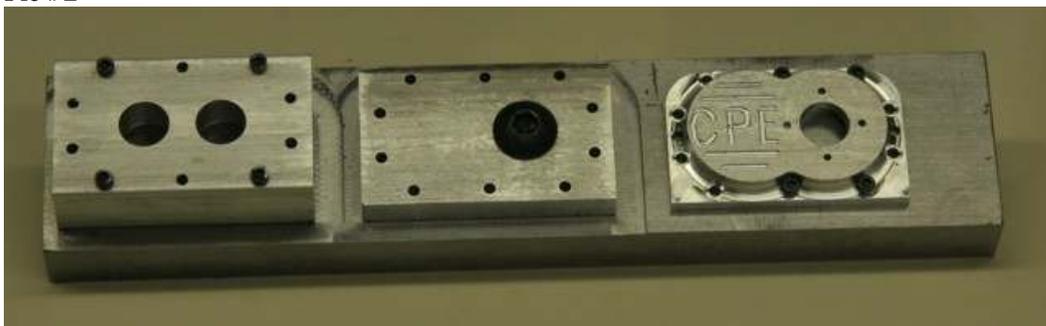
Pic #2

Although the main housing remains the same, the entire front of the supercharger had to undergo a radical change, as you can see from pictures #2 and 3. In the past superchargers the timing gears were exposed to the incoming fuel, which had 20% oil content for lubrication. Since the new engine runs on gasoline, the gears now had to be isolated with their own oil supply. After about two weeks of late hours and extensive CNC programming, I can say that it is finished. Over the past years I made several hundred superchargers with the exposed gears and did not have one failure, so I am very confident that the changes and modifications on the new supercharger will make it as reliable. There are 7 ball bearings, 3 oil seals, 3 "O" rings, and all covers are now "dowel pinned" for exact reference and alignment. You can see the difference in the front housings of the finished supercharger in pictures #4 and #5.

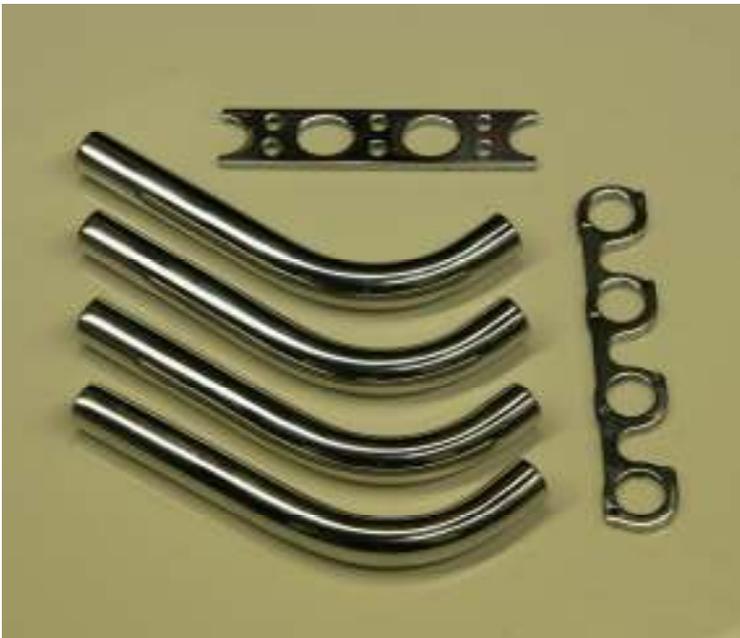
Pic #6

Picture #6 shows the new polished "Zoomie" header components. Notice the CNC header flange and spreader. (The engine will come stock, with the unpolished version).

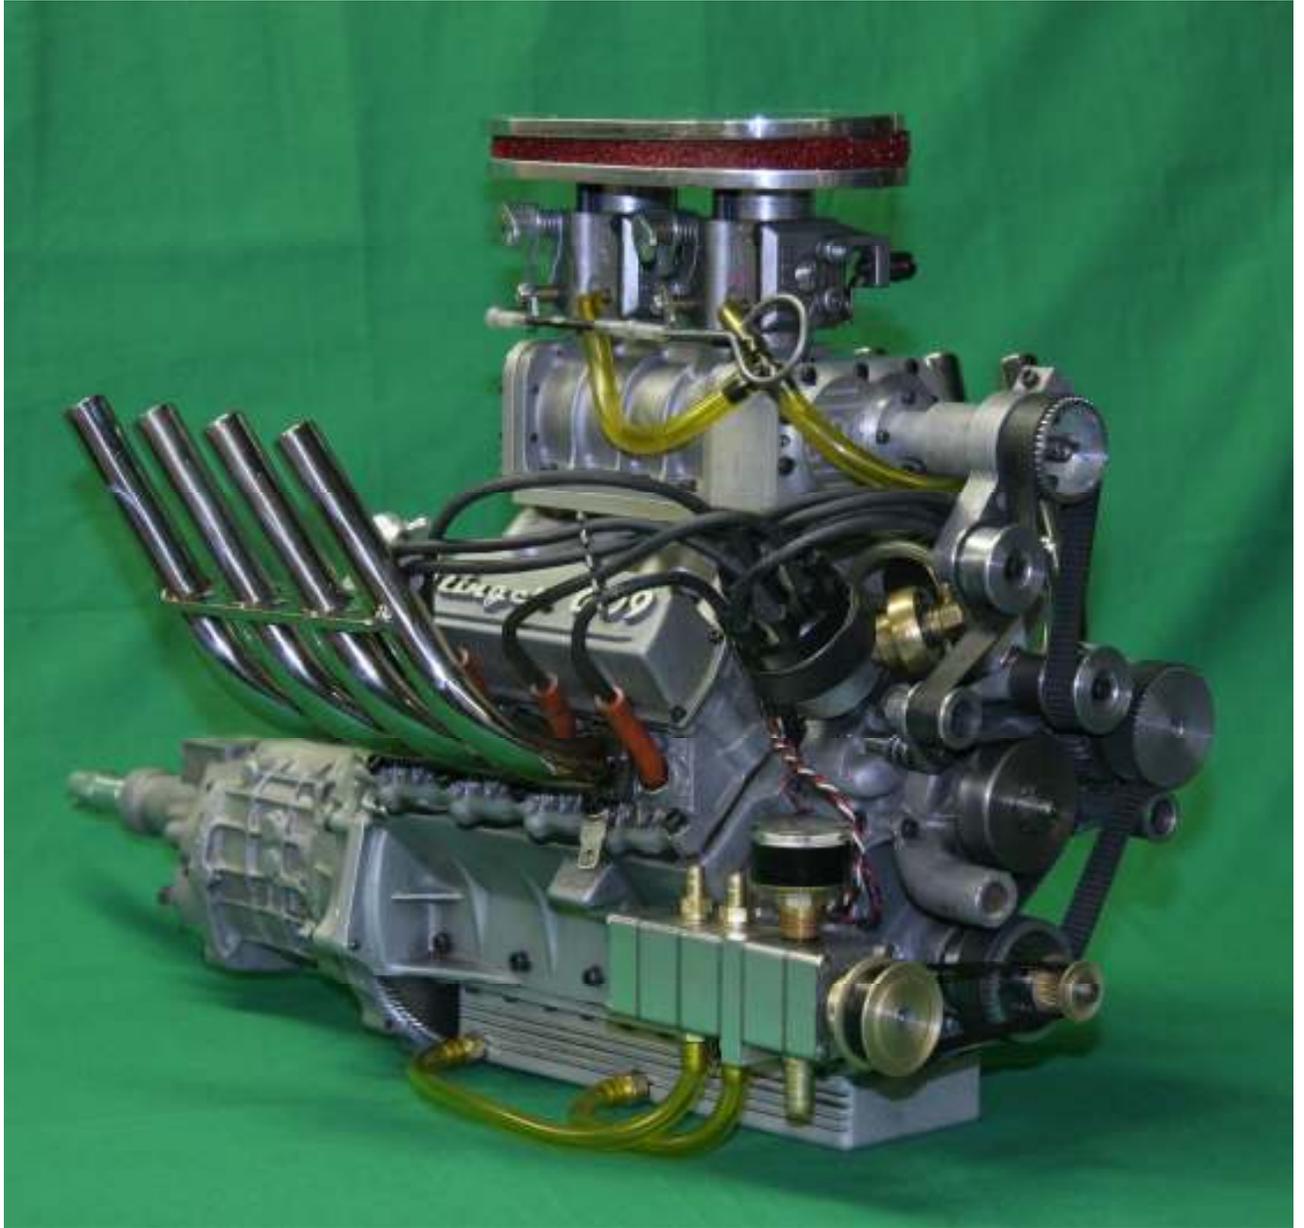
Pic # 7

Now for the great news, picture #7 and 8 shows the finished supercharged version of the Stinger engine. A lot of my current customers have asked what the finished engine will look like. The waiting is over. Although, I have not put it on the Dyno, I can say that it runs great!! No problems. None! Even the carb adjustments were simple. I will be posting a new video of the engine running in the very near future. The last two pictures also show the new Stainless Steel, polished "Zoomie" headers.
