(31 Dec 2007): New Years Eve

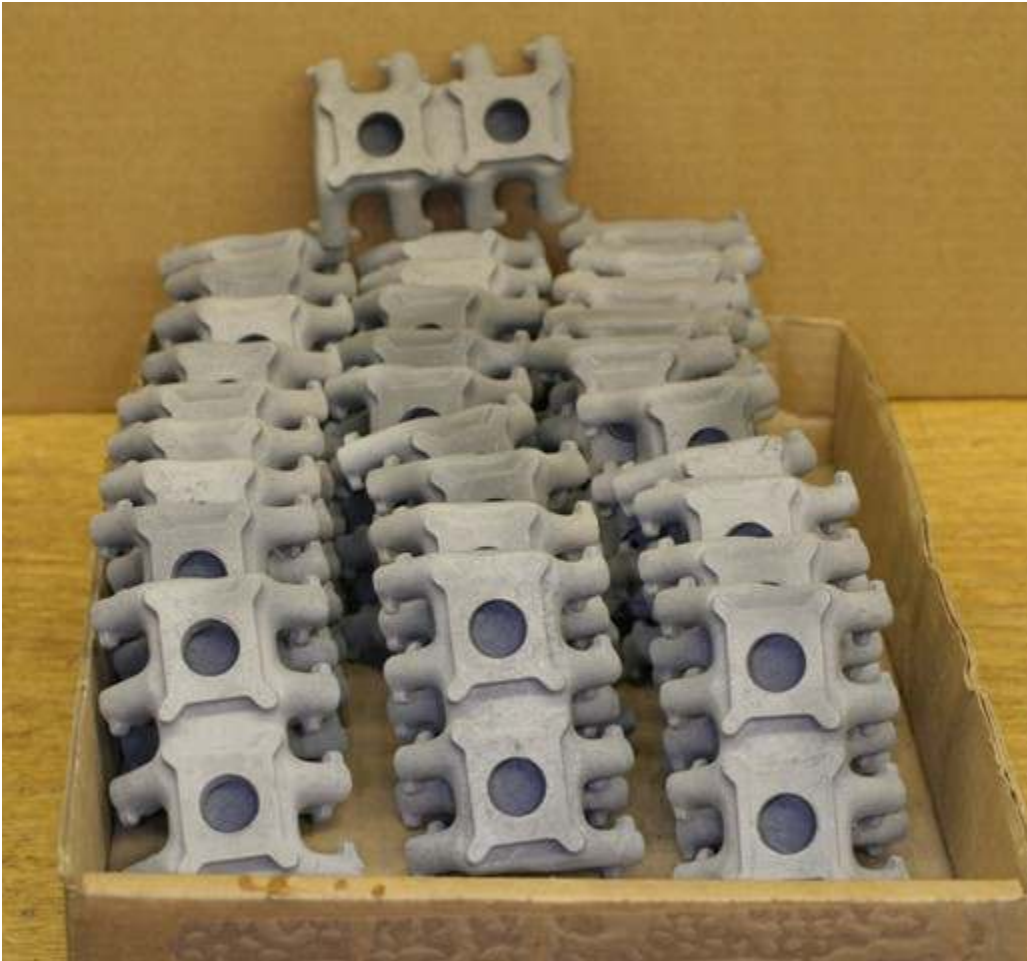
Pic #1

The first picture shows the castings for the intake manifold. Picture #2 & 3 shows the crankshaft being ground to the exact length. When I say exact, I mean between +/- .001. From now on, every machining and grinding operation will be taken from these ground end surfaces. This includes all of the main bearing and rod journals. Since the engine is running pressurized oiling, the center distance, width, and diameter, is critical to maintain the correct oil pressure. Picture #4 shows the flywheel end of the crankshaft ground to length and waiting for the next operation which will be finish grinding the outside diameter of the flywheel end. Once again, I cannot overemphasize how accurate this must be. If the diameter is not exact, then the dowel pins that locate the flywheel will be off center and with the engine spinning over 9,500, this could be a real problem.
