It is not about 6:30 A.M. New Years Eve and I have forced myself to make some time to do an update, before starting to work. I received an email from a customer, asking why I could not do the updates more often, even if it was short and simple. The answer is easy, by the time I set up each item to be photographed, take all the necessary pictures, edit each of them, and write the script, it takes an average of 4 plus hours. There is not a day which goes by that I am not aware of doing an update, so if you do not see one in quite a while, it just means that I am very, very busy, making engine parts. Hang in there, everyone! Add to this, I took a much needed vacation to Costa Rica and returned on Thanksgiving Day – then the Christmas holiday season started, it is easy to see where some of the time goes. Although I was gone and trying to get back into the “swing” of everything, work was still proceeding on the next run of engines. If you remember, the heads were in the process of having the valves lapped. When you consider that each head takes about 1+ hours, and there are over 160 heads, with any luck it will take over 4 weeks, just for lapping the valves. In reality it has taken almo

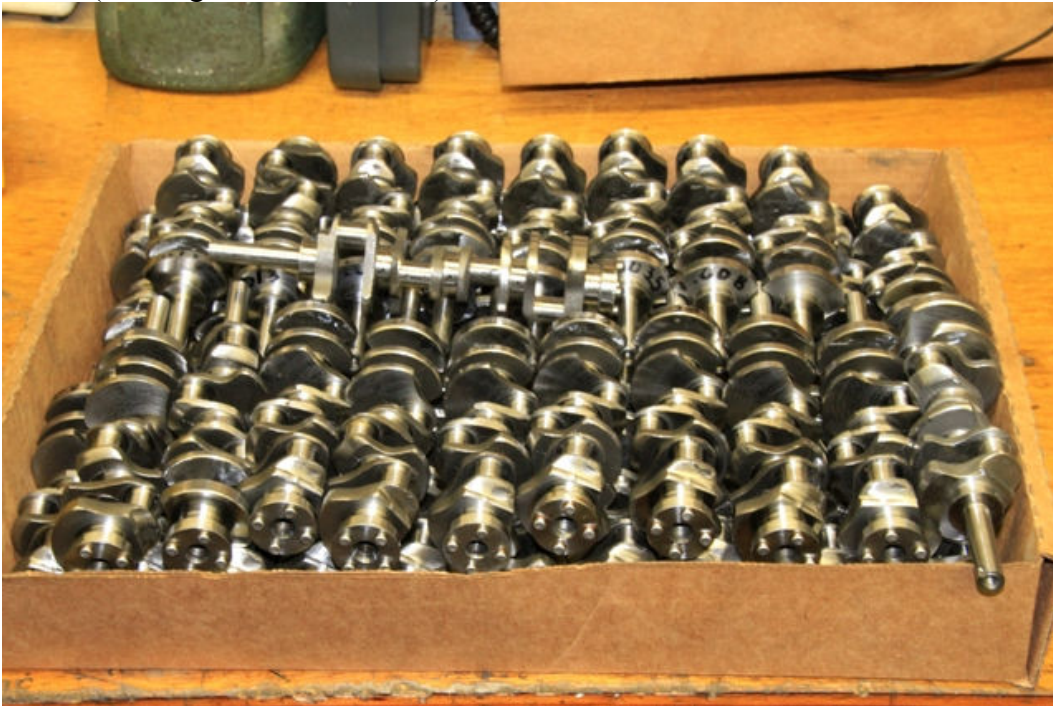
Pic #1 (Finish ground crankshafts)

The crankshafts are finish ground and in stock. I only need to drill the oil holes and machine a small alignment notch in the front of each. In the scheme of things, this is quite small.

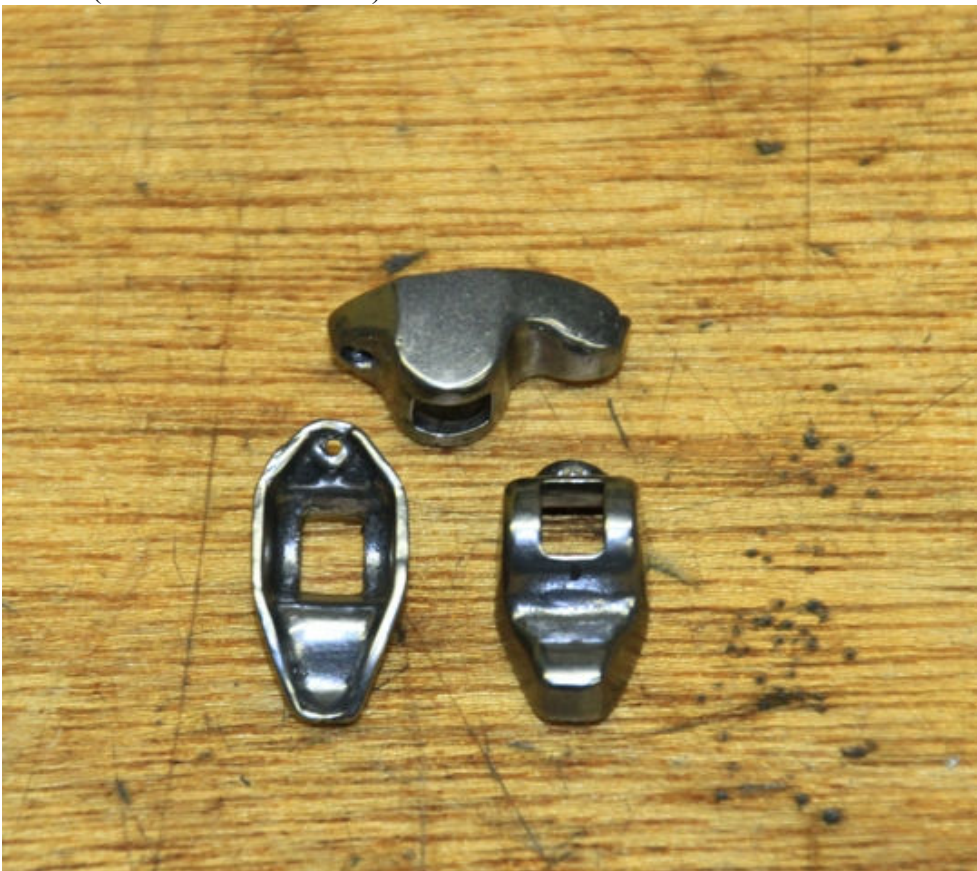
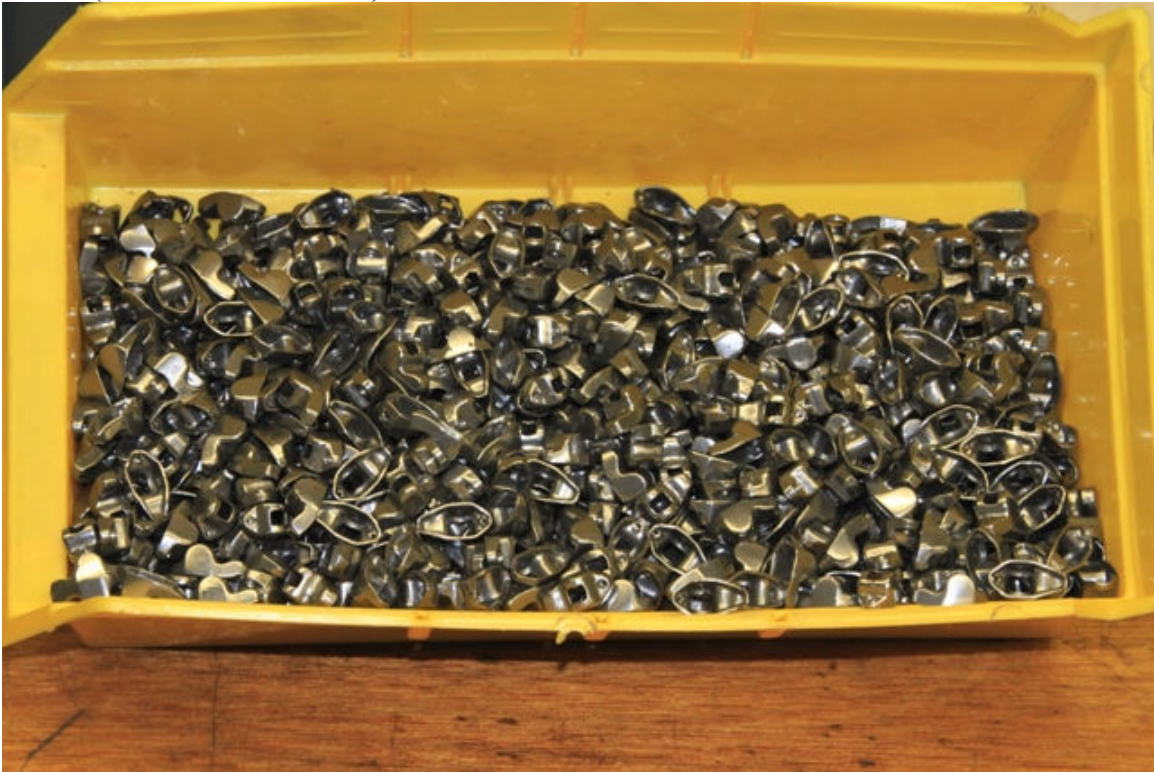
Pic #2 (Finished rocker arms)

Pic #3 (Finished rocker arms)

The rockers have been finished, along with the pivot for each. They were then put in a vibratory polisher for about 3 days.

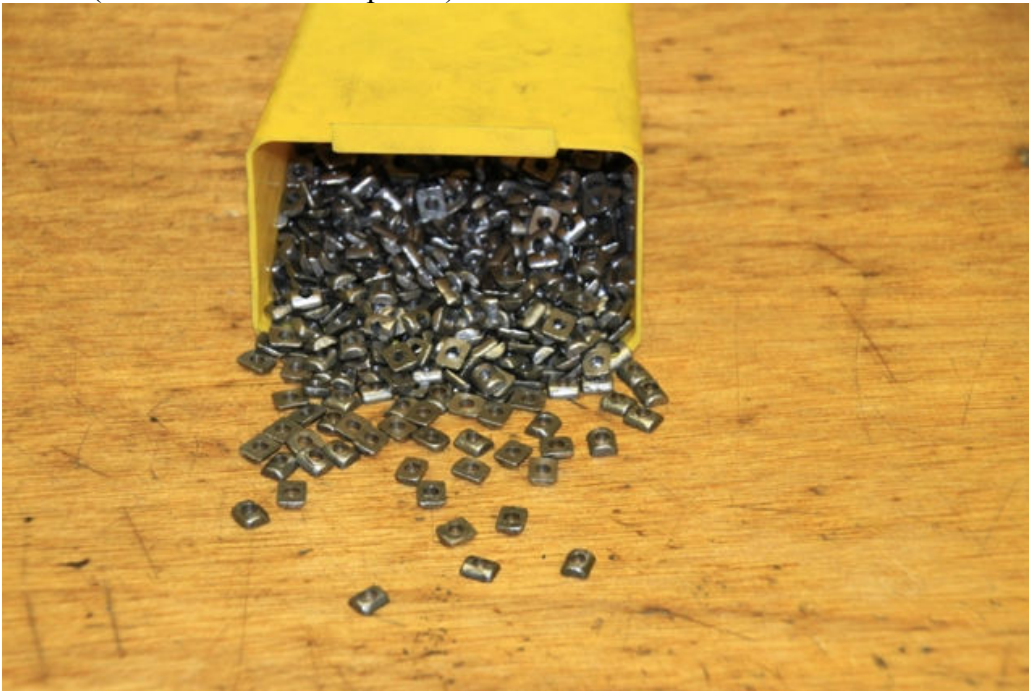
Pic #4 (Finished rocker arm pivots)

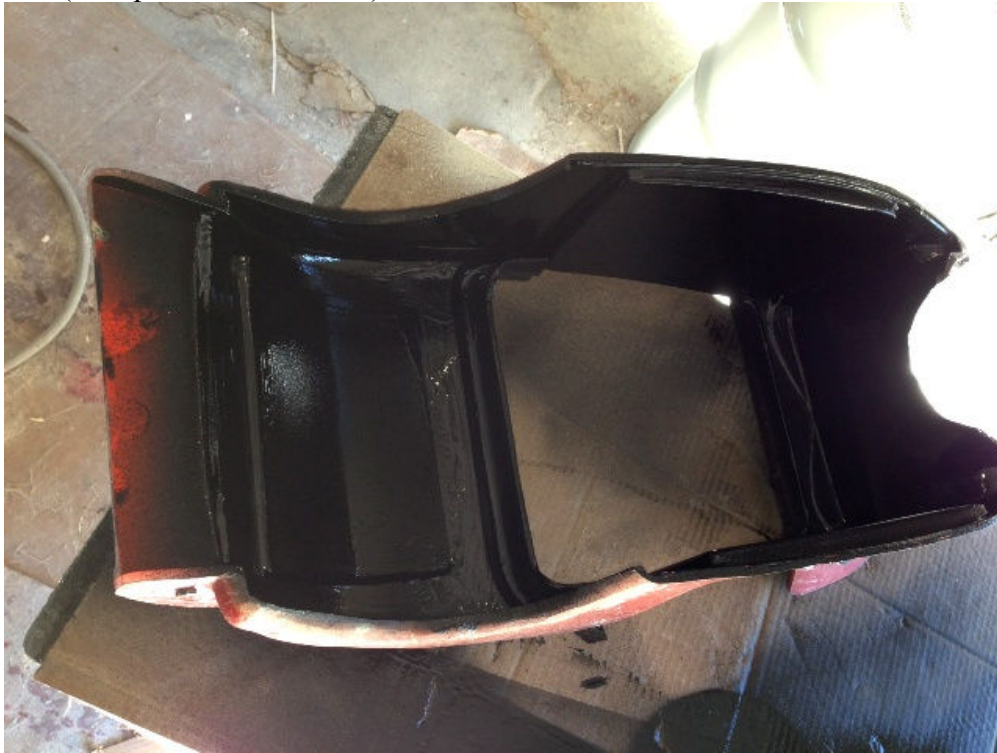
Pic #5 (Completed mold for 34)

Finally, the 34 body mold is finished and I should have the sample, for testing, by the end of this week. As you can easily see, a lot of “things” are happening at one time.

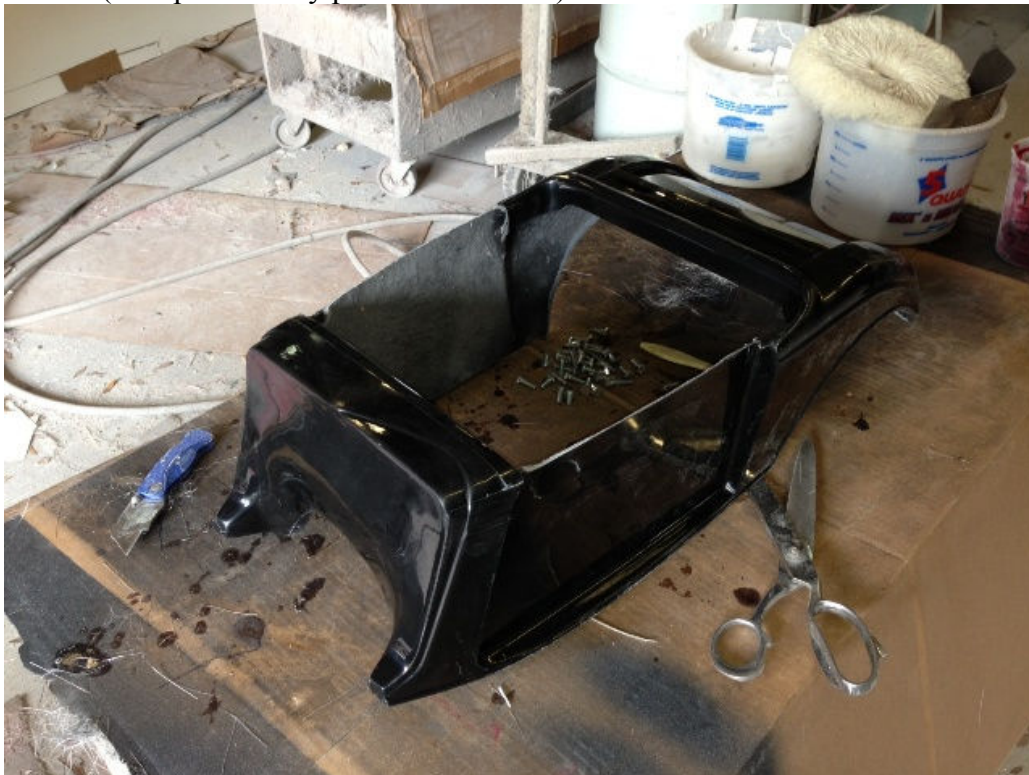
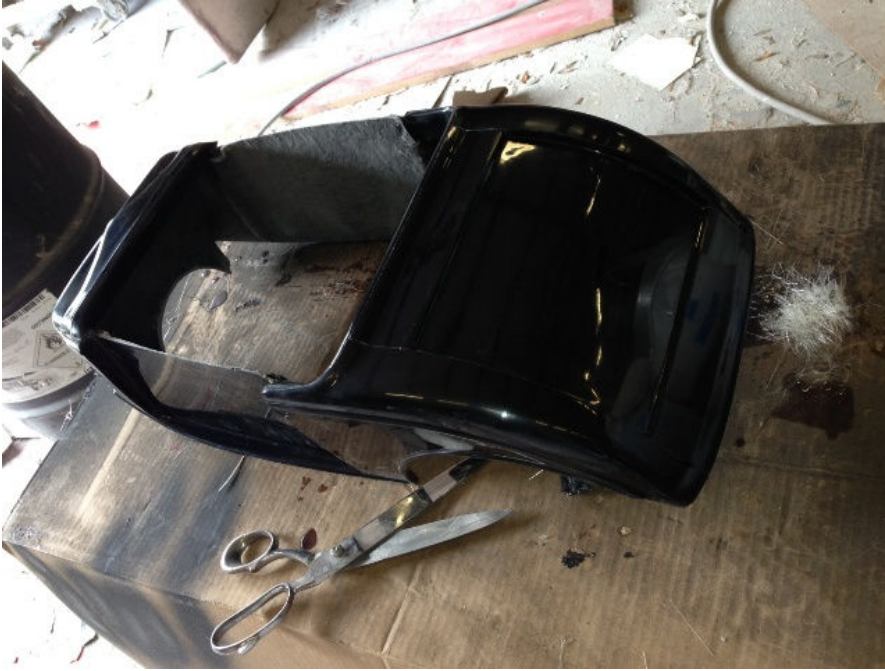
Pic # 6 (Completed body pulled from mold)

Pic #7 (Completed body pulled from mold)

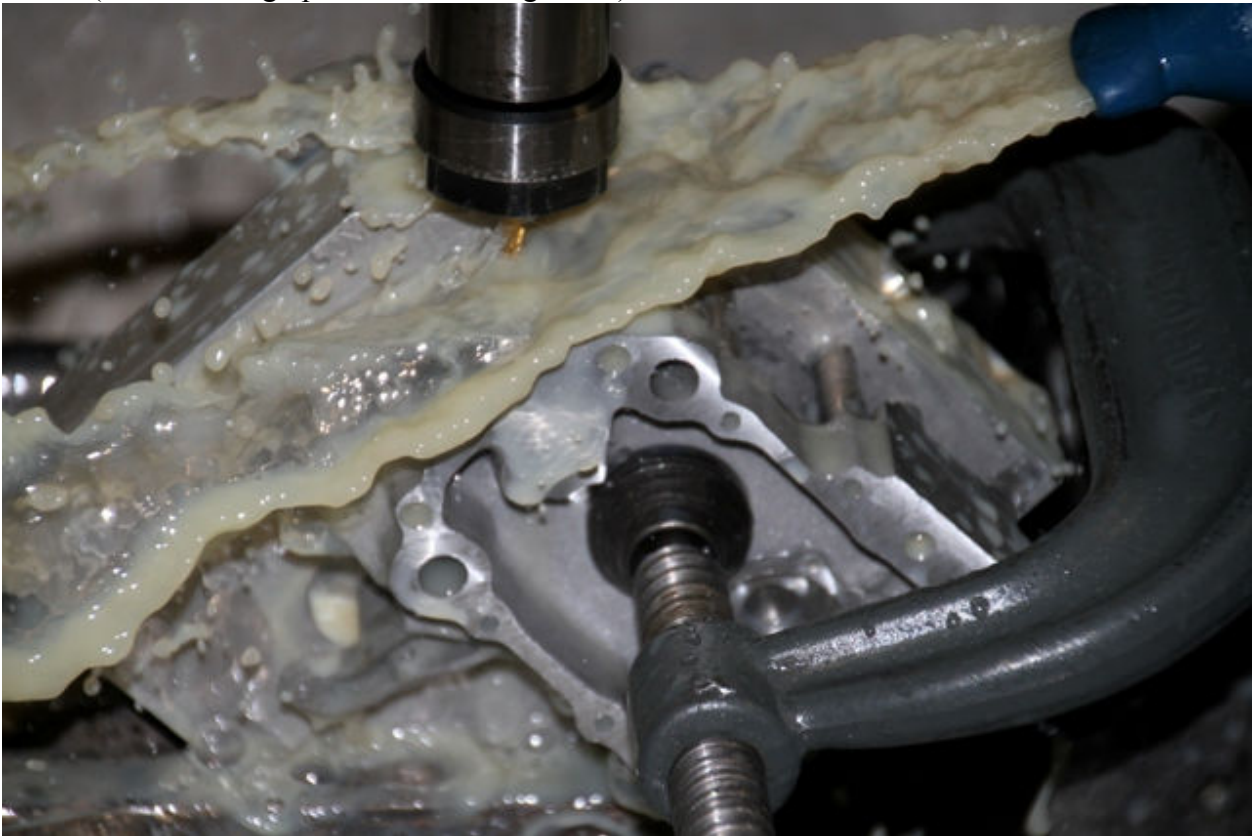
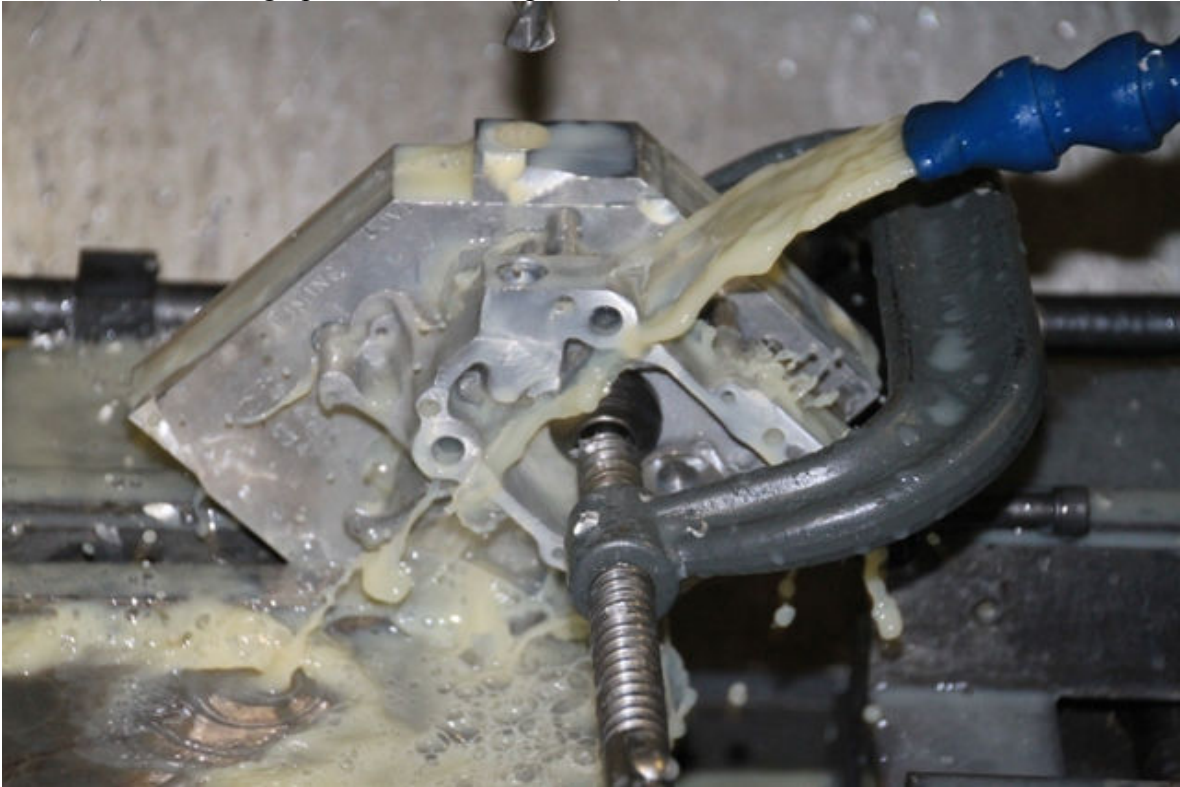
Pic #8 (3rd machining operation on timing cover)

Pic #9 (3rd machining operation on timing cover)

If that were not enough, I have completed the 3rd machining operation of 8, on the timing covers.

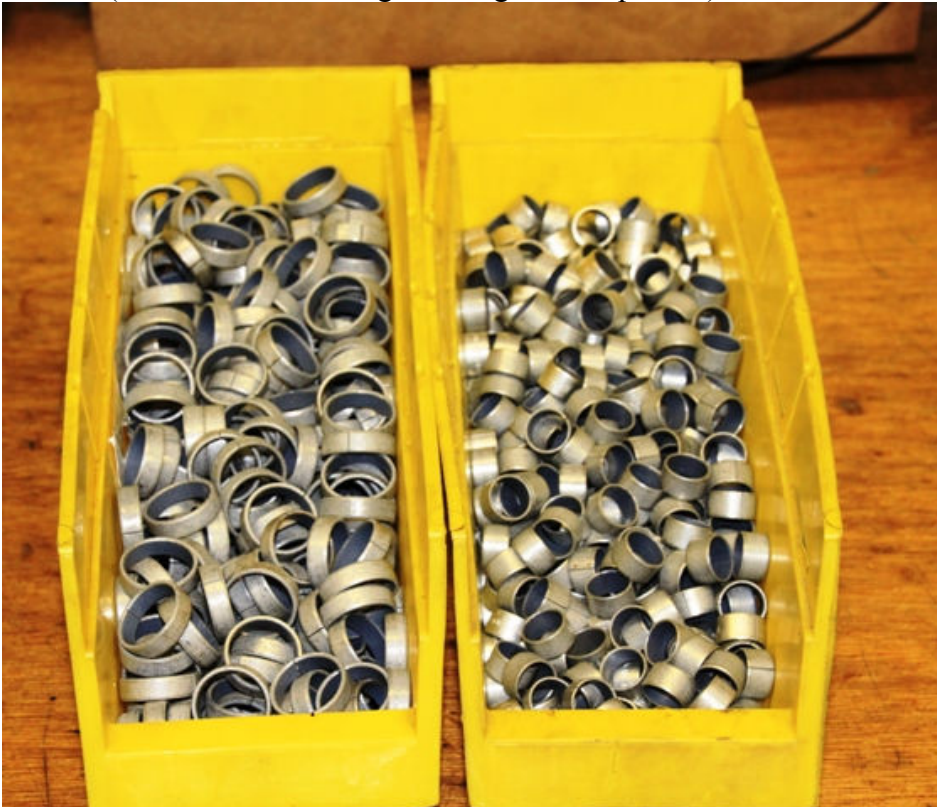
Pic #10 (Main and rod bearings waiting for completion)

I almost forgot to say that the main and rod bearing are in. A little machine work and they will be ready to install.
