O4 January, 2009

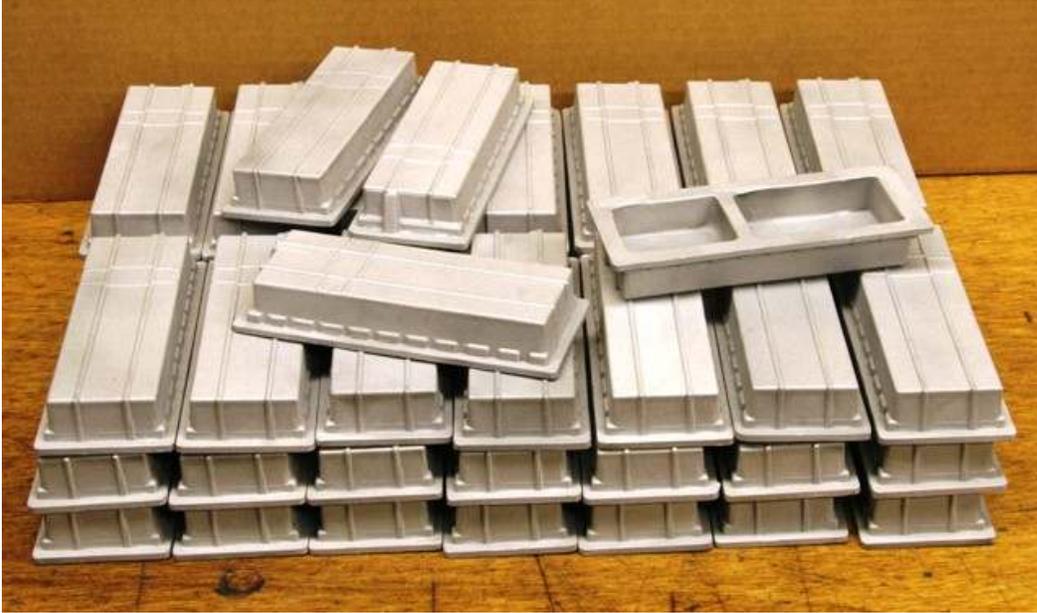
Pic #1

It seems as though I just did a weekly update recently, but upon further examination the last one was December 15. I truly do not know where the time goes? A lot has happened over the past three weeks. The finish castings for the pans arrived, as you can see in picture #1. The teeth on the starter ring gear have been cut, picture #2. The distributor drive gears have also arrived, picture #3. Progress on the blocks is doing extremely well. All the water passages have been drilled and I am now in the process of making the main bearing supports. Picture #4 shows what has to be done to drill just one water passage hole.

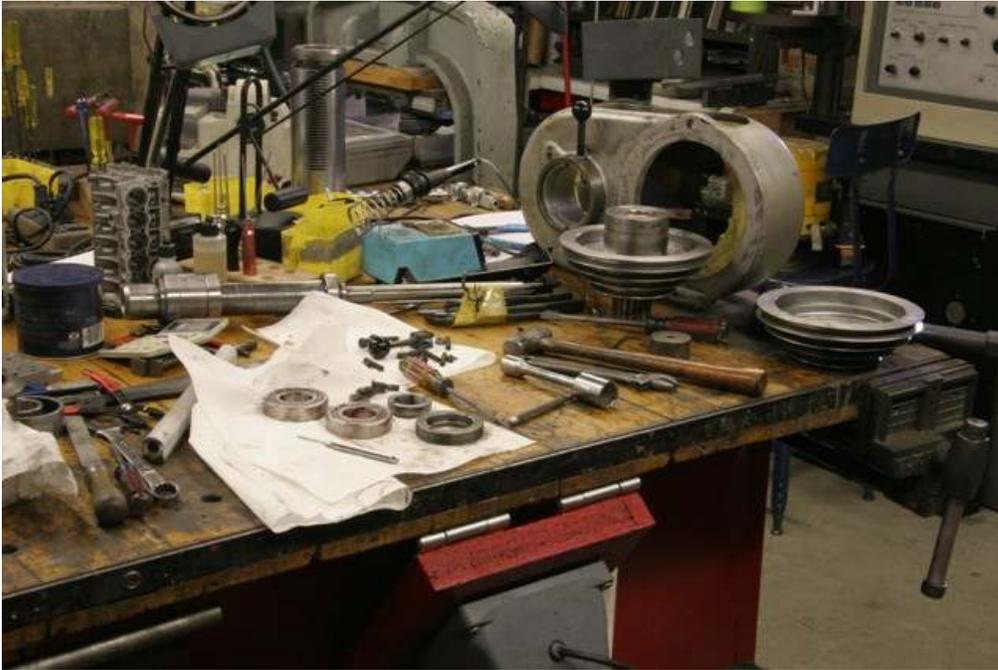
Pic #5

Unfortunately, things do not always go as planned. It all started with I attempted to make the jigs needed for holding the rough cut main bearing caps. This is where 5 days of "hell" ensued. The surface finish on the steel was very rough and nothing that I could do was making any improvements! Remember, this Friday the day after Christmas. Reluctantly, I removed the spindle from my manual milling machine and was unable to find any significant problems. The next item that was removed was the entire quill. This proved to be a "Pandora's Box" of gremlins! Unfortunately, it did not come out as expected. After a few choice words and 3 hours later, the quill was out. Over the years, and the constant up and down motion had made some significant abrasions, not only on the quill, but in the head castings. Another 4 hours of carefully polishing and fitting and the quill was like new, or so I thought. Picture #5 shows what happens when all the components of a Bridgeport milling machine are removed. On Monday morning I attempted to replace the quill, but unfortunately something happened and it would not slide smoothly. Another 3 plus hours of hand fitting, some choice words, and the quill and spindle assembly was installed. During this installation process the quill cover was installed backwards. This is a small sheet metal cover which keeps out any particulate matter when the quill is all the way down. Another hour was spent to remove the quill and reinstall the dust cover. All the components were reinstalled and bolted down, including the motor, which was rewired to the switch. In my haste to put the covers in place, somehow the "V" belt had been overlooked. Another 2 hours and everything was operational. I made another cut on the proposed jig material and the surface finish had not improved. If anything, it was worse! The inevitable solution was replacement of the spindle bearings and almost \$500.00 dollars later, everything was working fine.

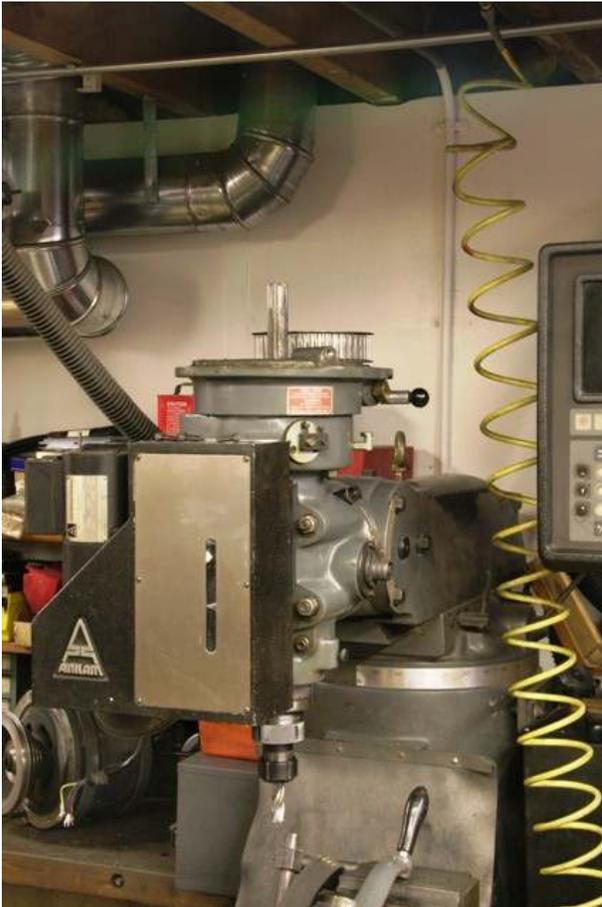
Pic #6

It is now Tuesday, December 30th and I needed to use the CNC mill for drilling and machining the, now "square" pieces of metal for the main bearing jigs. When I went to turn on the motor on, nothing happened. After removing the cover on the switch, I observed pieces of the switch that had broken and were laying in the bottom of the box. Once again, "Pandora's Box". Without going into a lengthy explanation, the switch was extremely difficult to locate! It arrived on New Years Eve. Not only did I replace the switch, but the brake shoes needed to be replaced. Once again, not an easy job! Pictures #6 & #7 shows both machines without motors or top housings.
