Now, down to what has been happening in the past weeks. The air cleaner bases and tops are completed and ready for installation. The same is true for the air cleaner element and stainless steel grate.

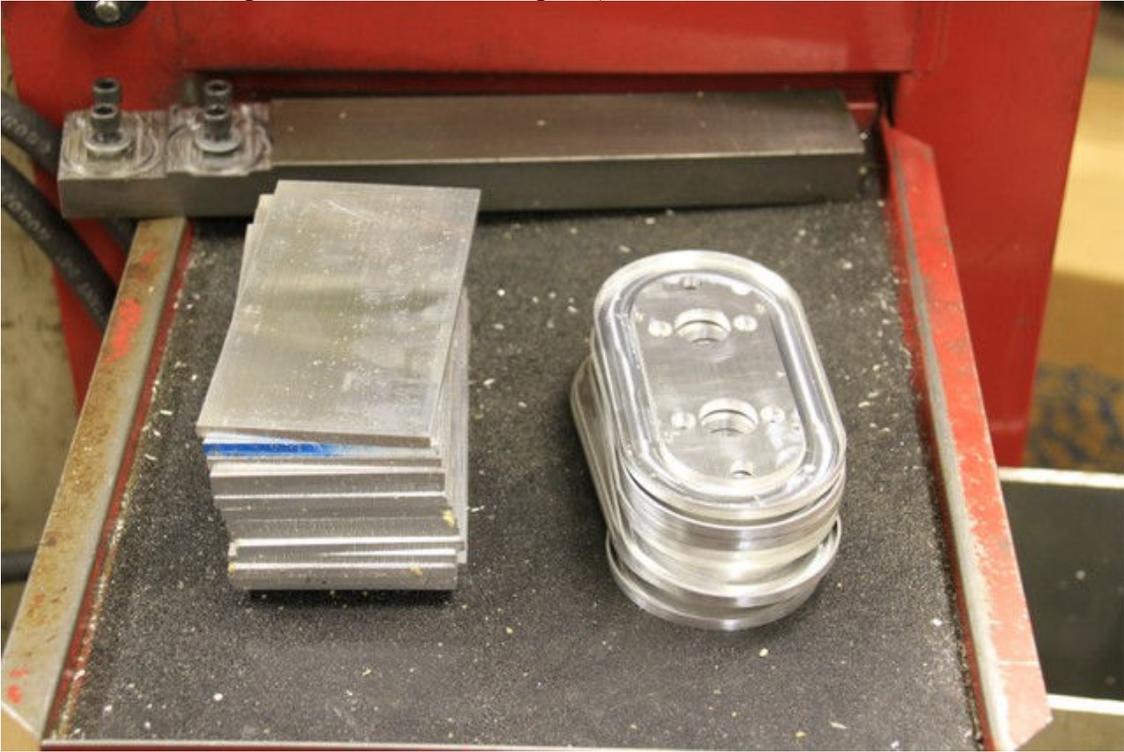
Pic #1 (Partial completed air cleaner base plate)

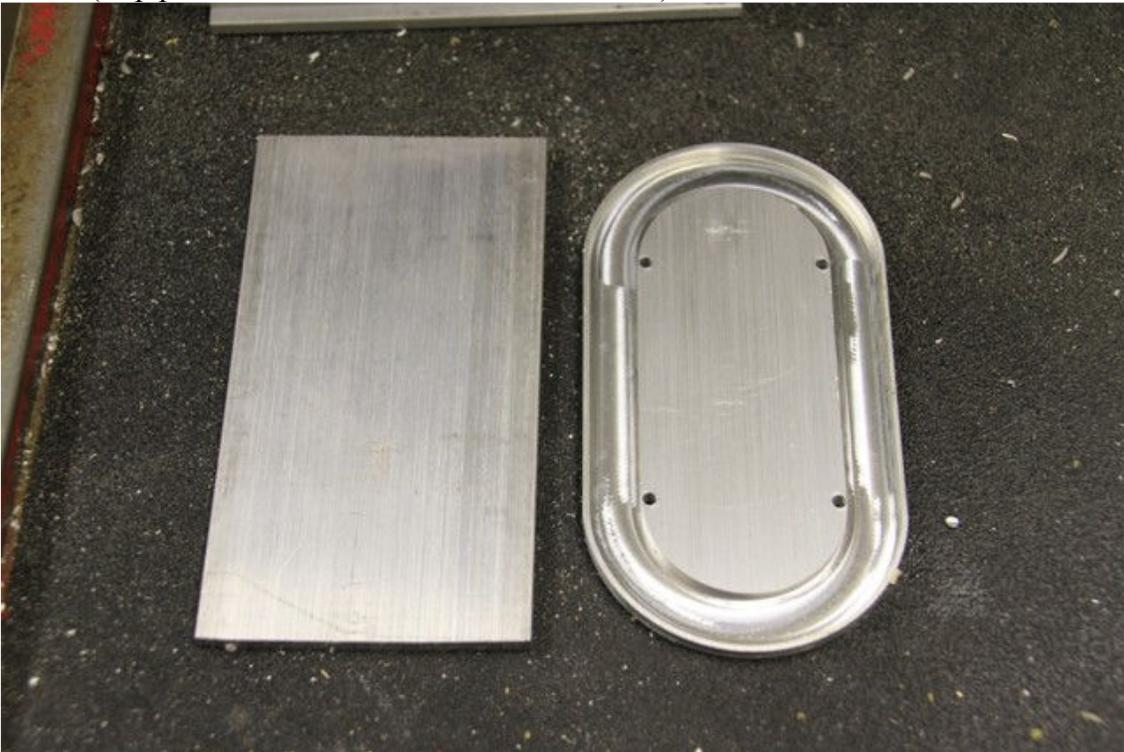
Pic #2 (Top portion of air cleaner – before and after)

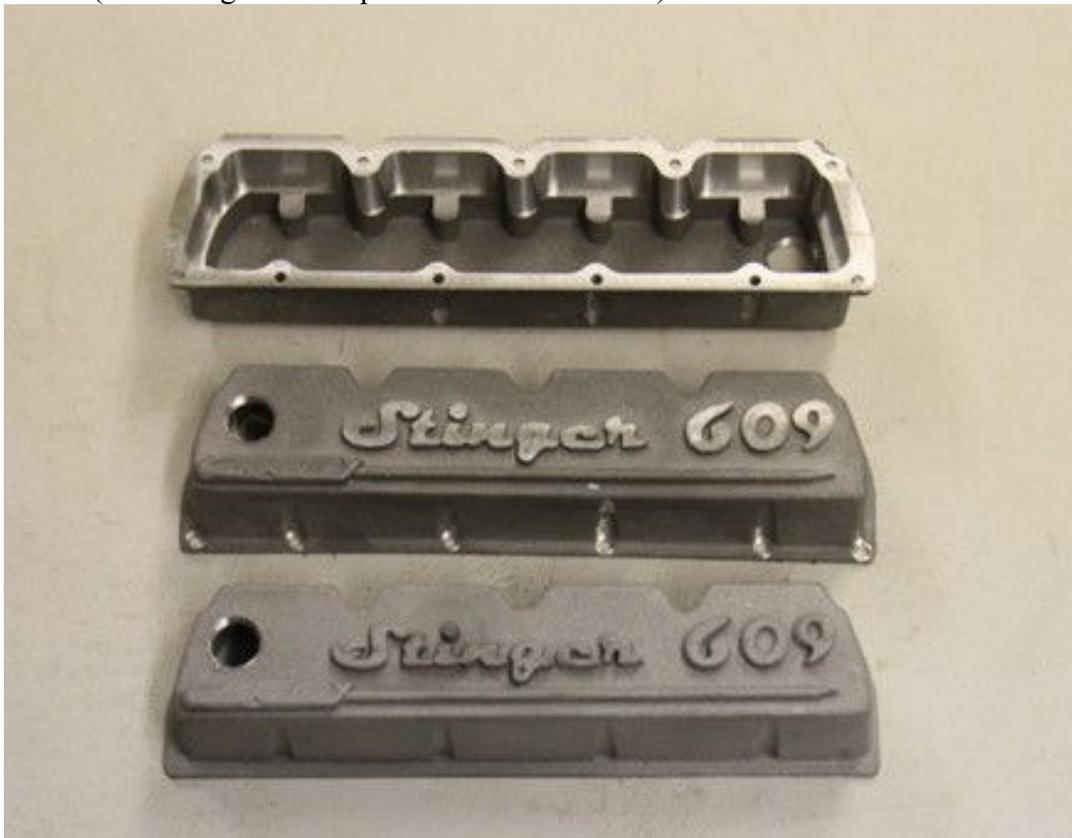
Pic #4 (Three stages of completion on valve covers)

The valve covers are machined and ready for glass beading. I should also tell everyone the program for machine just one valve cover takes over 10 minutes to complete. If you multiply this times 150 valve covers, it is easy to see how much time is needed.

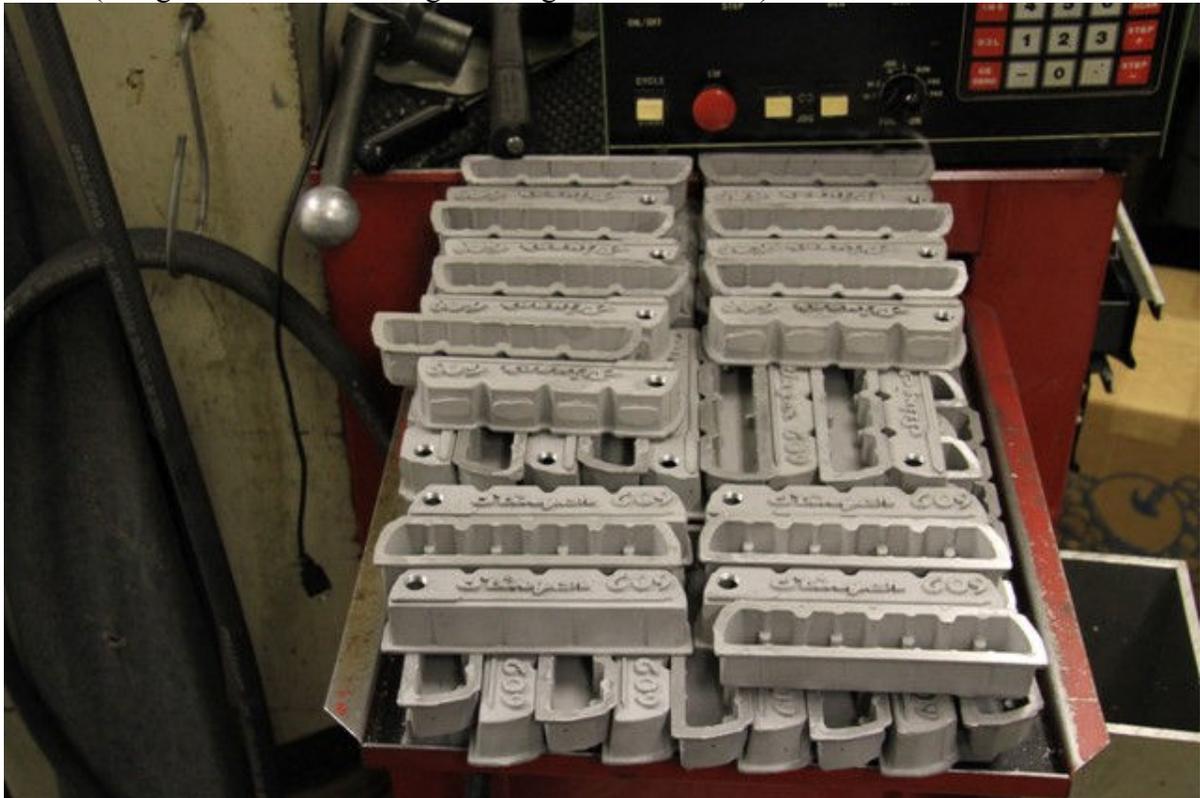
Pic #5 (Rough valve cover castings waiting to be machined)

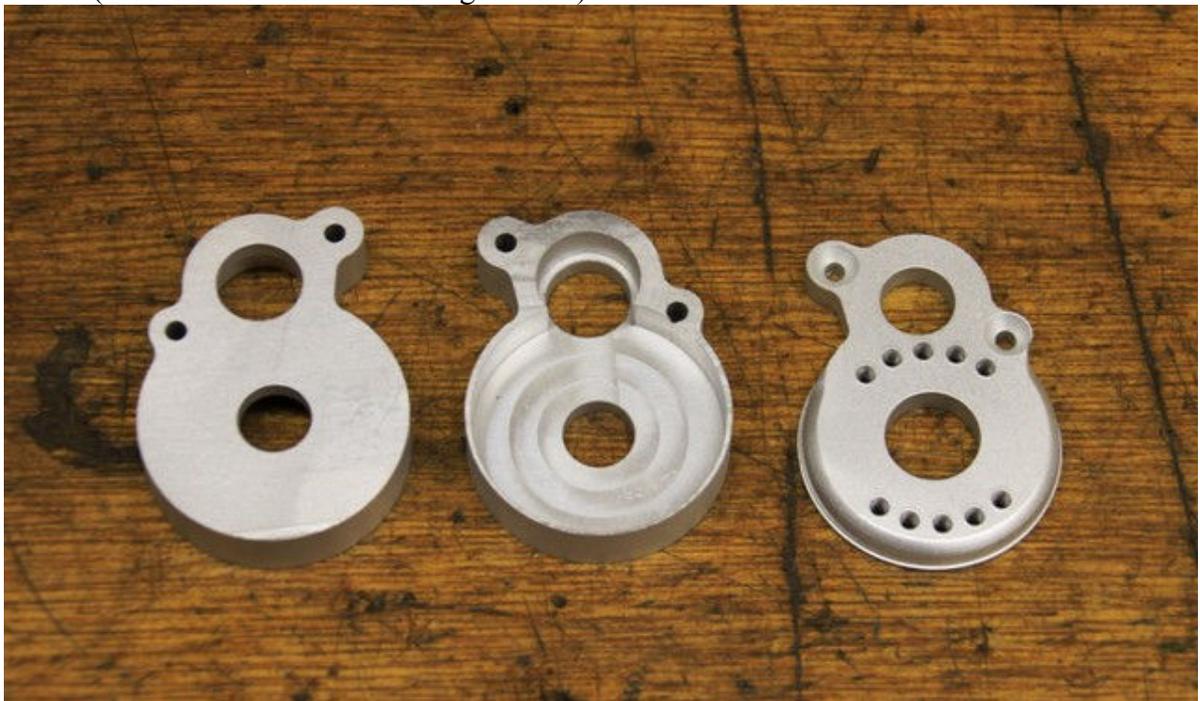
Pic #6 (Pieces of new starter motor gear case)

The gear cases for the new starter motor are all completed. The final pictures show the bearing support being machined, which will be installed in each gear case.

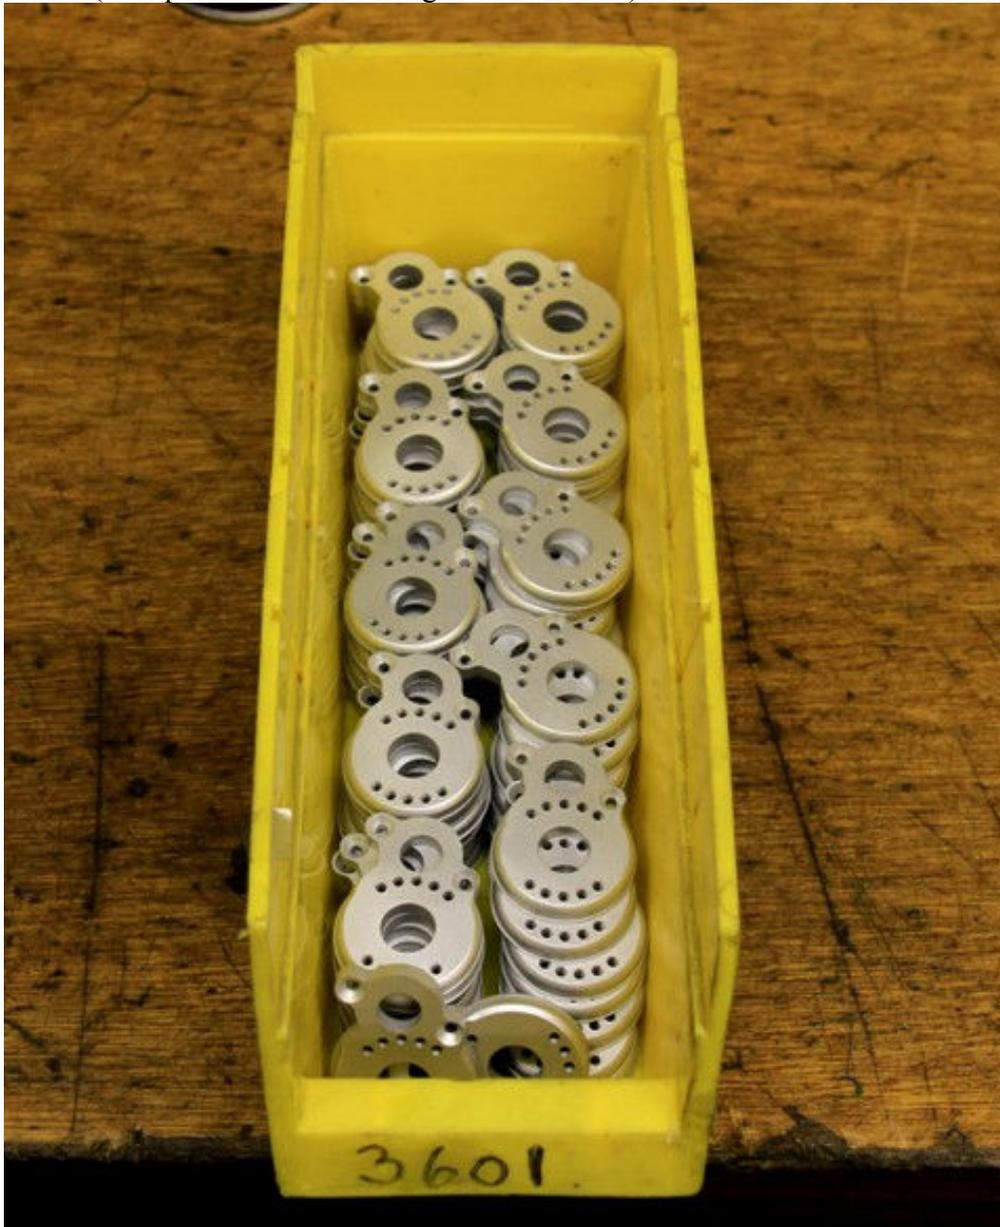
Pic #7 (Completed starter motor gear case halves)

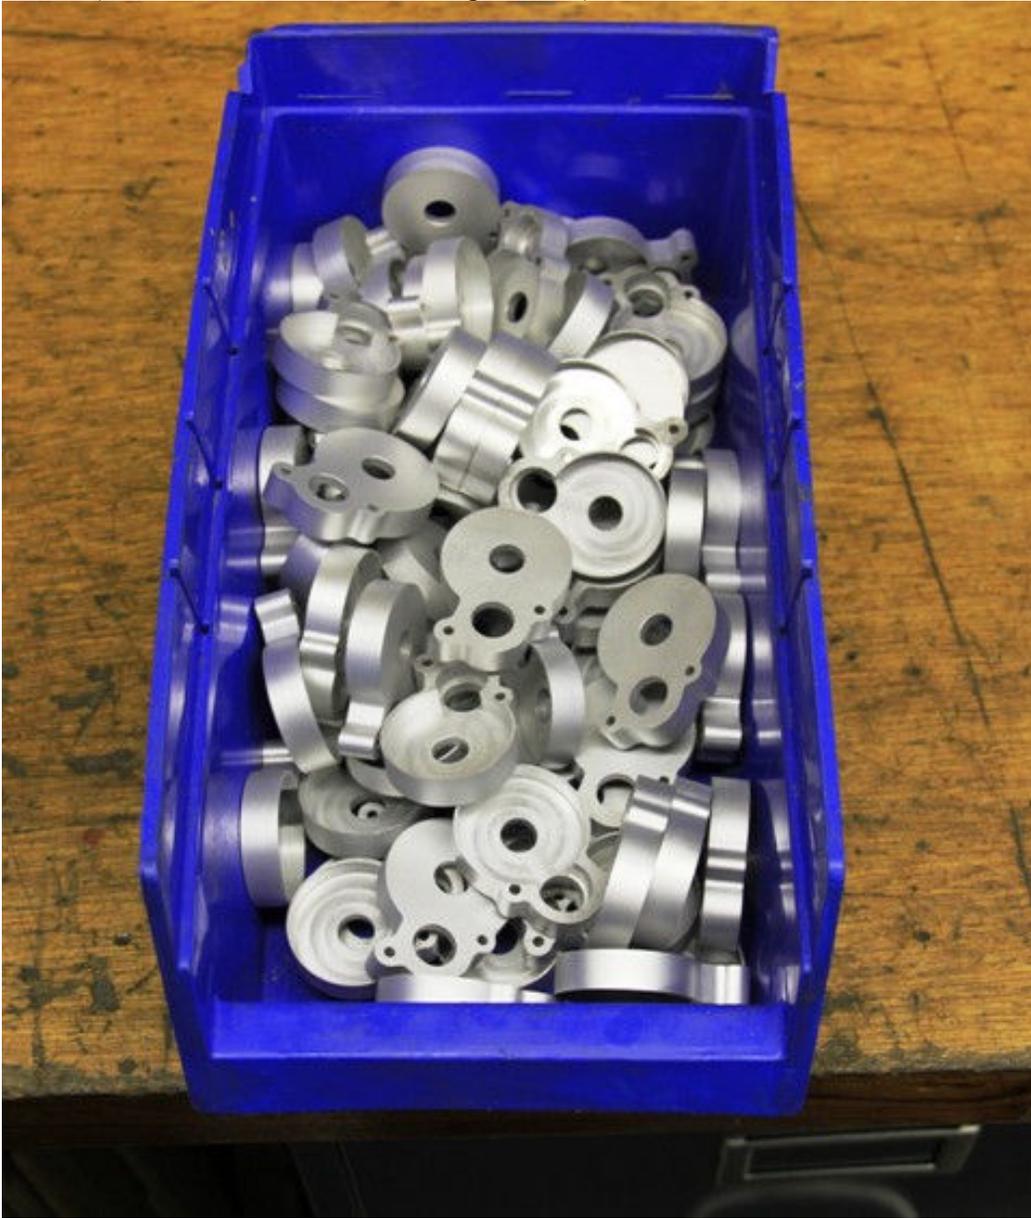
Pic #8 (Second half of starter motor gear case)

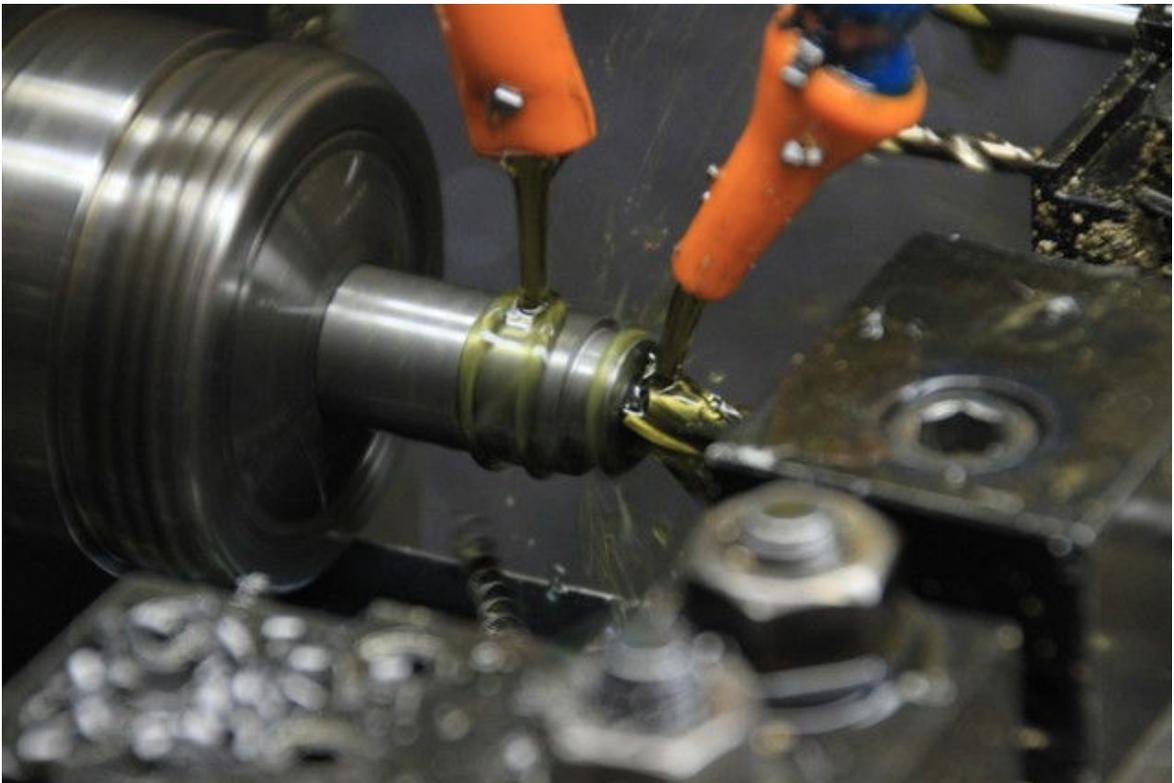
Pic #10

Pic #9 & 10 (Machining bearing support for new starter motor gear case)
