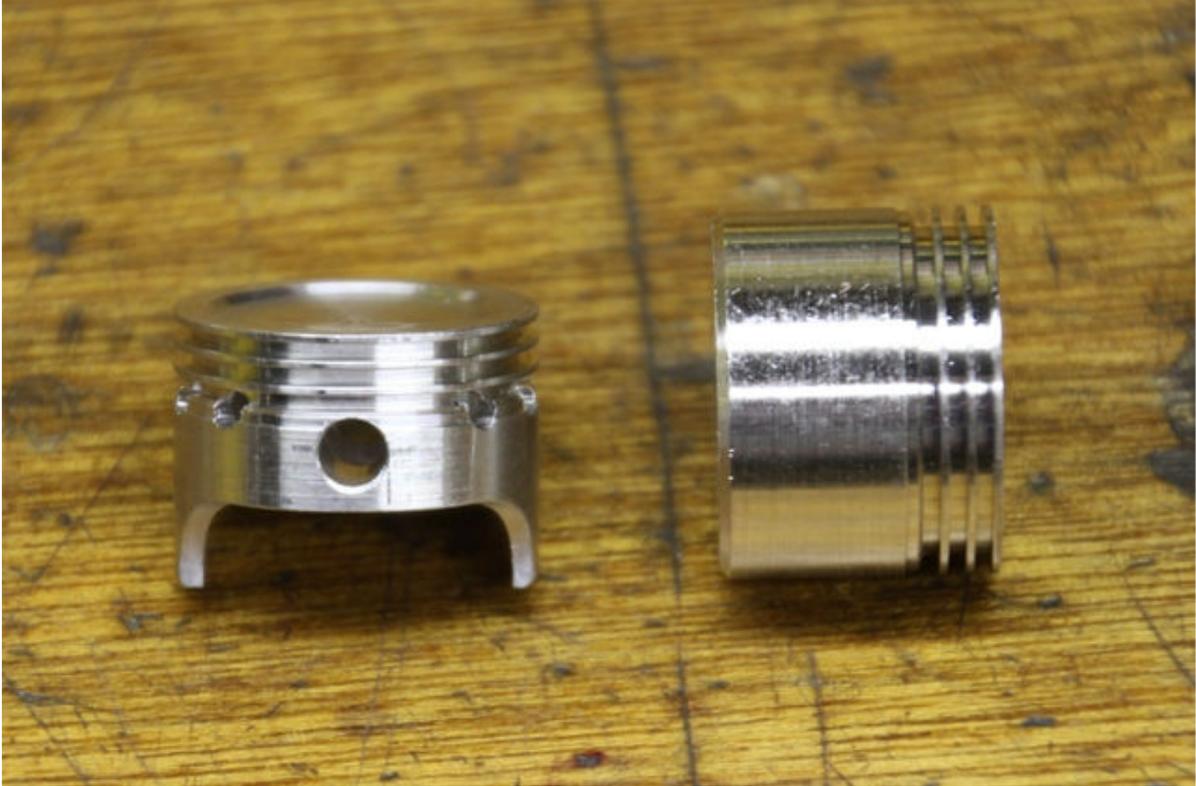
The pistons are finished and have been taken to be centerless ground. When completed then each must be machined. Picture # 1 shows the finished piston on the left and the newly (un-ground) piston on the right. You can see immediately the work which must be done to complete the pistons. Once again, there are no short cuts.
