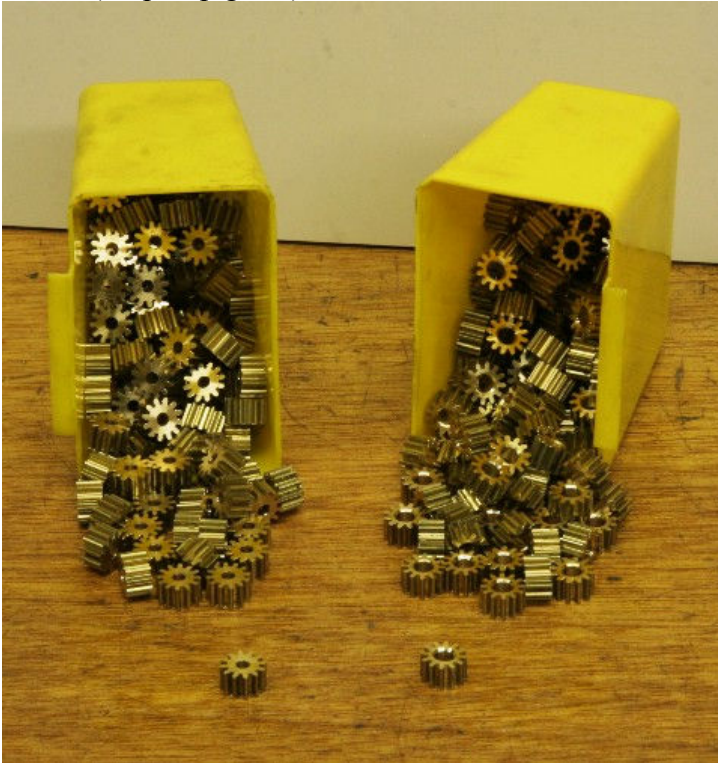
Pic #3 (oil pump gears)

It almost the first of November and at the risk of repeating myself - where does the time go? It is all a complete blur sometimes, because my days start at 6:30 am and often end past midnight. Seventeen hours is a long time to be on your feet and this is almost an everyday occurrence. I am not complaining but rather trying to understand where the time goes so fast. At initial glance the first set of pictures show some short rods of different length, which look to be quite simple. In fact, the three shafts on the left side of the picture are for the oil pump, the fourth from the left is the water pump shaft, and the larger of the shafts is for the distributor. Not only did each shaft have to be the exact length, but each was ground to .0005 under size. That is not 5 thousands but rather 5 ten-thousands of an inch. There will be a series of flats machined on each end and then the gears will be attached to each shaft. Speaking of gears, pictures #3 & #4 show the gears after they have been lapped. This process brings them to the exact thickness, which is critical to maintain oil pressure. The gears are purchased in 4 foot length and then machined. The finished gear with the small hole is not driven via a shaft but is the counterpart for completing the oil pump. It is becoming very evident that this engine is requiring more than originally anticipated. One would think that since I designed the engine I would be aware of all that was needed. Keep in mind when you only make one pump for the prototype, it was not too difficult, but when you need to make 50+ everything changes. There are almost 60 parts that go into each pump and this is only one component of the engine.

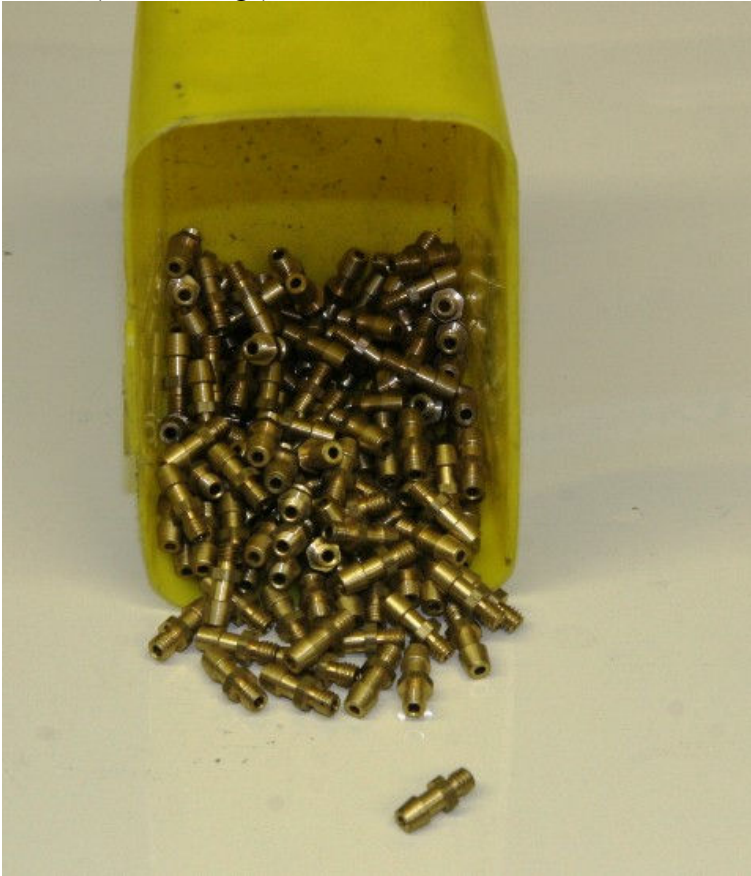
Pic #5 (Barb fittings)

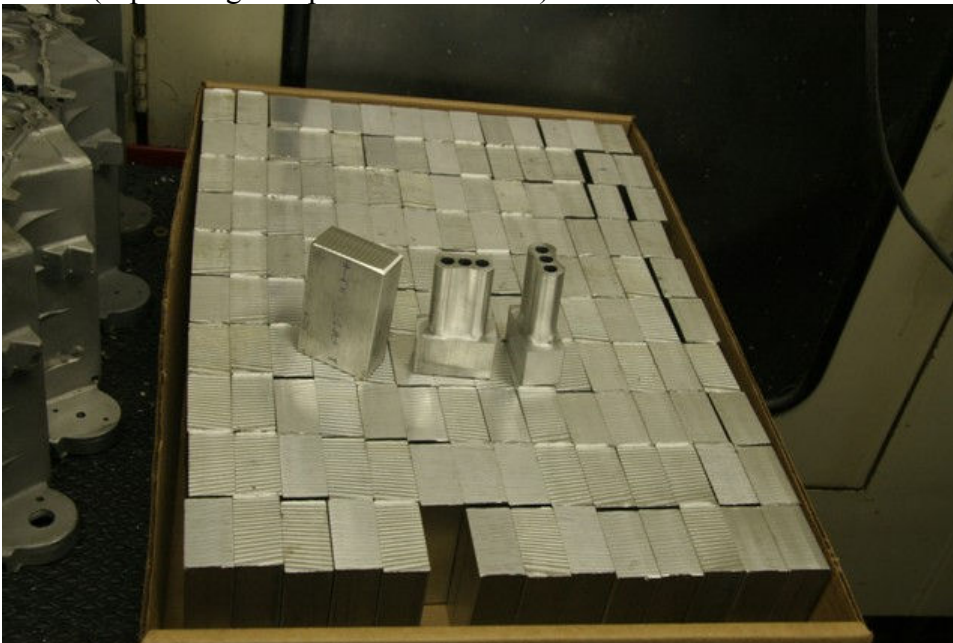
Pic #6 (supercharger impellers and blanks)

The final two pictures show the net result of over 3 solid days and sleepless nights. The supercharger impellers must be EXACT! Although you might think this would be simple operation with the CNC equipment, in fact this program was probably one of the hardest that I have ever had to complete. It literally started last Friday morning and consumed the entire weekend. Monday morning was used to make the final changes and I can say that the pieces are coming out perfect. Because of the clearance that must be maintained, there are over 600 lines of code to machine the outside contour of each impeller section. Once finished the square is removed from the bottom end, then a shaft and two pieces of chrome-moly tubing are pressed into two identical pieces. The gears are attached, and then two sets of completed rotors are timed. Once again, this process must be exact. If not, then the impellers could come in contact with each other which could be catastrophic. Not only must the clearance between rotors be maintained, the rotor to housing clearance is just as critical. More about the assembly of the supercharger will be in later updates.

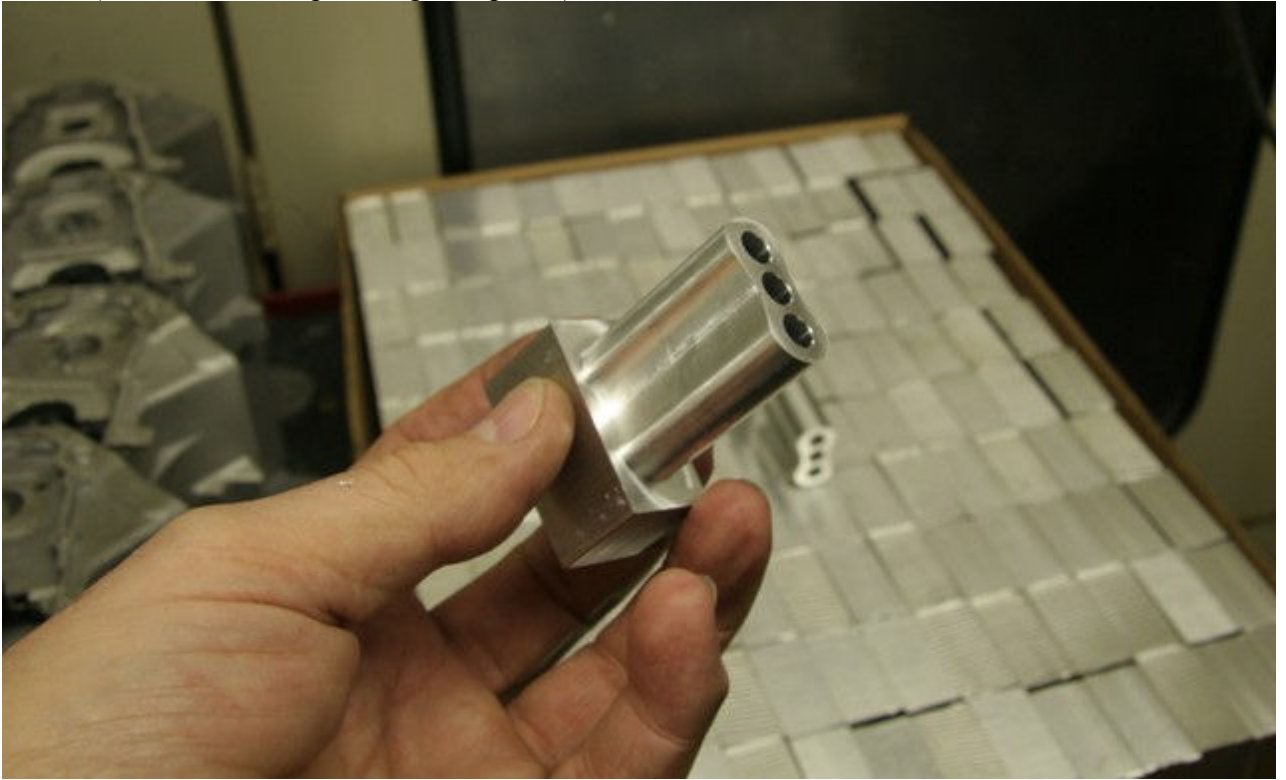
Pic #7 (semi-finished supercharger impeller)
